Rendezvous Sensor on ATV:

Fiber Optic Link of Optical Head and E-Box

Investigations after Fiber Rupture on ATV Cone

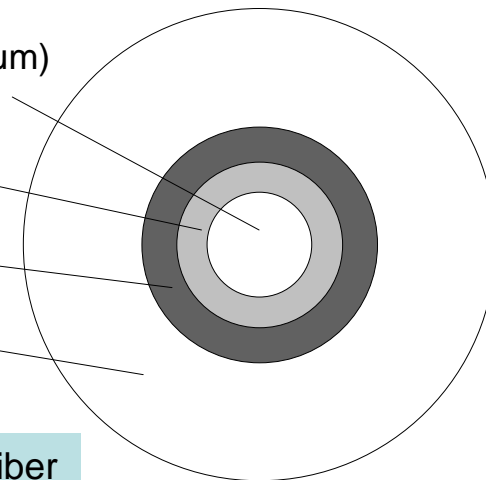
Cross section of the Step index fiber

Undoped fused suprasil silica core -F100 (\varnothing : 200 μ m)

Fluorine doped cladding (\varnothing : 278 μ m)

Polyimide coating (\varnothing : 310 μ m)

FEP secondary coating (\varnothing : 600 μ m)

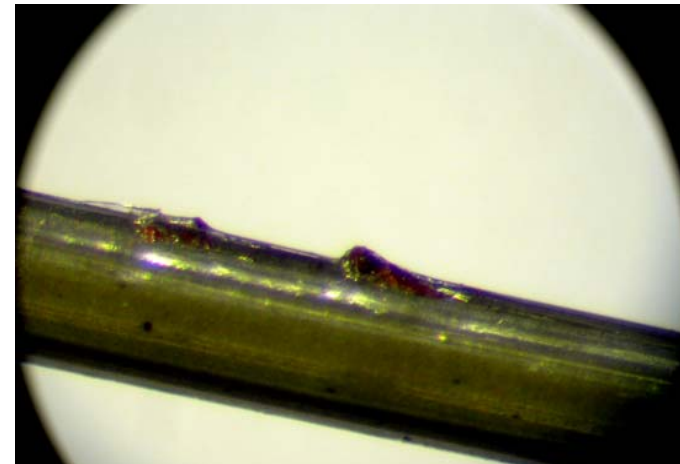
- F) Some irregularities were visible on the coating surface, not leading to increased risk of break

Surface irregularity on a cut of the Step Index fiber

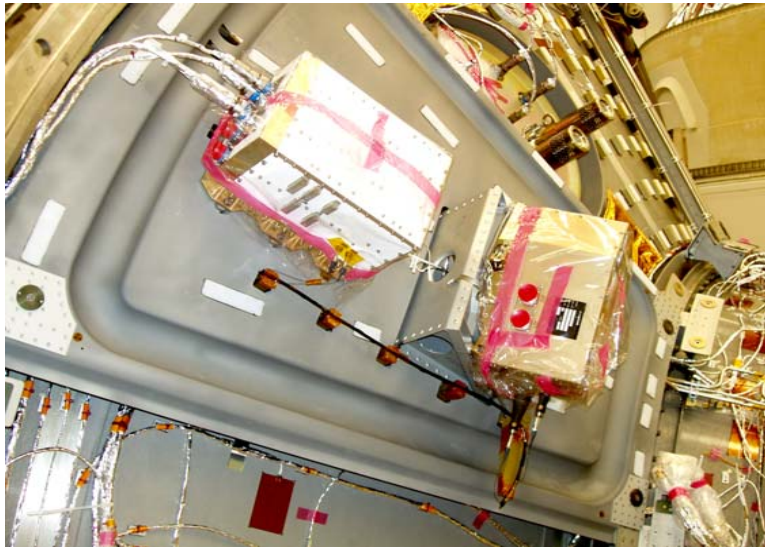
RVS on the ATV cone

Appropriate fiber handling is an important prevention of fiber break. The broken fiber (as well as the 3 other fibers on ATV cone) were already fixed - removed - fixed resulting from incomplete integration of components around RVS. Pre-damage of the fiber coating by the applied tools (knife to remove tape) cannot be excluded.

- **Simplified mounting procedure for fibers on further ATV**
- **Careful fiber cable handling, avoidance of “over-handling”**
- **Check of the already mounted cables by a magnifying lens**
- **Introduction of a mechanical protection on ATV to avoid fiber damage**
- **Dynamic bend test for cable assembly, and instead of Proof-test**
- **Optimization of fiber design and procedures in case of further fiber manufacturing (e.g. coating material, test methods)**

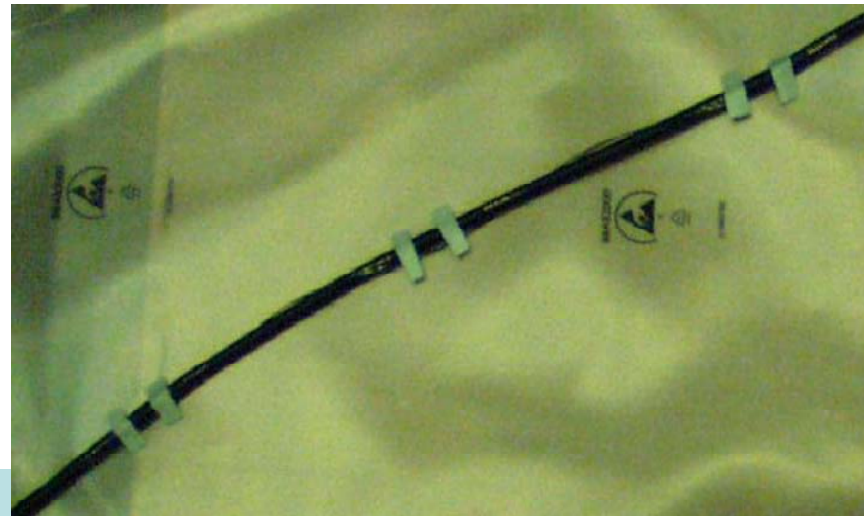
- H) Care must be taken on the bending radius of the fiber. The applied fixation by winding the fiber around a cable seems to be not optimum. An under-run of the allowable short term bending radius just before break seems probable.

Fiber winding around the Triax cable

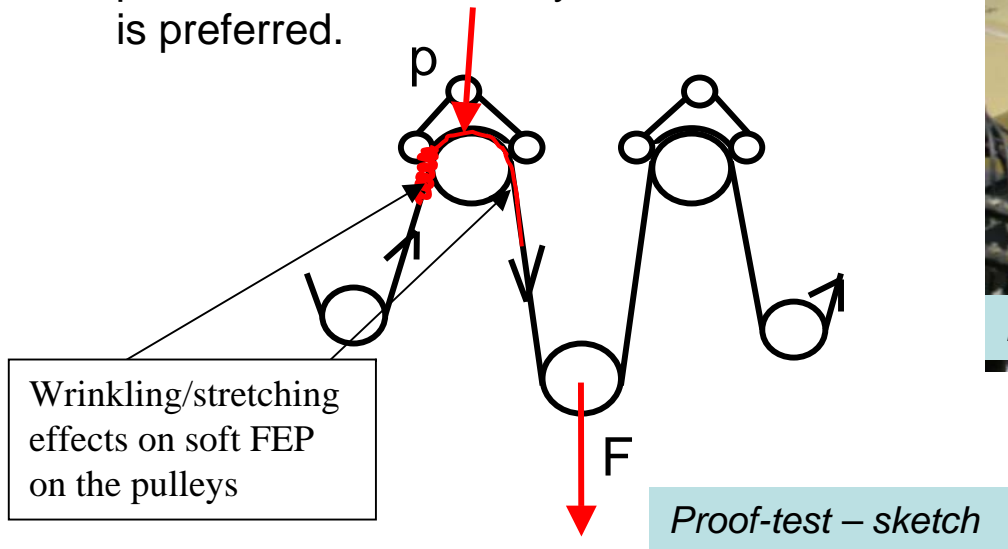
- l) On a fiber with soft outer FEP coating and rather stiff inner PI coating, an execution of a conventional Proof-test turned out to be inadequate. The additional Proof-test (refer to p.7) damaged a part of the remaining fiber in a way that it could no more used.

Reason: In case of pressure application during Proof-test, stretching of the FEP on one side of the “take-on/off”-roll leads to a wrinkling on the opposite side and to micro bending stress on the fiber core. Thus, a Proof-test, if any, on FEP coated fibers must be performed under very low pressure. A so-called dynamic bend test is preferred.
