**Failure Analysis Study and Long-Term Reliability of Optical  
Assemblies with End-Face Damage  
Technical Assessment Report**

***Phase I: International Space Station (ISS) Termini Root Cause  
Analysis Report***

**August 3, 2006**

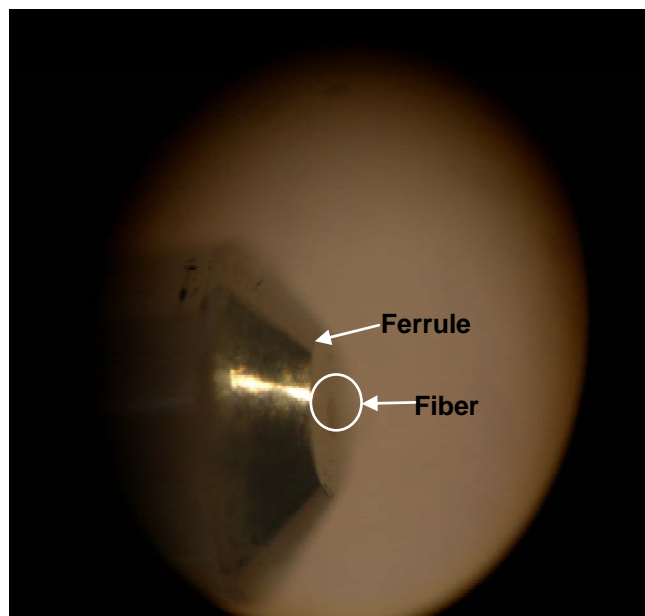
**Figure 4.0-1. Visual End-Face Profile @ Magnification of 40X**

In many applications, a physical contact connection is implemented to mate fiber optic connectors such that the insertion losses are reduced. In the case of this connector, the high vibration levels originally used to “qualify” the connectors for military standard applications showed data indicating that the terminus/connector system should not be of a physical contact type. Therefore, the same processes were specified in this application. For a “concave” polish, it is imperative that the glass end-faces do not come in contact with one another in order to comply with the military standard method and reasoning for non-contact. As stated in OHB’s “Fibre Optic Manufacturing Procedure” Section 4.6: “Inspect the profile of the terminus end-face under 40X magnification. The surface should be slightly concave with the face of the ceramic tip.” This is not an effective method for determining the fiber’s profile. Figure 4.0-1 shows what the profile looks like at 40X magnification. The end-face appears to be flat, and not protruding. This method is non-conclusive for true determination of the end-face profilometry. The profile should be determined using an interferometer or confocal microscopy as illustrated in Figure 4.0-2. The confocal data clearly shows the end-face of the fiber to be convex, which should have failed inspection.

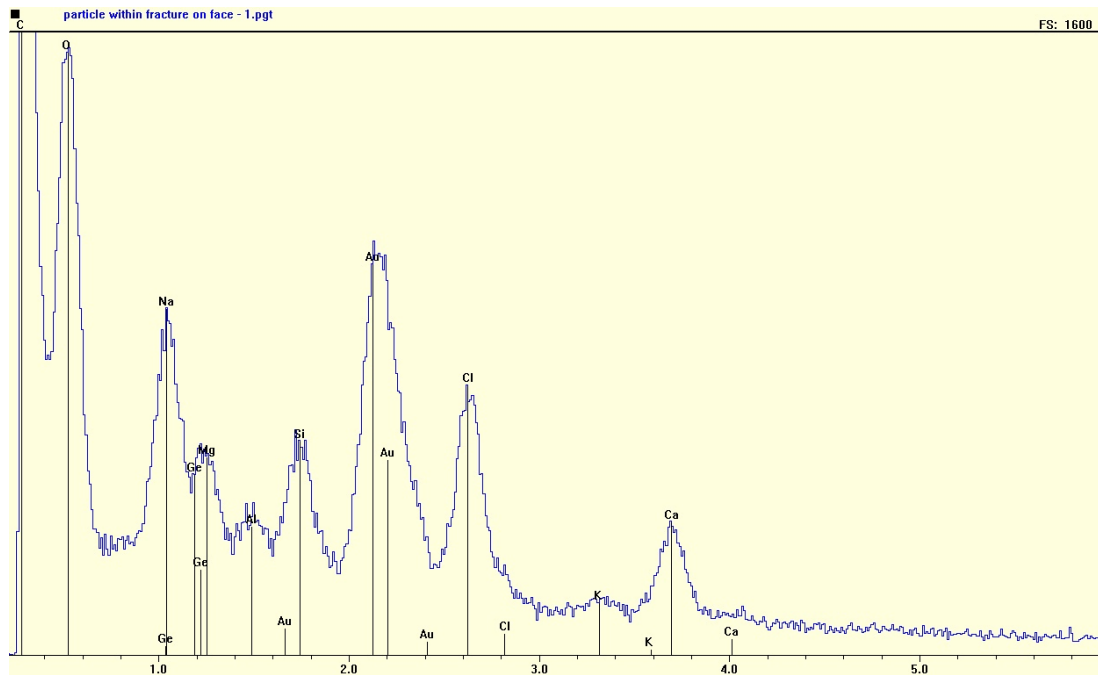
**Figure 7.1-5. EDS of Particle inside the Fracture**

The discovery of salt crystals in the glass was puzzling. To identify where the salt crystals are located on the end-face, elemental mapping was performed. Elemental mapping was not effective at 500X magnification to locate small traces of certain elements, so to locate Na and Cl, a higher magnification was used. Figure 7.1-6 shows the results when this sample was mapped for Si, Na, and Cl.

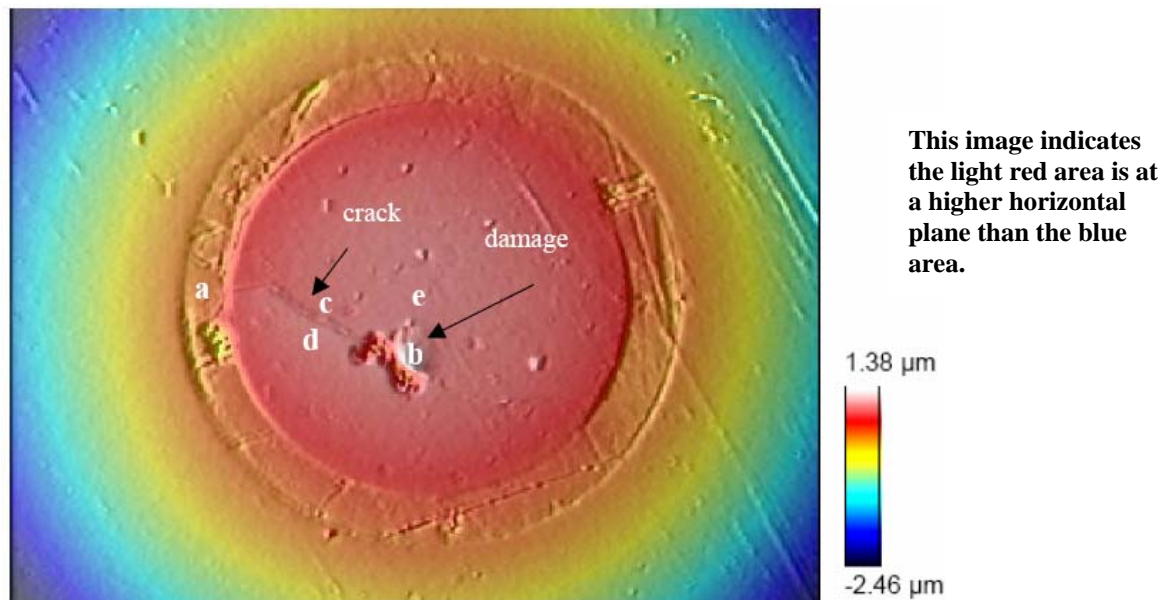
**Figure 7.1-7. Confocal Topographical Image**

Optical microscopy and SEM do not have the ability to generate a profile of the end-face so confocal microscopy is performed. Confocal microscopy (Figure 7.1-7 and Table 7.1-1) will generate a topographical map and a profile in the X-Y axis. It was discovered that the fiber has a convex end-face rather than concave.

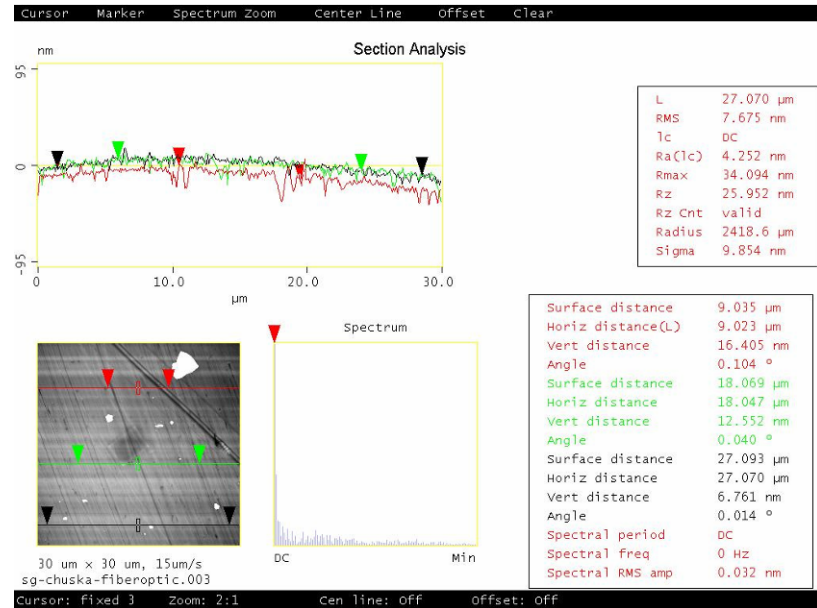
Figure 7.1-10. Fiber End-face AFM Data

Atomic Field Microscopy (AFM) was performed which further supported this sample is convex, and not concave as expected. The first AFM analysis was taken in a 30μm x 30μm area, in the northwest region of the core. The second was taken in the fracture area.

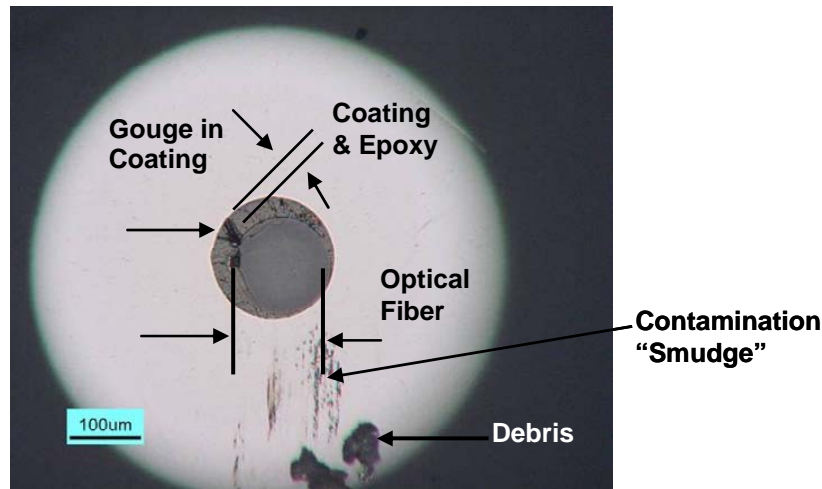
**Figure 7.2-1. Magnification of 100X Optical Image**

The deep scratches indicate the end-face was “wiped” with something that had an abrasive particle present. It could have been mated with debris present as well.

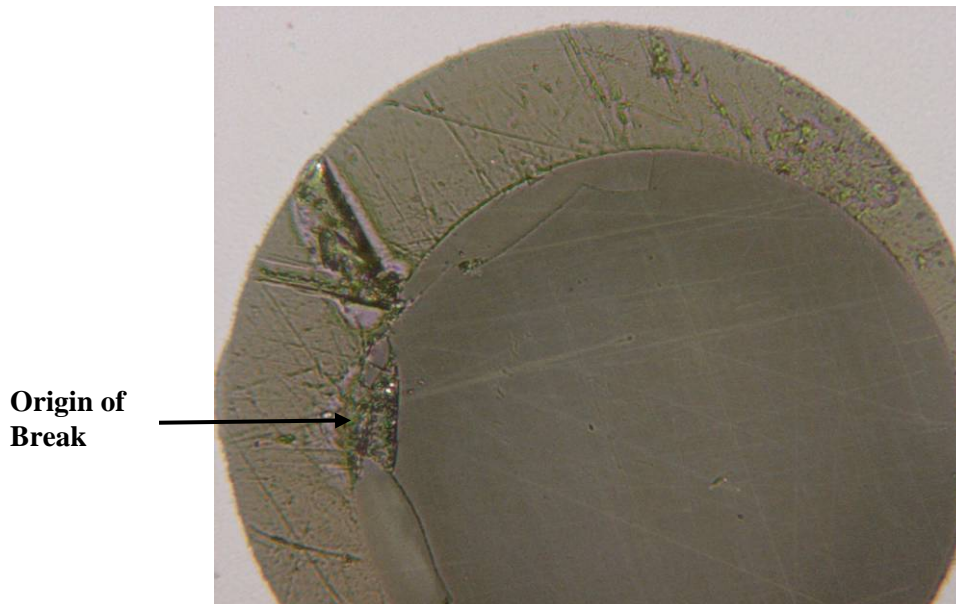
during the epoxy curing procedure. The non-uniform distribution is due to the non-concentric location of the fiber in the coating.

**Figure 7.2-3. Deep Gouge in Coating**

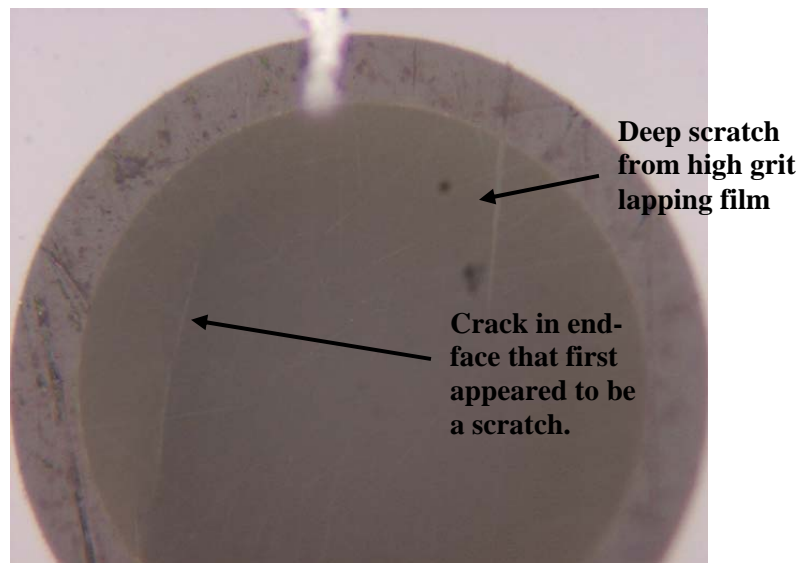
When looking at this fiber at 500X magnification, a deep scratch can be seen. There is also a crack in the fiber that first appeared to be a scratch. This signature of linear scratches is indicative of polishing with high grit lapping film, and not removing the scratches with lesser grit lapping film. Refer to Figure 7.3-1.

**Figure 7.3-1. Scratched/Cracked End-Face**

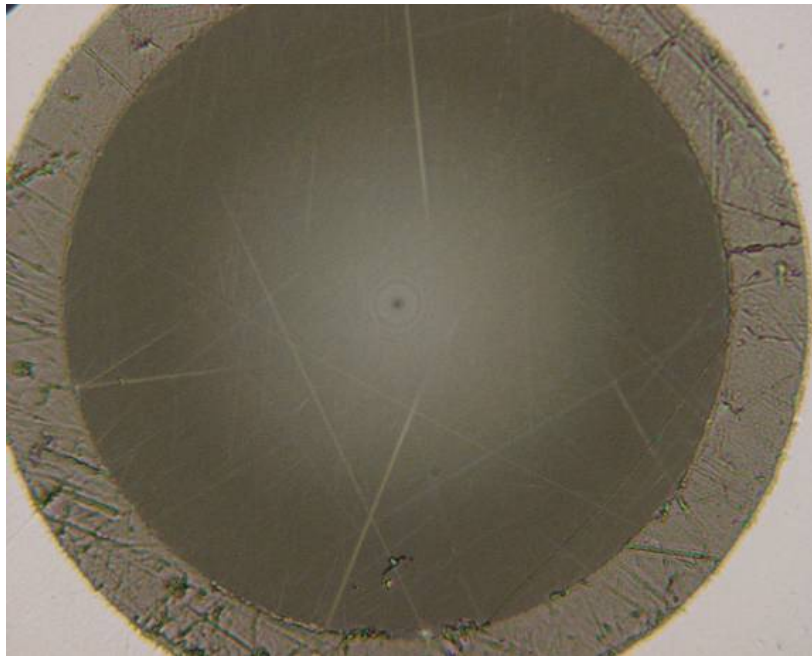
**Figure 7.4-1. Bright Field Image Magnification of 500X**

At 500X, some deep scratches on the end-face can be observed (Figure 7.4-1). By changing the illumination field settings, a crack in the fiber can be seen (Figure 7.4-2). *Light will pass through a crack that is  $<1/8\lambda$ , and the crack will not be visible.* Some debris on the end-face can also be observed.

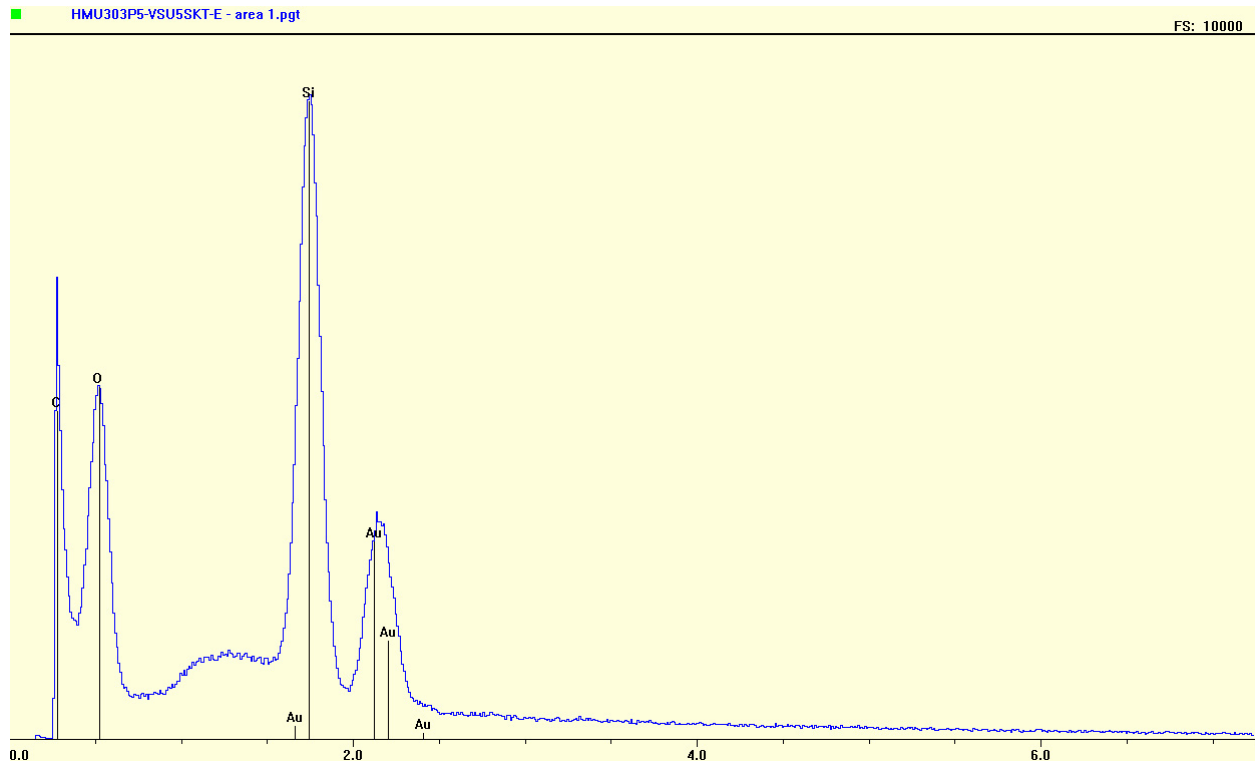
**Figure 7.4-5. EDS Data of Crack**

An EDS data analysis was performed (Figure 7.4-5) in the crack region to identify any foreign particles, and a high concentration of carbon, oxygen, and silicon was found. This may suggest the grit of the lapping film was too coarse.

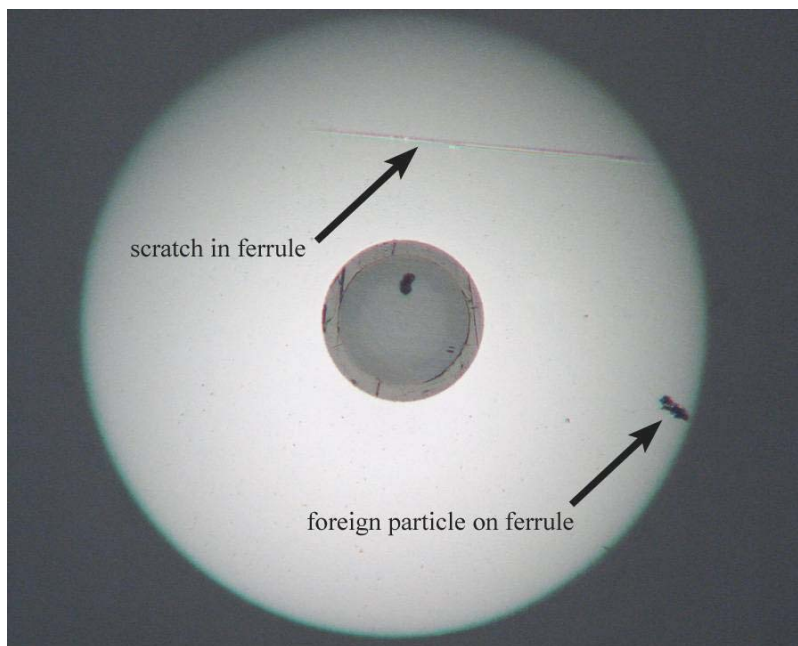
**Figure 7.5-1. Magnification of 100X Optical Image**

The scratches indicate the end-face was cleaned with a contaminated product, or mated with present debris. The foreign material indicates the ferrule was not cleaned properly.

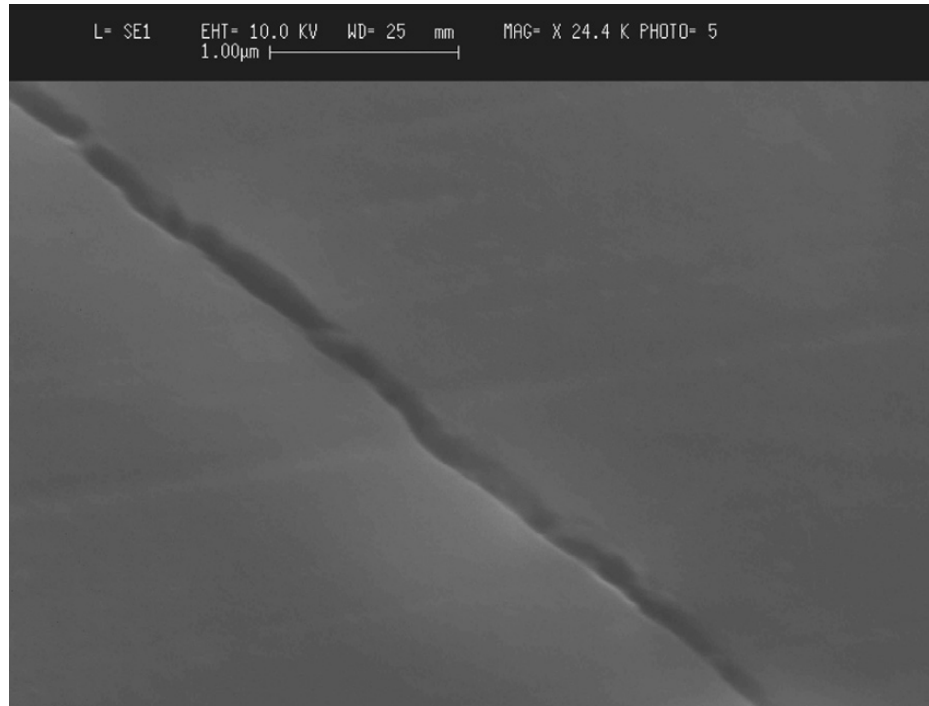
**Figure 7.5-5. Magnification of 24,400X SEM Image of Crack**

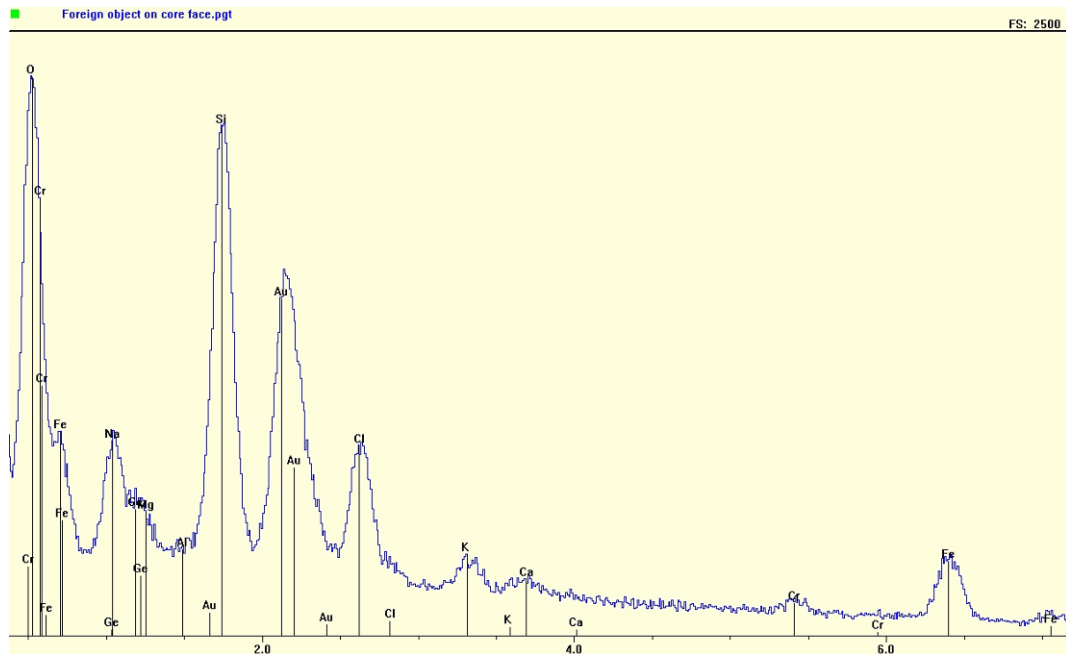
**Figure 7.5-8. Foreign Object on Core Face (Figure 7.5-2)**

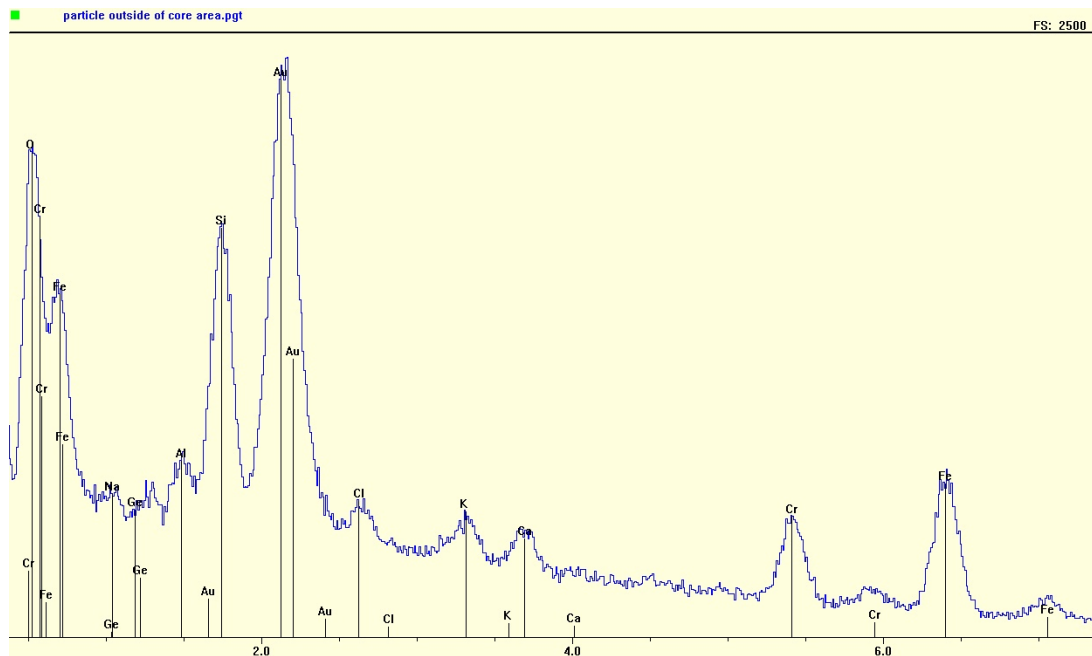
**Figure 7.5-9. Foreign Particle Outside of Core Area (Figure 7.5-1)**

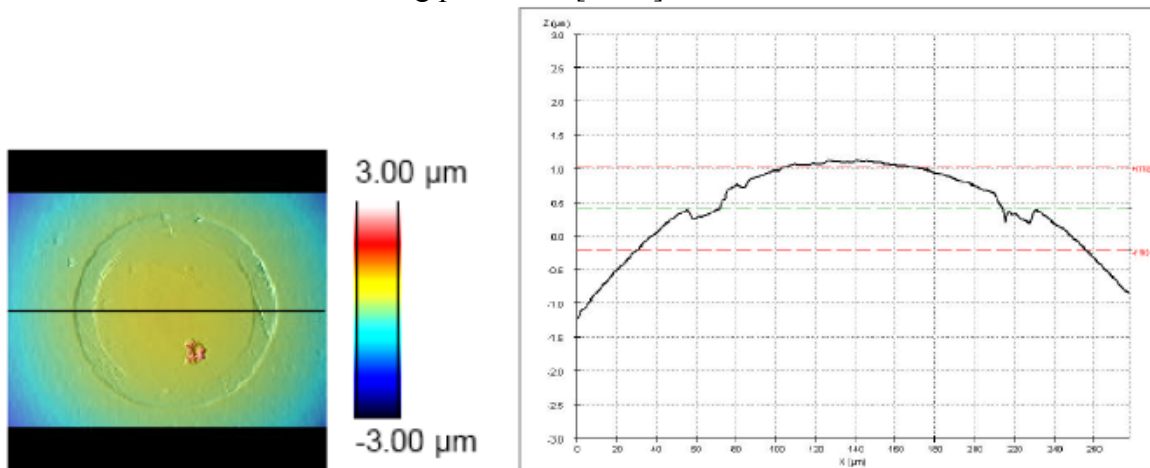
**Figure 7.5-10. Confocal Data**

The confocal data (Figure 7.5-10) indicates the fiber is convex which, again, violates the requirements stated in the manufacturing procedure [ref. 3]. The radius of curvature is 4.0 mm.

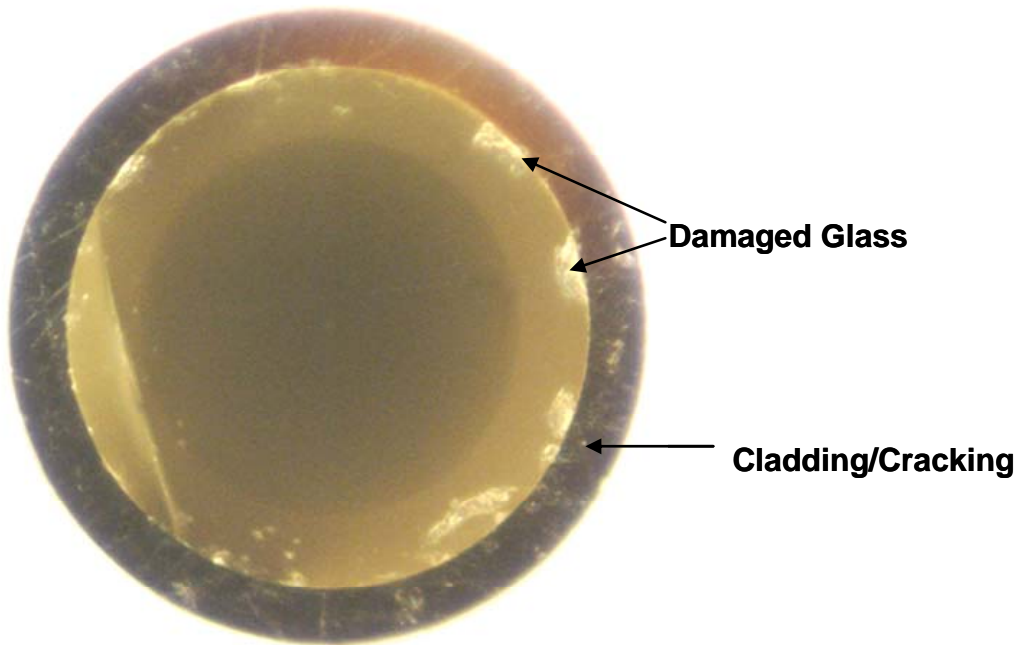
**Figure 7.6-1. Magnification of 200X Optical Image**

1. There was a crack in the cladding area.
2. There was damage to the glass in several areas around the perimeter of the cladding.

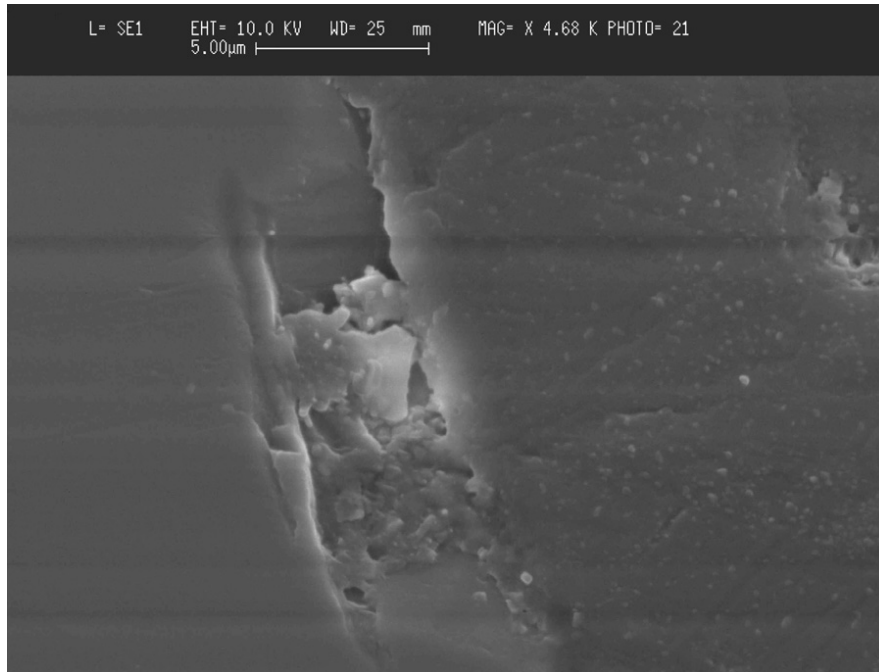
**Figure 7.6-3. Magnification of 4,680X SEM Image (Corrosive Attack)**

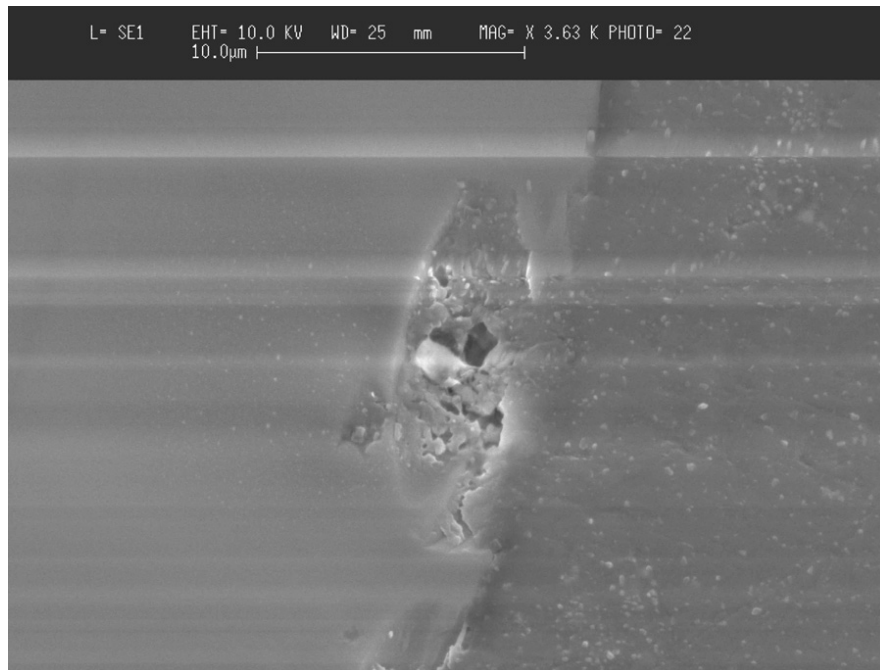
**Figure 7.6-4. Magnification of 3,630X SEM Image (Corrosive Attack)**

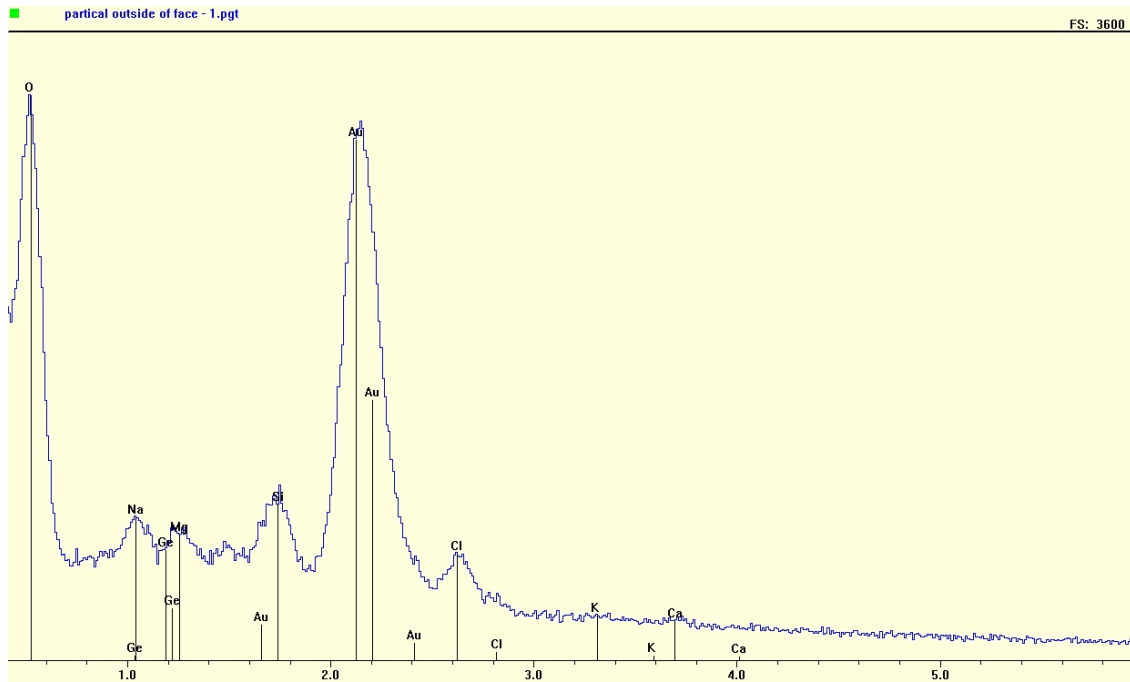
**Figure 7.6-5. EDS Data of Particle on Ferrule - 1**

An EDS data analysis (Figure 7.6-5 and Figure 7.6-6) was performed on some debris on the ferrule end-face.

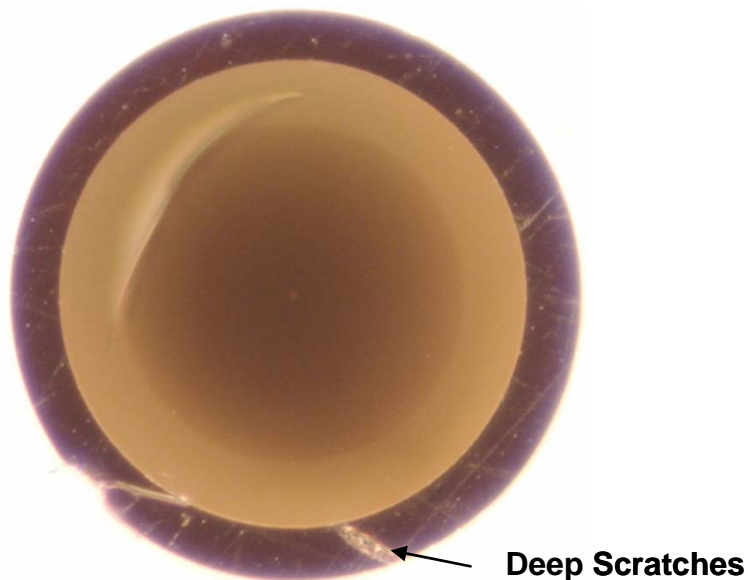
**Figure 7.7-1. Dark Field Image @ Magnification of 200X**

Figure 7.7-1 shows a deep scratch in the end-face of the fiber. This is not a crack that has propagated deep into the fiber. This is evident from how the light is emitted through the crack. When Figures 7.7-1 to Figure 7.10-2 are compared, how the light is affected by a deep crack is observed. There are two areas in the coating with significant damage as well. The damage in the coating is not linear (like the minor visible scratches), thus suggesting it did not occur due to polishing.

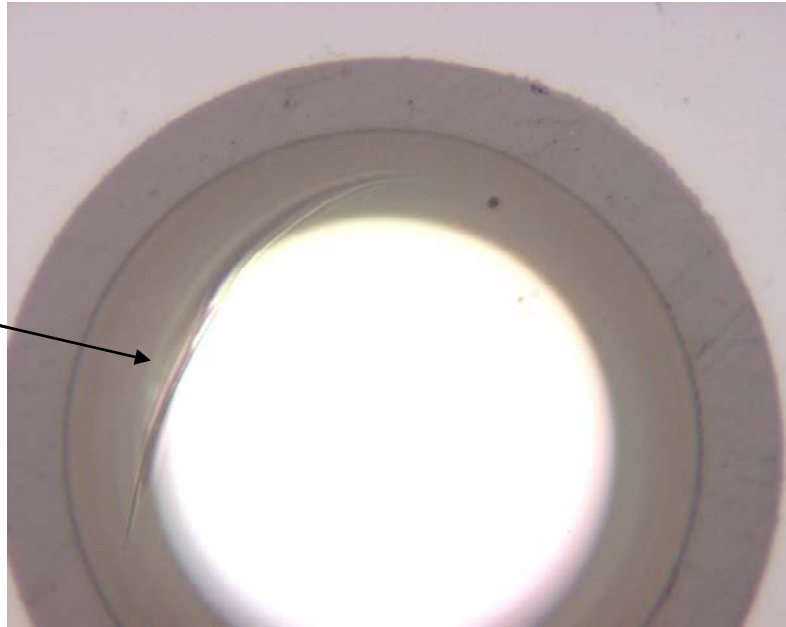
**Figure 7.7-3. Curved Scratch in Glass at Magnification of 500X**

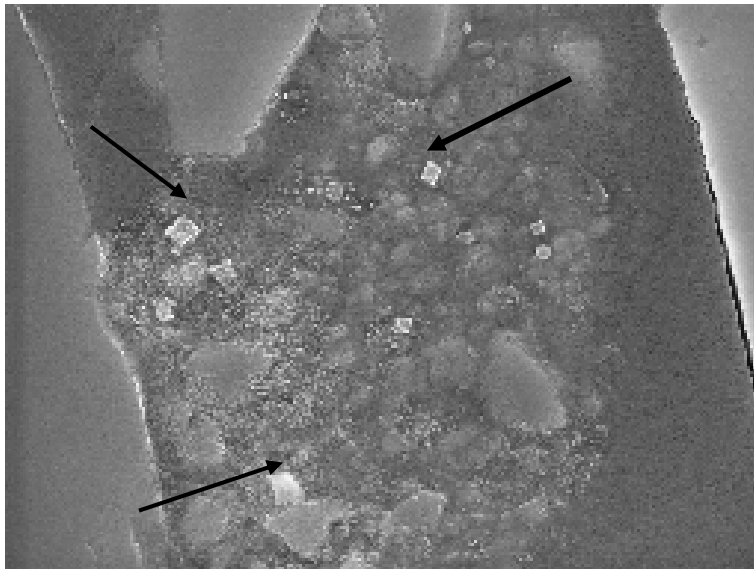
**Figure 7.8-7. Visible Crystals in the Polyimide Coating**

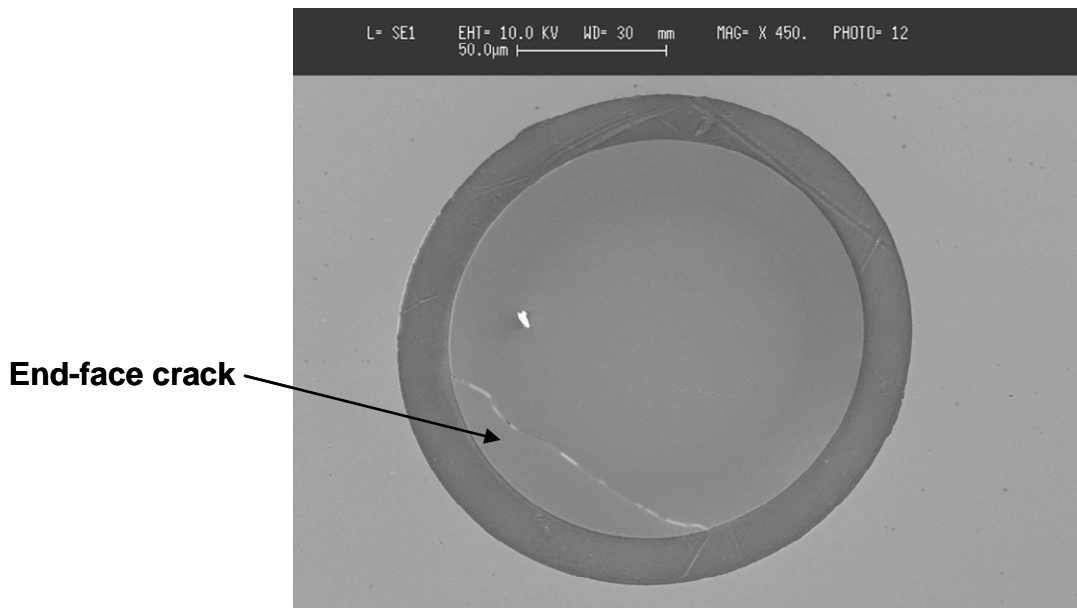
**Figure 7.9-3. Crack in the End-Face**

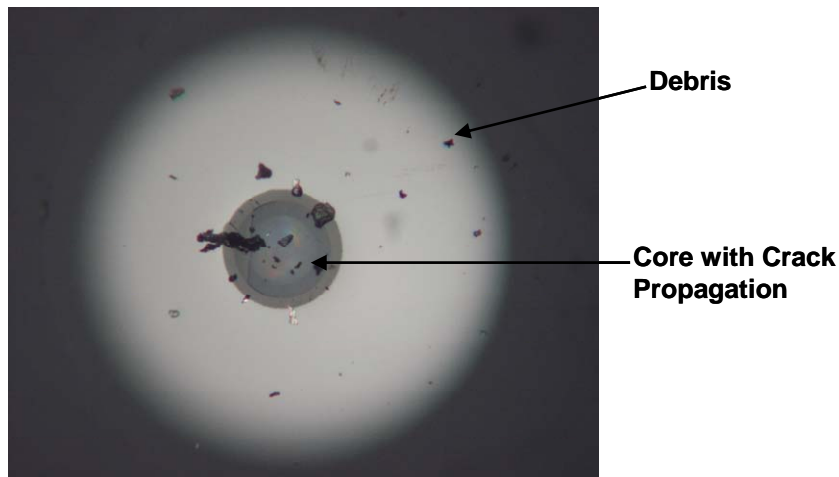
**Figure 7.12-1. Connector with Considerable Debris**

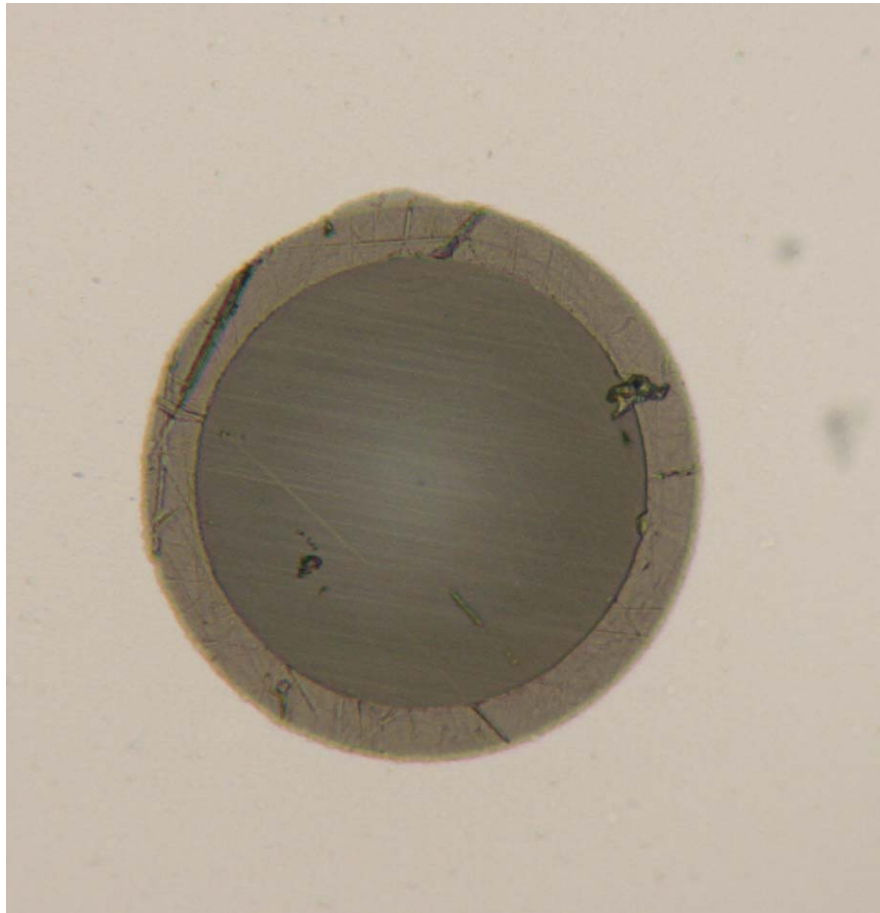
**Figure 7.13-1. Deep Scratches from Polishing Process**

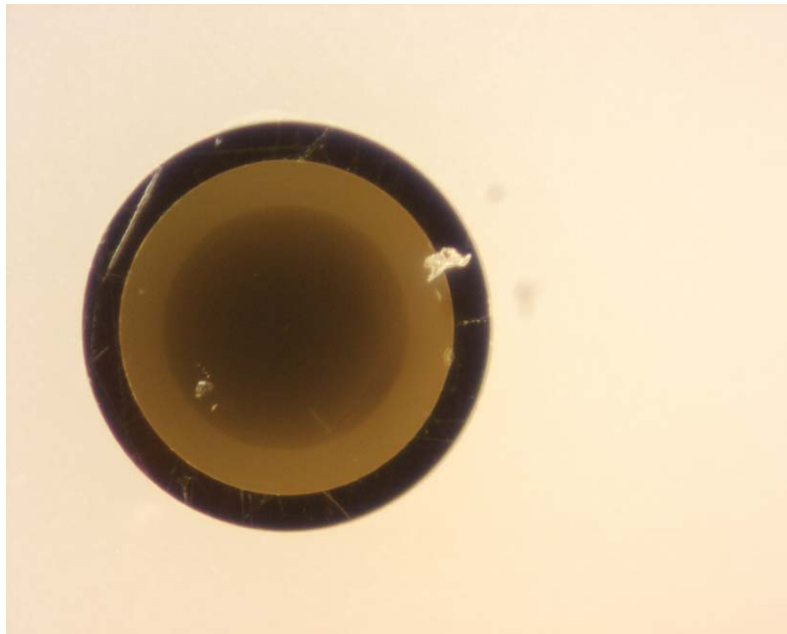
**Figure 7.13-2. No Visible Cracks**
