# Vibration performance comparison study on current fiber optic connector technologies

William J. Thomes, Jr.<sup>a</sup>, Frank V. LaRocca<sup>a</sup>, Robert C. Switzer<sup>a</sup>, Melanie N. Ott<sup>b</sup>,  
Rick F. Chuska<sup>a</sup>, Shawn L. Macmurphy<sup>a</sup>

<sup>a</sup>MEI Technologies / NASA Goddard Space Flight Center, Lanham, MD, USA 20706

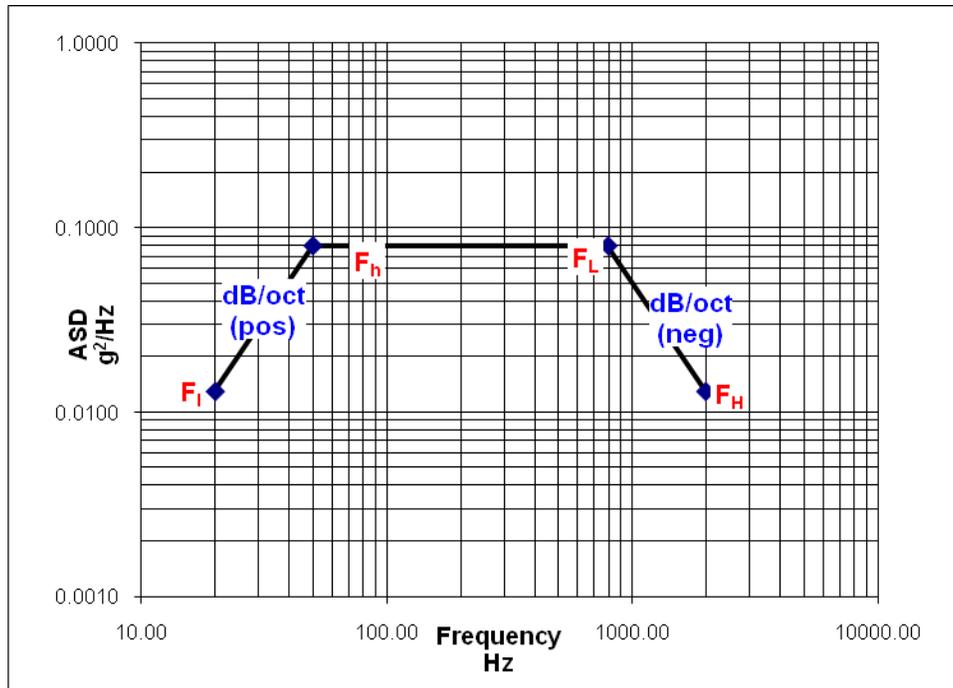
**Figure 1: Vibration profile for 10.0 Grms testing based on GEVS.**

studied, so therefore the 10.0  $G_{rms}$  level was chosen as an initial test condition. GEVS testing requirements provide a general guideline for any part being used for a GSFC mission. The GEVS testing levels are modified based on specific mission designs and analysis, but they are used as a reference point. The only modification to the standard for the current testing was that the test duration was increased from 1 min/axis to 3 min/axis. This change was made based on recent flight project requirements that dictated the longer test to simulate launch conditions for a satellite. Table 1 gives the vibration testing levels over the range of frequencies from 20 to 2000 Hz. Figure 1 shows a graphical representation of the 10.0  $G_{rms}$  testing profile.

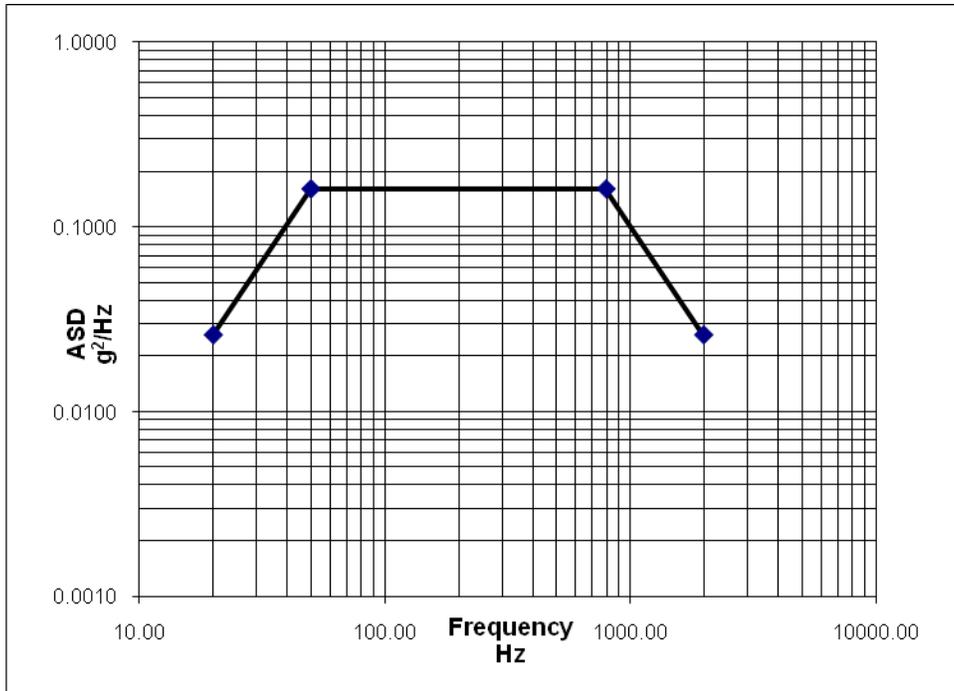
**Figure 2: Vibration profile for 14.1 Grms testing based on GEVS.**

The next vibration level tested was 14.1  $G_{rms}$ , as derived from the GEVS requirements for random vibration qualification level testing of flight hardware. This would also be considered the protoflight level for components weighing 50 lbs or less. Table 2 gives the vibration testing levels over the range of frequencies from 20 to 2000 Hz. Figure 2 shows a graphical representation of the 14.1  $G_{rms}$  testing profile.

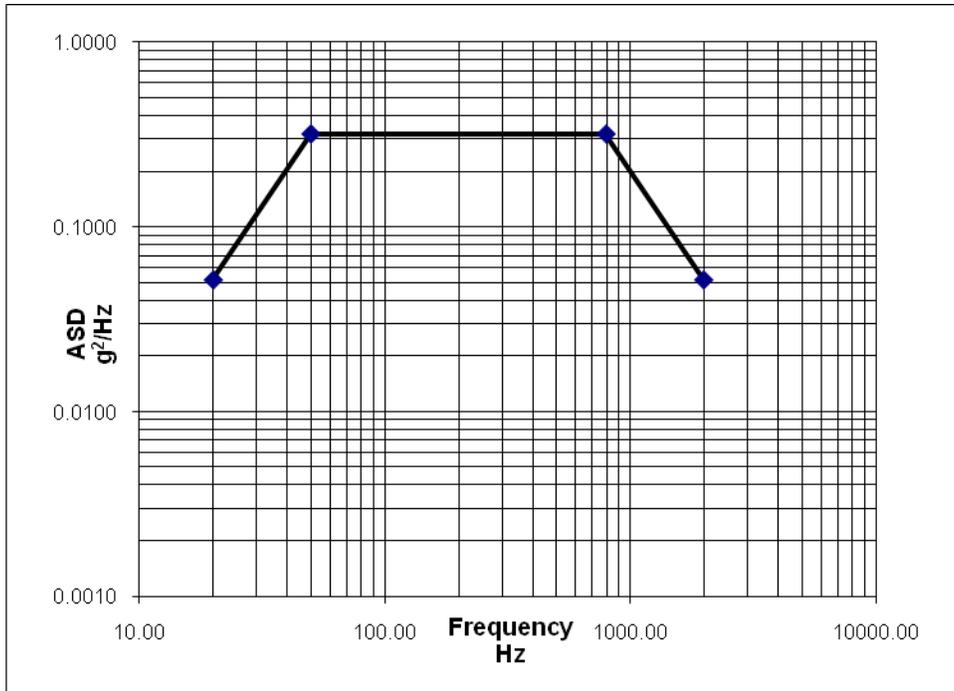
**Figure 3: Vibration profile for 20.0 Grms testing based on Photonics Group requirements.**

The NASA GSFC Code 562 Photonics Group has an internal standard for random vibration testing that has been derived from a compilation of requirements for various flight programs. We typically perform qualification-level testing of fiber optic cables and custom assemblies to 20.0 G<sub>rms</sub>, which encompasses the vibration requirements across the frequencies of interest for the majority of flight programs. If properly designed, most assemblies will survive testing at this level without degradation of performance. Table 3 lists the vibration level and frequency for points at which a change occurs in the test profile. Figure 3 shows a graphical representation of the 20.0 G<sub>rms</sub> profile.

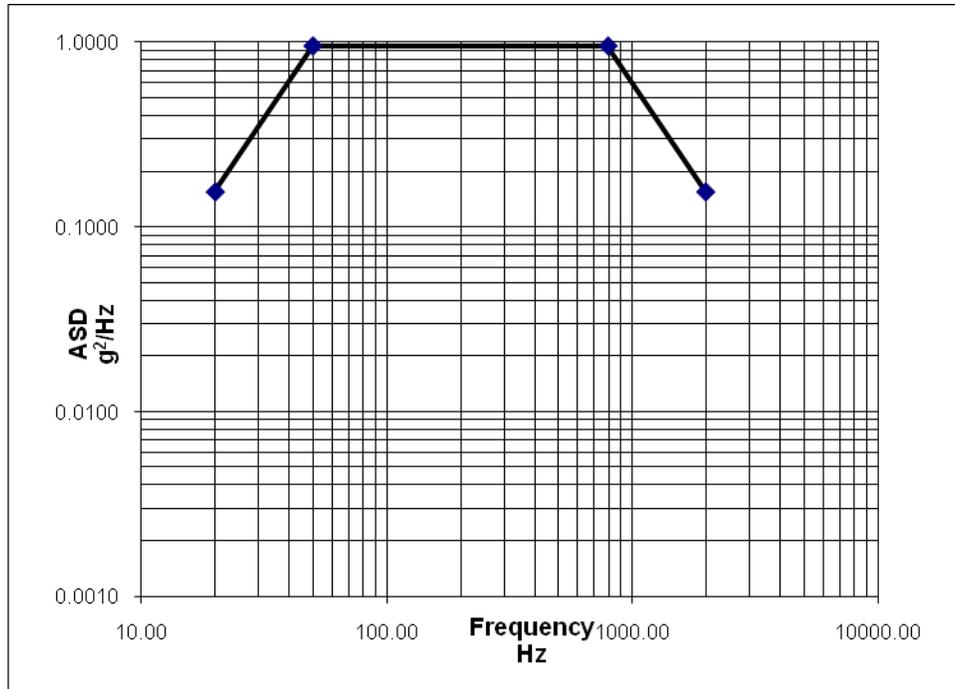
**Figure 4: Vibration profile for 34.6 Grms testing based on equipment limitations.**

Most space flight programs would not require testing to vibration levels higher than 20.0  $G_{rms}$ , but testing was also conducted to 34.6  $G_{rms}$  in an attempt to expose weaknesses of any of the connectors in this study. The 34.6  $G_{rms}$  level was chosen because of mechanical limitations of the vibration system being used. Vibration testing at higher levels would result in the shaker drum traveling outside of its displacement limits. Table 4 lists the vibration profile, and Figure 4 shows a graphical representation for the 34.6  $G_{rms}$  testing.

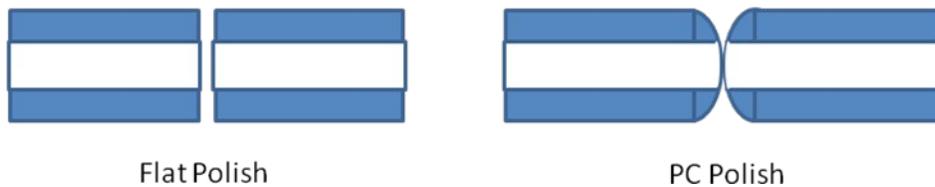
**Figure 5: Representation of flat and PC polish of fiber endfaces.**

Three types of fiber cables were studied with the various connectors. These included a 100/140 step index fused silica fiber with a flat polish, a 400/440 step index fused silica fiber with a flat polish, and a 100/140 graded index fused silica fiber with a PC polish. The graded index fibers are usually used for communications applications at 1310 or 1550 nm and would have a PC polish. The PC polish leaves a slight curvature to the fiber endface such that the glass fiber cores are in intimate contact. This type of polish provides lower loss between the fibers, but it places higher stresses on the fibers themselves. The germanium-doped fiber is more brittle than the step index fused silica, so the combination of the PC polish and the graded index is expected to be the most susceptible to damage during testing. The step index fibers are usually used in sensing applications, which usually require a flat polish to avoid distortion of the optical signal. Figure 5 shows a representation of a flat polish and a PC polish.

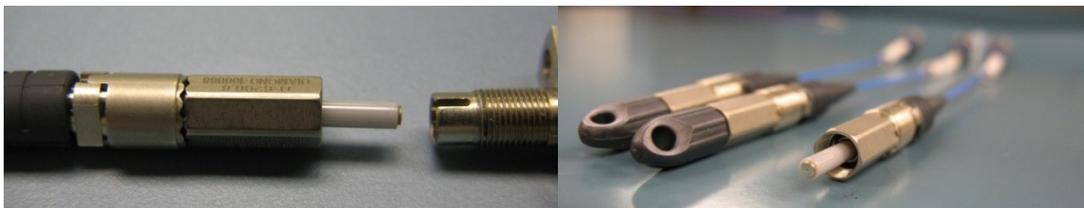
**Figure 6: Diamond AVIM connector (ratcheting mechanism on nut slightly offset to show detail).**

The AVIM connector manufactured by Diamond is the baseline connector for many NASA GSFC missions. It has a 2.5 mm diameter ferrule that is either ceramic with a metal insert or all metal. The connector has a key inside for alignment with the adapter. The outer nut, which screws onto the adapter, has a ratcheting mechanism that prevents the nut from loosening during exposure to harsh environments. Since the ratcheting feature acts as a lock once installed, no secondary locking mechanism is needed. Figure 6 shows the AVIM connector and part of a low-profile adapter.

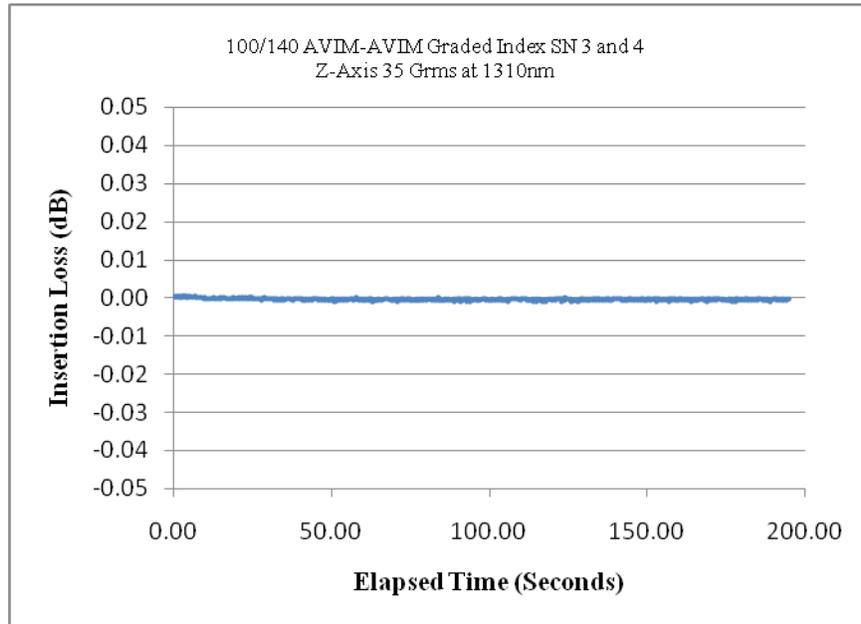
Figure 7: Insertion loss of 100/140 graded index fiber in AVIM connector tested at 35 Grms along connector axis (Z axis).

To obtain baseline vibration performance data for comparison with the other connector types, all three fiber types were tested with the AVIM connector. A standard low-profile AVIM adapter was used. The adapter has a split ceramic sleeve captured inside that provides the alignment between the fiber endfaces. Figures 7 through 9 show representative insertion loss data during vibration testing of the different fibers in each axis. As can be seen from the graphs, the

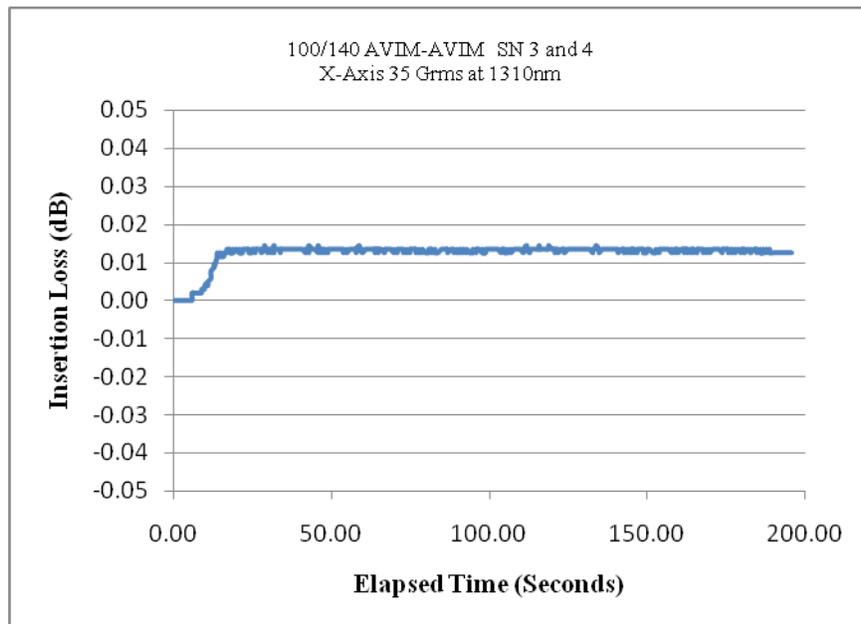
Figure 8: Insertion loss of 100/140 step index fiber in AVIM connector tested at 35 Grms perpendicular to ferrule endface with key in displacement direction (X axis).

insertion loss change was less than 0.02 dB. Figure 8 illustrates a small shift in the fiber alignment immediately after the start of the vibration testing, but optical performance was stable following this slight change.

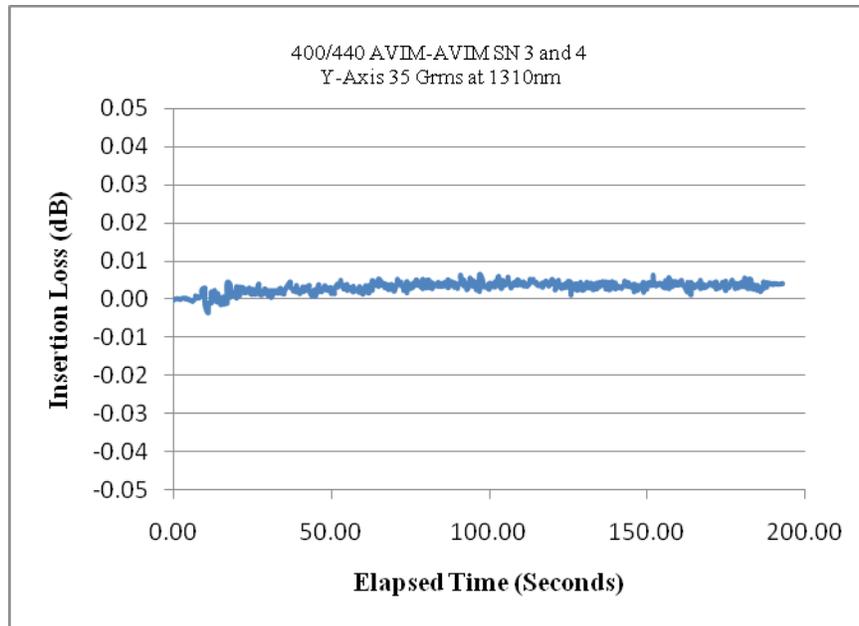
**Figure 9: Insertion loss of 400/440 step index fiber in AVIM connector tested at 35 Grms perpendicular to ferrule endface with key perpendicular to displacement direction (Y axis).**

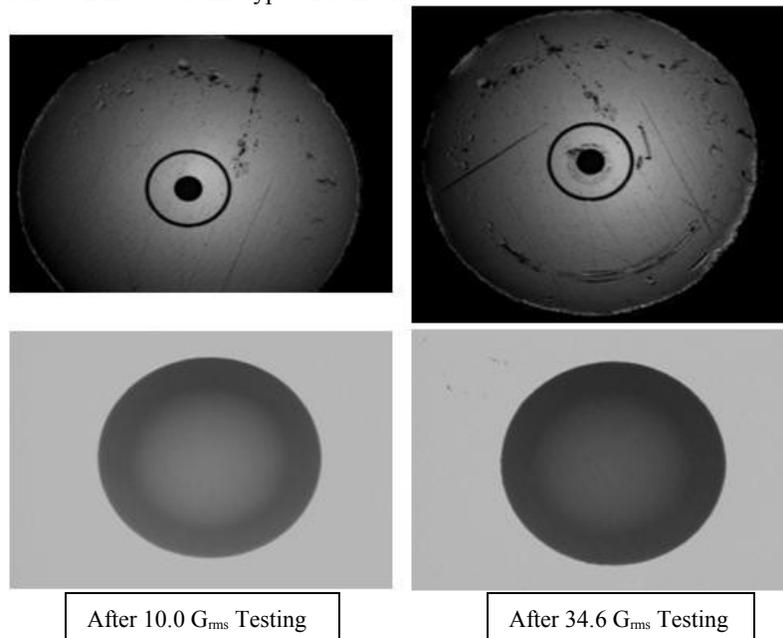
**Figure 10: Endface pictures of 100/140 graded index fiber with PC polish following vibration testing. Top pictures show entire metal ferrule ends, while bottom pictures show the fibers under higher magnification.**

No fiber endface damage was found following the vibration testing, but the outer regions of the metal ferrules showed slight damage. Figure 10 shows endface pictures of the fiber and ferrule for a 100/140 graded index fiber (the most brittle of the fibers tested) with a PC polish (resulting in highest forces on fibers). Most AVIM connectors tested exhibited similar issues. It appears that the adapters may have allowed the ferrules to pivot slightly about the center and make intermittent contact toward the edges of the ferrule, in which case the centers would not lose contact with each other and the glass fiber was not damaged. Our group has noticed small metal contamination in the past from mating and de-mating of the metal connectors. While not specifically seen during this study, it is possible that small contamination pieces could contribute to this type of behavior.

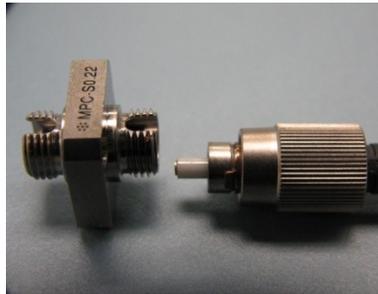
**Figure 11: The FC connector and adapter.**

The FC connector has a ferrule nearly identical to the AVIM connector, as shown in Figure 11. The spring-loaded ferrule is 2.5 mm in diameter. A connector key and matching slot on the adapter provide alignment and anti-rotation features. The connector attaches to the adapter with a larger outer nut. Secondary fastening is required for rugged environments to ensure the connector does not loosen.

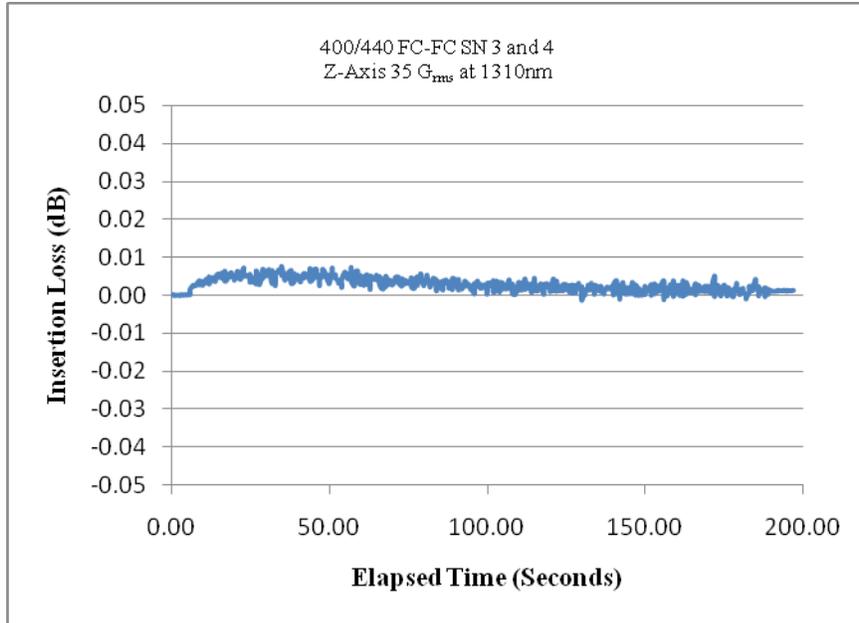
Figure 12: Insertion loss of 400/440 step index fiber in a FC connector tested at 35 Grms along the connector axis (Z axis).

Insertion loss data from a representative vibration test of the FC connectors are given in Figure 12. Endface images are shown in Figure 13. Both results are similar to those found during evaluation of the AVIM connector, in which the insertion loss was essentially unchanged during vibration testing to 34.6 G<sub>rms</sub>, but the outer edges of the metal ferrule exhibited some pitting and scratching.

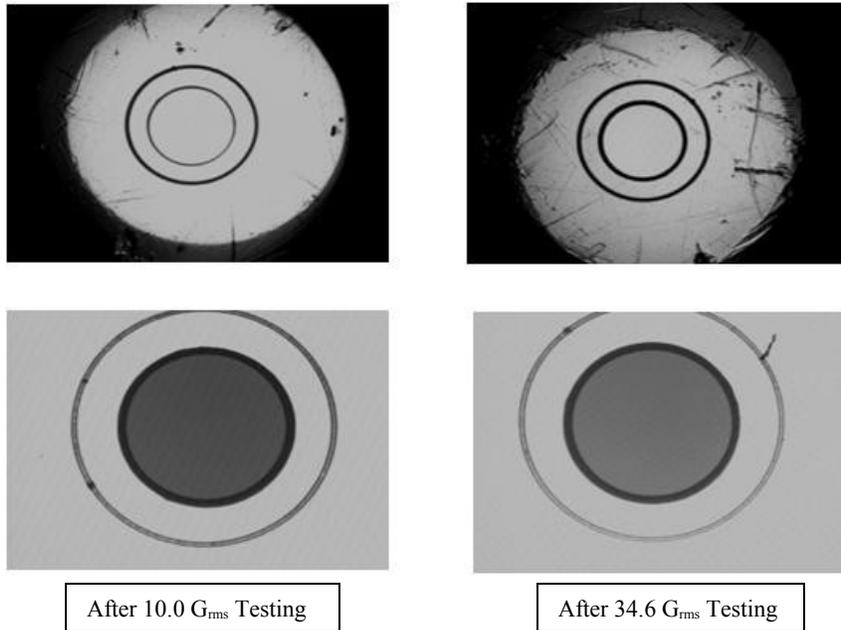
Figure 13: Endface images of FC connector showing damage during subsequent vibration testing.

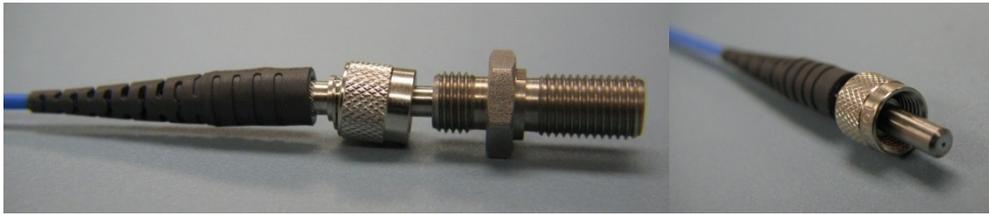
Figure 14: The SMA905 connector and adapter.

The SMA connector has a fixed 3.16 mm diameter ferrule that is either ceramic or metal. There are two common varieties of SMA connectors, the SMA905 and SMA906. The SMA905 has the same diameter along the entire length of the ferrule, while the SMA906 drops to a smaller diameter near the connector endface. The metal ferrule SMA905 was used for all testing in this study. Figure 14 shows the SMA connector and adapter. There is no keying feature with this connector. The outer nut screws onto the adapter to hold the connector in place, so some type of secondary locking (usually epoxy or wire tie) is needed to ensure that the connector does not loosen during harsh environments. The mating adapter for the SMA is a threaded barrel that has a smooth inner wall to align the fiber endfaces.

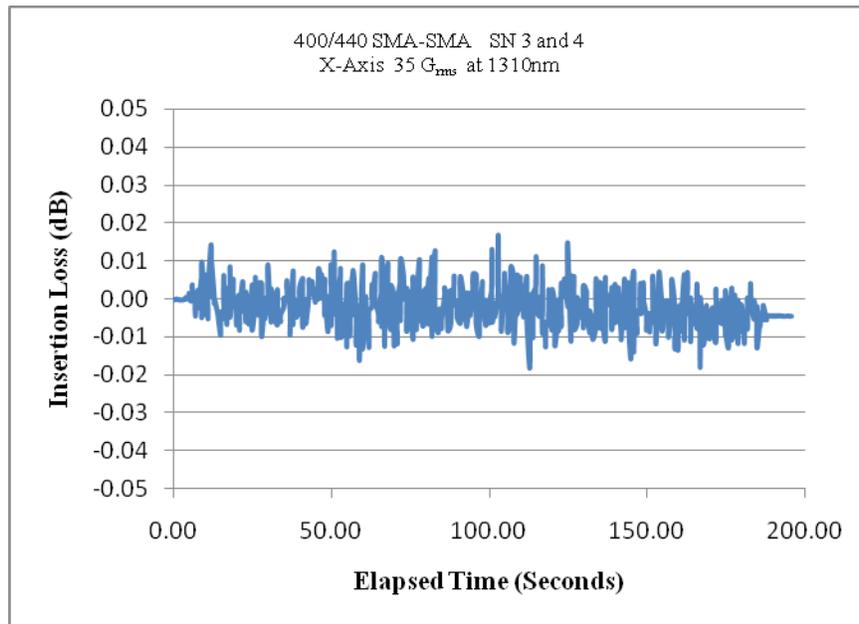
Figure 15: Insertion loss of 400/440 step index fiber in a SMA connector tested at 35 Grms parallel to the connector endface (X axis).

Insertion loss data taken during vibration testing for a 400/440 step index fiber are given in Figure 15. During this test, the random vibration displacement was perpendicular to the long axis of the connector and adapter (parallel to the connector endface). The measurements exhibit more noise than in the AVIM and FC vibration testing because of the looser tolerances in the SMA adapter holding the alignment of the fiber endfaces. The effect becomes more noticeable in the smaller core fibers since the alignment mismatch of the fibers leads to larger changes in the insertion loss. Figure 16 shows data from vibration testing of a 100/140 fiber in the same configuration. As can be seen from the graph, the fiber transmission showed a steady decrease (increasing insertion loss) throughout the 3 min vibration test. Not all of the smaller core fibers showed this effect, but it was not observed for any of the AVIM or FC vibration testing.

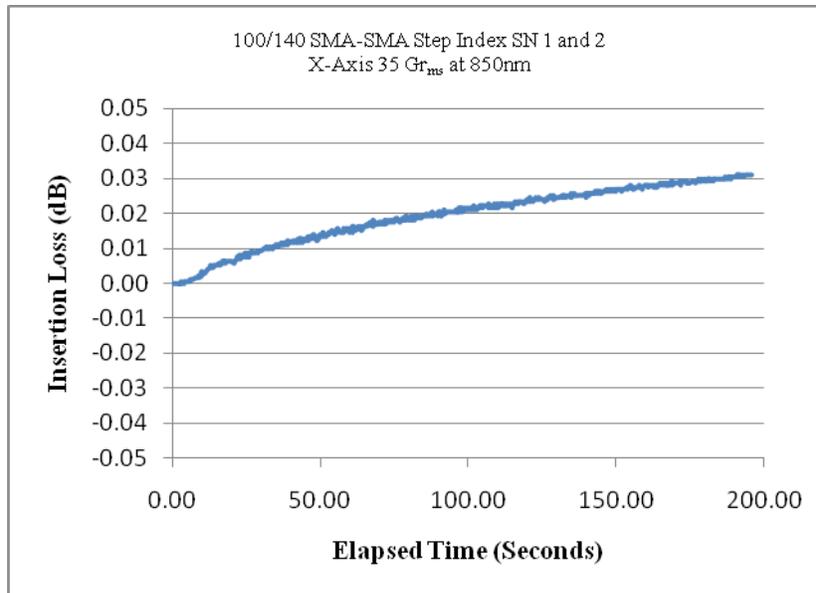
Figure 16: Insertion loss of 100/140 step index fiber in a SMA connector tested at 35 Grms parallel to the connector endface (X axis).

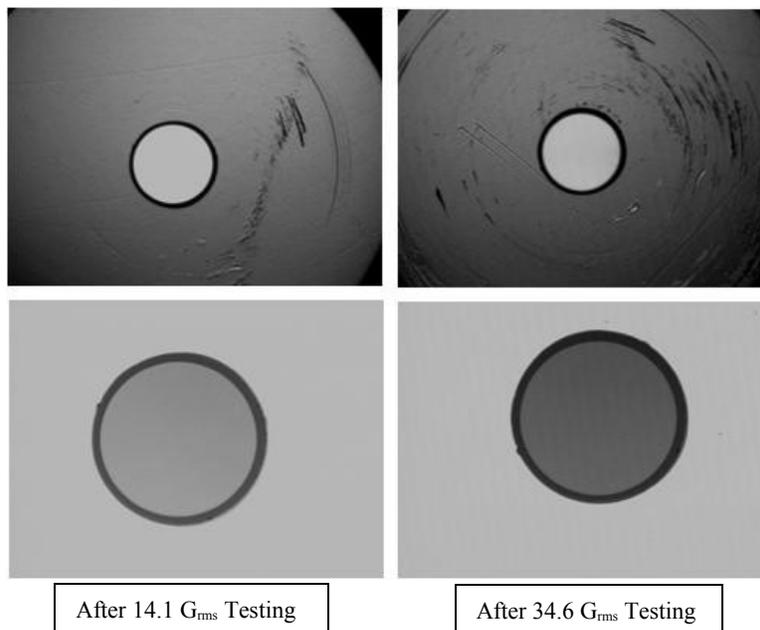
Figure 17: Endface images of 400/440 fiber in a SMA connector showing damage during vibration testing.

Figure 17 shows representative endface pictures of the SMA fibers taken following vibration testing at the specified levels. No damage was found on the glass fibers themselves, but the metal ferrule surrounding the fiber showed signs of scratching and pitting. Due to the lack of a keying feature on the SMA connector, the ferrule can rotate inside of the adapter, causing this type of circular damage pattern. Table 7 lists the insertion loss of the SMA cables before and after vibration testing. No permanent degradation of optical transmission for the SMA cables was found to have been caused by the vibration testing.

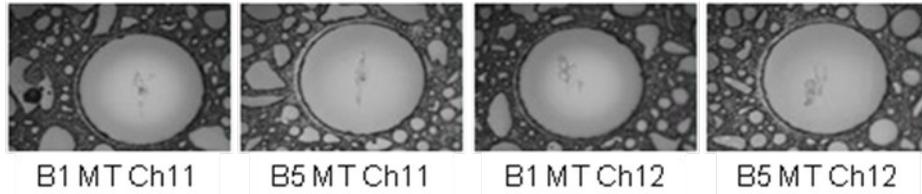
**Figure 19: Fiber endfaces following vibration testing at 12.78 Grms.**

The MTP connector with multimode fiber showed a change in insertion loss of less than 0.5 dB during testing, with typical results much lower. Four fibers exhibited evidence of some movement during vibration, with minor scratching/pitting of the fiber endfaces. Figure 19 shows the endface pictures following vibration testing for these connectors. These results are consistent with vibration testing previously performed by this group for other programs.<sup>[6]</sup>

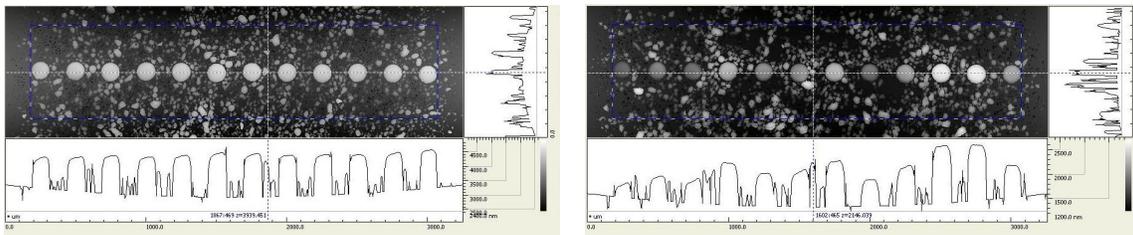
**Figure 20: MTP fiber geometry on cables manufactured by an outside vendor and sent to GSFC for inspection. Uneven polishing of connector on right will result in uneven loading of fibers, resulting in higher insertion loss fluctuations and possible damage.**

Endface geometry will influence performance of the MTP connector in a mated pair configuration. Figure 20 shows endfaces taken on two different fiber optic cables that were terminated by an outside vendor and sent to GSFC for inspection. The desired geometry is for all of the fibers to be equal in height and slightly protruded from the composite ferrule, as in the image on the left. However, if not tightly controlled and inspected, the fibers can be polished at uneven heights, resulting in the geometry shown in the image on the right. The uneven fibers will be spring-loaded into the mating fibers and the forces will be carried by the protruding fibers. This will likely result in performance fluctuations and fiber damage.

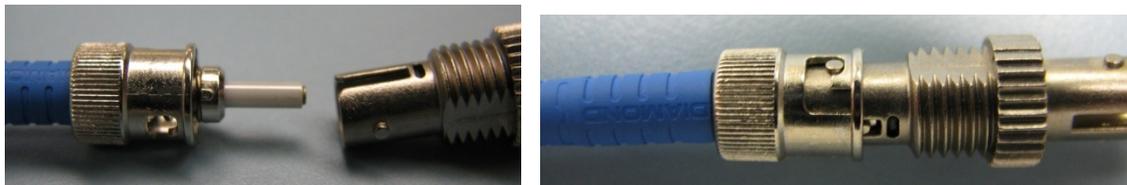
**Figure 21: The ST connector and adapter. Picture on right shows engagement of adapter tabs into connector slots.**

The ST connector has a 2.5 mm diameter ferrule that is ceramic, metal, or ceramic with a metal insert. The body of the connector is spring-loaded against the outer “nut”. A key on the connector provides alignment and prevents rotation of the ferrule inside the adapter. Two slots in the outer “nut” slide over small tabs on the adapter and are locked by twisting to engage the tabs into offset indentations in the slots. Figure 21 shows the ST connector and a mating adapter.
