Gold-Indium Intermetallic Compounds: Properties and Growth Rates

Jane E. Jellison
Code 313:
Materials Control and Applications Branch (MC&AB)

8 November 1979

Note: Jane Jellison originally composed this as a memo to the TIROS Project to describe her study of failures on gold-ball bonds in detectors made by Honeywell for a TIROS satellite. Henning Leidecker recast her memo into the present article in July 2003.

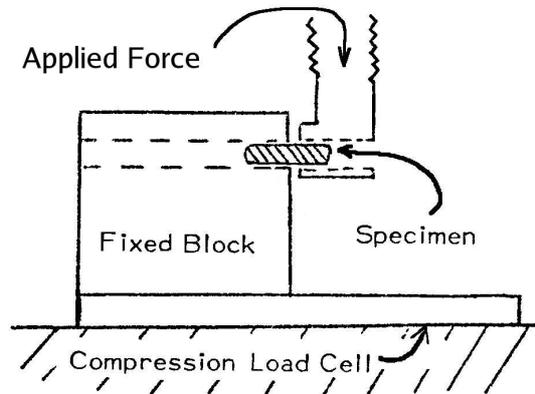
Since it was suspected that both compounds were brittle, no attempt was made to form the ingots into a more convenient shape for mechanical testing. One end had been squared off by the cutting off of the metallographic sample, and it was decided to run a shear test to remove the other rounded end, leaving a cylindrical section for further testing. Accordingly, a fixture was designed and built consisting of a fixed block with a suitable hole through it, and a pusher with a corresponding hole to accommodate the other end of the specimen. The fixture was placed in an Instron Universal Testing machine, and the load required to shear the end off was recorded: see Table 2 and the sketch.

Compound	Maximum Load	Shear Stress
AuIn	139 lb.	10,300 psi
AuIn ₂	50 lb.	3,700 psi

Table 2: Resistance to shearing measured for present specimens.

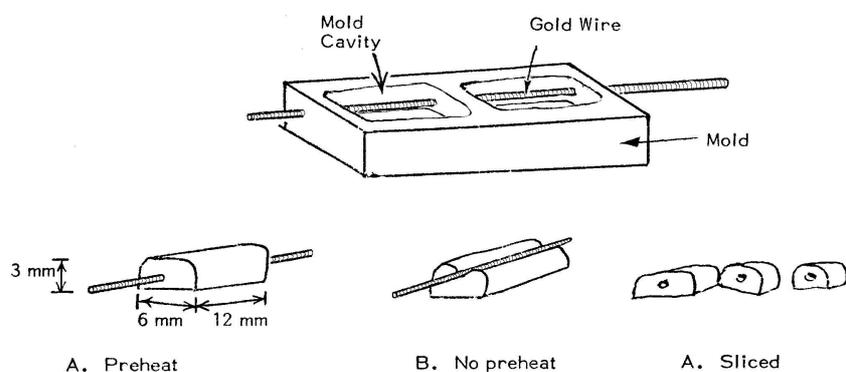
Gold wires were threaded through the sides of silicone rubber molds so that when the molds were filled with molten indium the wires would run through the centers of the resulting ingots. Some of the molds were pre-heated to insure that the indium would flow under and around the gold wires so as to surround them completely. Others were not preheated, so that the indium froze upon contacting the wires and did not completely cover them (see sketch).

The Type A ingots (gold wire completely surrounded by indium) were sliced with a razor blade into approximately 3 mm thick sections. Several of these were put into an oven at each test temperature and were withdrawn one at a time at various time intervals for metallographic examination of intermetallic layer thickness.

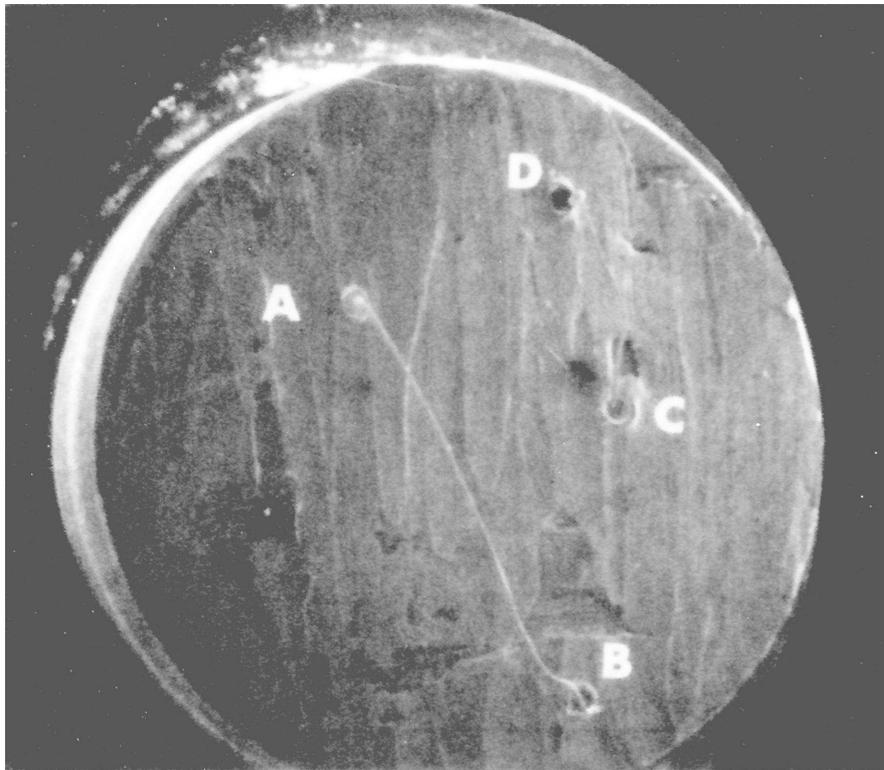
Figure 1: Bond specimen #1 (after pull testing) showing location of bond pairs. Bonds A and D are ball bonds, while bonds B and C are wedge bonds. The wedge bond B and the ball bond D have lifted in this image. 15×

Two groups of bonds were prepared, to be observed at temperature in a vacuum furnace hot-stage metallograph. Two beryllium-copper specimens of the appropriate dimensions for the hot stage were first coated with a RF-sputtered layer of nichrome to act as a barrier between the indium and the Be-Cu substrate. Next, indium was melted onto this surface and spread with a spatula (no indium target was available for the RF coater). This method left a rather thick indium coating, and considerable difficulty was encountered in thermo-sonically bonding 1 mil gold wires to it. Most of them were deeply buried in the indium.

One bond was pull tested prior to elevated temperature exposure. Failure was in the wire at a load of 6 g_f . After inserting specimen #1 in the vacuum furnace, the temperature was raised to 140°C. The temperature was lowered to 120°C at night to avoid accidental overheating and melting of the indium due to the normal increase in line voltage which occurs at the end of the workday. The specimen was removed for SEM examination and bond pull testing after a total of 73 hours at 140°C plus 97 hours at 120°C.

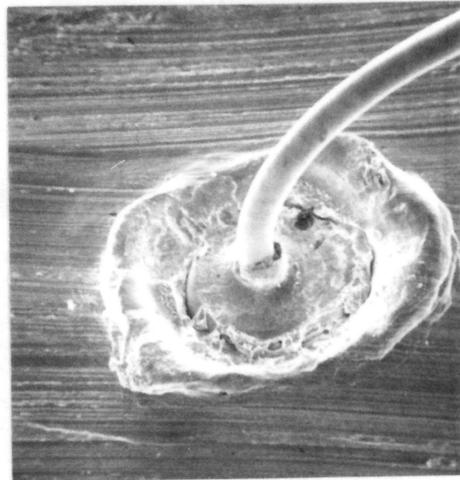
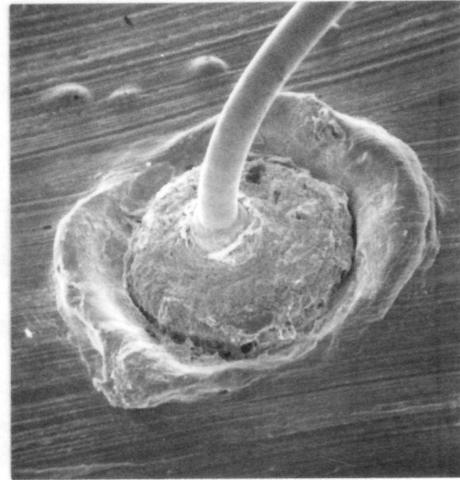
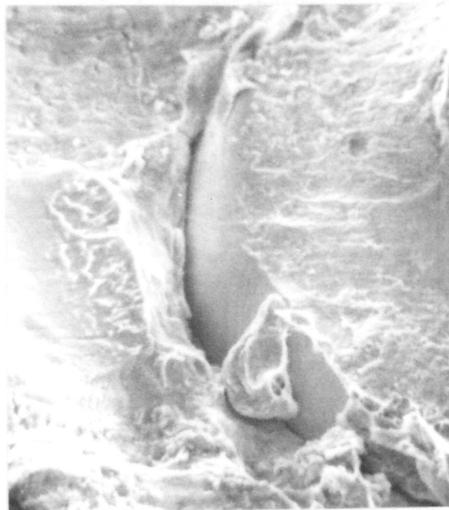
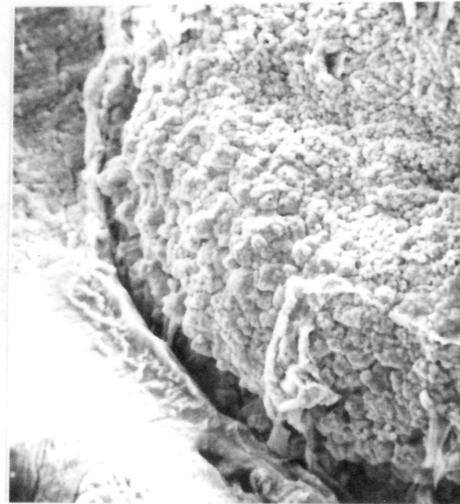
Figure 2: Bond 1-A before (left) and after (right) exposure to 73 hours at 140°C and 97 hours at 120°C. Surface of gold ball is covered with crystalline growth.

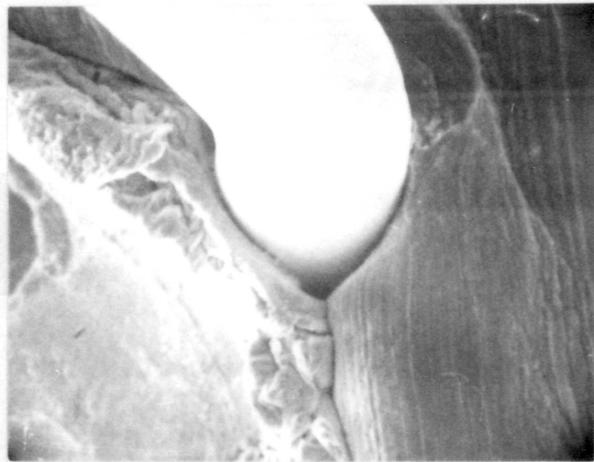
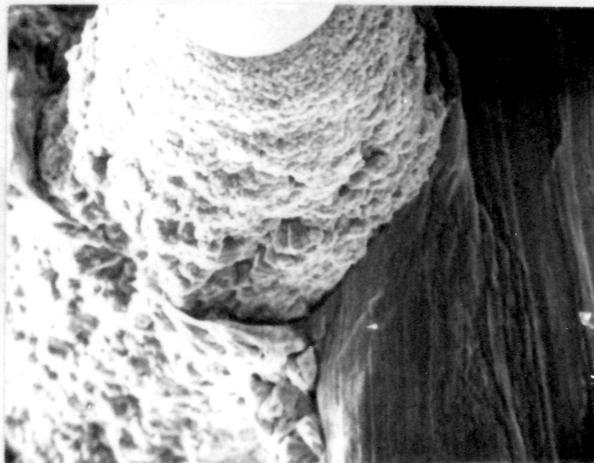
Figure 3: Bond 1-B before and after elevated temperature exposure. Compound growth has extended upward on the surface of the gold wire.

After the initial reaction, further visual examination became more difficult because of the 3-dimensional nature of the areas of interest and the lack of depth of field in the optical viewing system. However, SEM photographs of each bond were obtained before and after temperature exposure and bond testing and are presented in Figures 2 through 7. An overall view of the specimen surface, Figure 1, shows the layout of the bond pairs 1A-B and 1C-D. Bond 1A, Figure 2, shows that after the exposure to temperature the surface of the gold ball, as well as the area immediately adjacent to the indium, was covered with intermetallic compound. The higher magnification photo shows that crystalline growth has filled the gap between the ball and the indium. The other half of this pair, Bond 1B, Figure 3, shows the upward movement of the compound growth as well as the pushing aside of the indium caused by the increasing volume of compound. When this bond pair was pull tested, Bond 1B lifted at a force of 2.3 g_f .

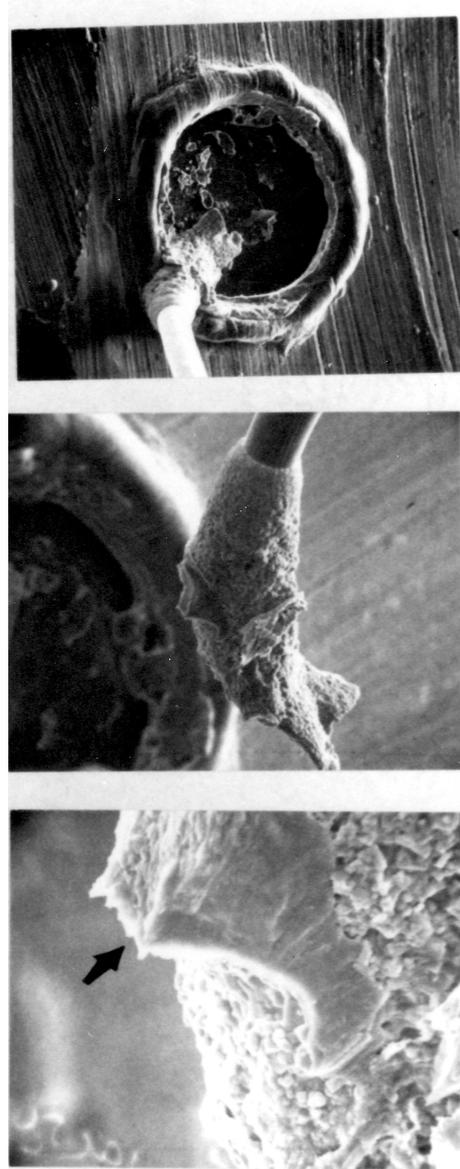
Figure 4: Top image, 250×: Bond 1-B after 73 hours at 140°C plus 97 hours at 120°C. Middle image, 500×: Bond 1-B after temperature exposure and pull testing. Most of the under surface of the wire is covered with intermetallic compound. Bottom image, 2,500×: The arrow points to an area of ductile failure in indium at the heel of the bond.

Most of the failed interface area on the wire was covered with granular material similar to that which formed on the exposed surfaces, Figure 4, indicating that

the indium beneath this area had been totally consumed by the reaction at the heel of the bond where the compound-coated wire had still been in contact with bulk indium. An area of ductile failure in the indium is shown in the bottom of Figure 4.

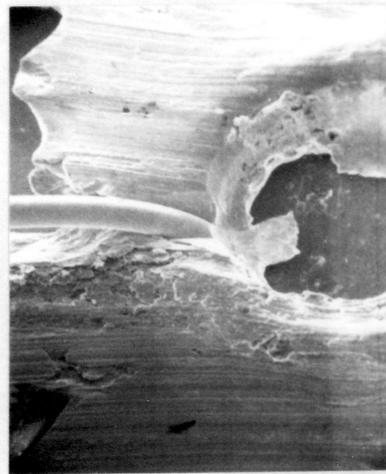
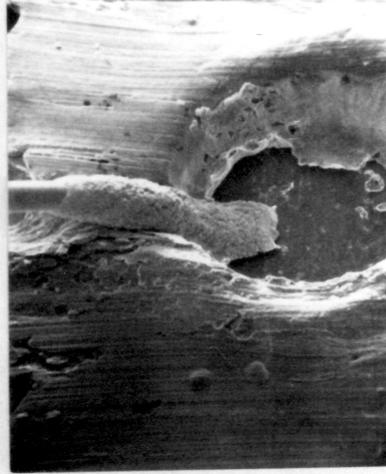
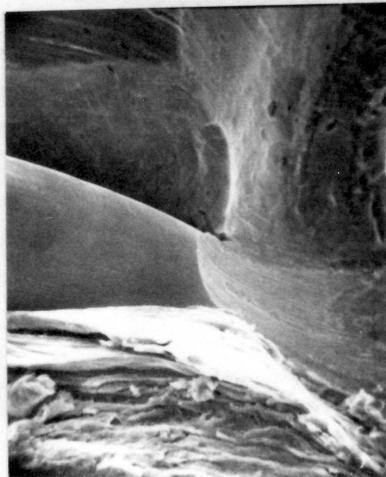
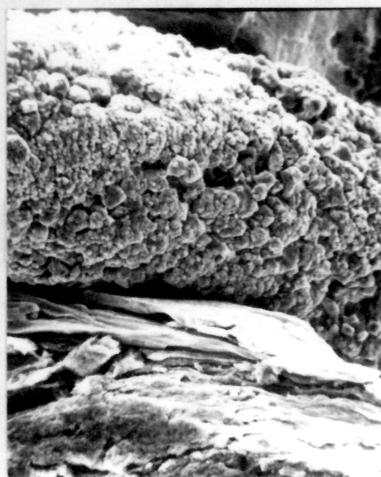
Figure 5: Bond 1C before and after exposure to 140°C. Thick coating of crystalline growth surrounds wire near bond area.

Similar photographs of bond pair 1C-D are presented in Figures 5 through 7. Bond 1C shows a coating of intermetallic compound which approximately doubles the apparent diameter of the wire and which extends several micrometers up the wire, illustrating the mobility of the indium under these conditions. Upon pull testing, Bond 1D lifted at a force of 2.0 g_f . The whole surface of the gold ball showed extensive compound formation, with small areas of ductile indium fracture surface interspersed with granular intermetallic compound.

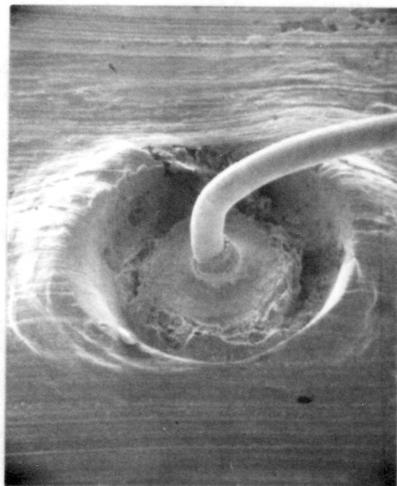
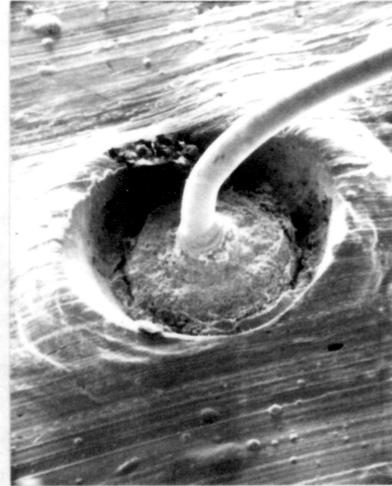
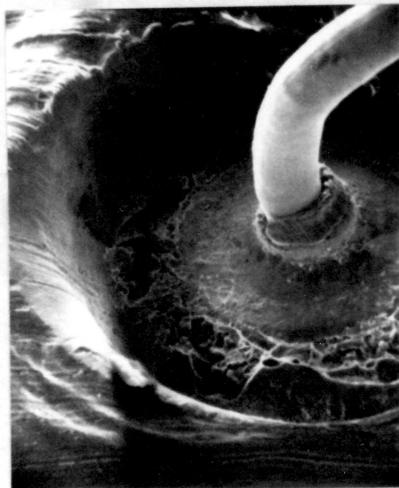
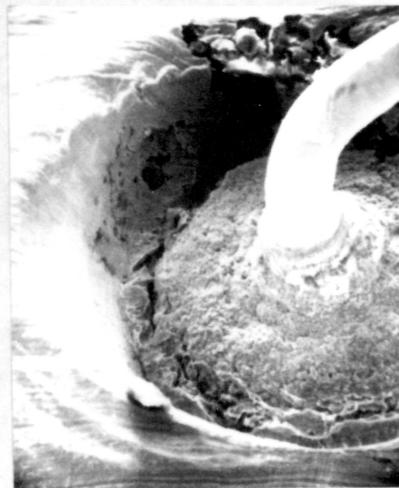
Figure 6: Bond 1D before and after exposure to 140°C. Extensive coverage of gold ball by crystalline growth.

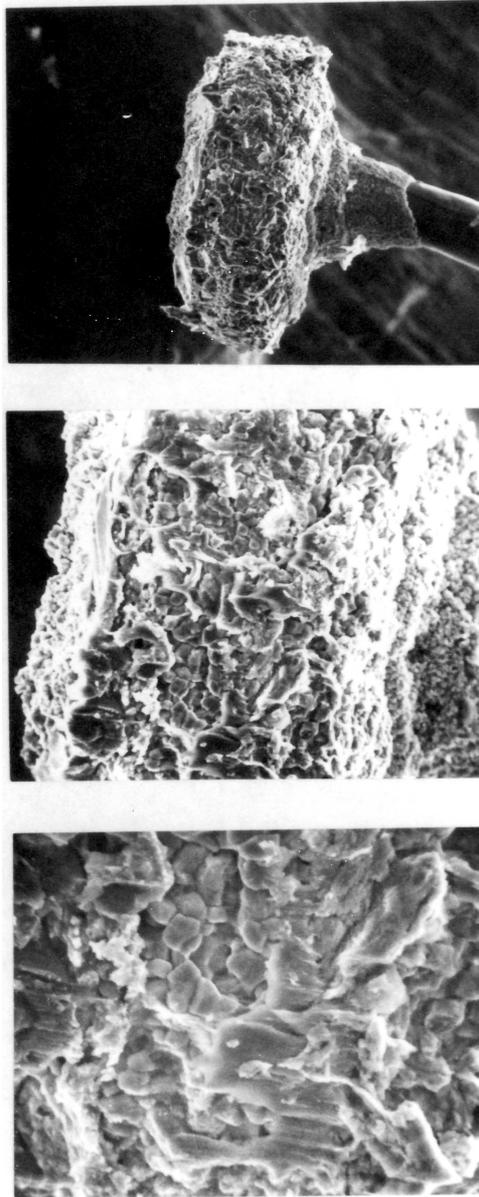
Figure 7: Top image, 500 \times : Bond lifter after pull testing. Bond lifter at 2 g_f load. Middle image, 1,250 \times : Blocky grains of intermetallic compound on all ball surfaces. Bottom image, 2,500 \times : Higher magnification view of blocky grains mixed with ductile failure of indium.

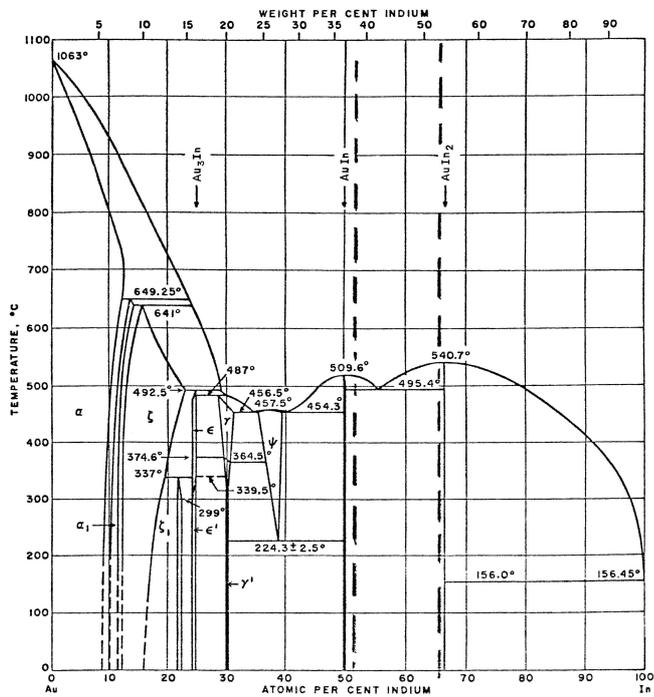
Figure 8: Phase diagram for the gold-indium system (Ref. 2). The compounds prepared in this study (whose composition is shown by the dotted lines) were chosen slightly inside the boundaries of the AuIn-AuIn₂ eutectic region to avoid the presence of other phases.

The compositions had purposely been calculated to fall slightly within the eutectic region of the phase diagram whose end points are AuIn and AuIn₂ (see Figure 8) so as to avoid complication due to the presence of other phases. Figures 9 and 10 show the microstructures of the two alloys in the unetched and etched conditions. The nominally AuIn specimen shows a matrix of this compound with some AuIn₂ present. The reverse is true for the AuIn₂ specimen. (The AuIn₂ phase etches brown with the etchant selected.)

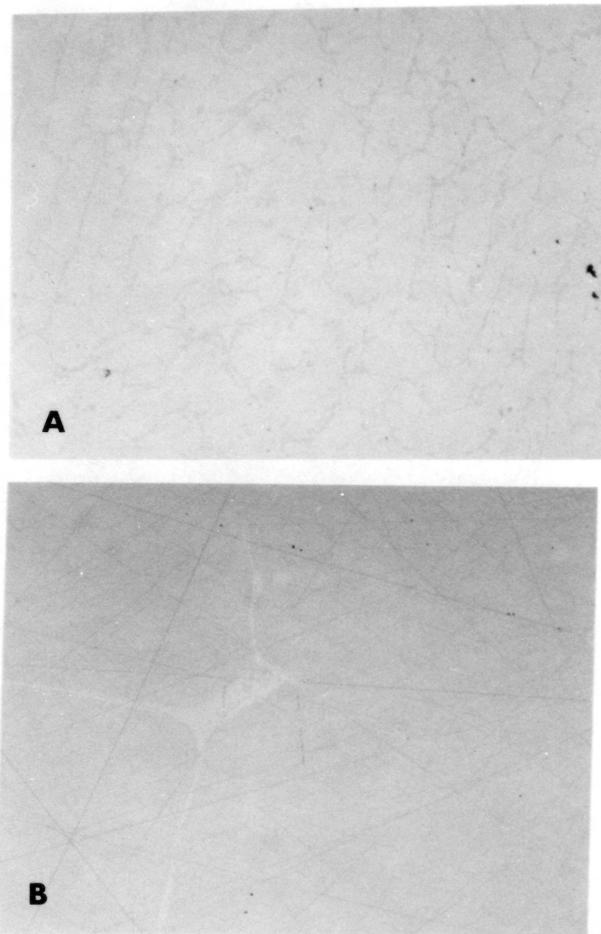
Figure 9: Microstructures of compounds at 100 ×, unetched. Top image, A: AuIn matrix with AuIn₂ network. Bottom image, B: AuIn₂ matrix with AuIn at grain boundaries.

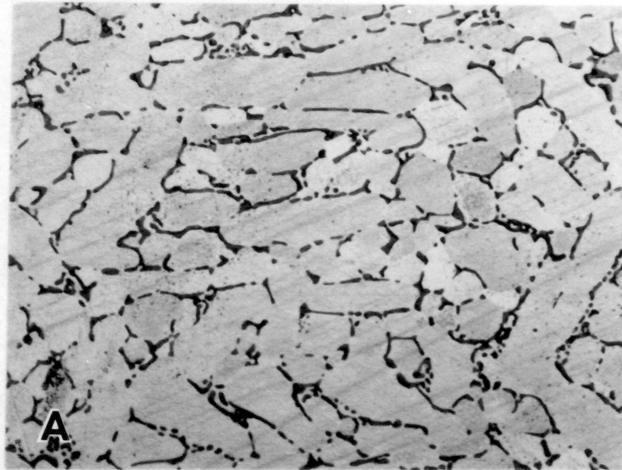
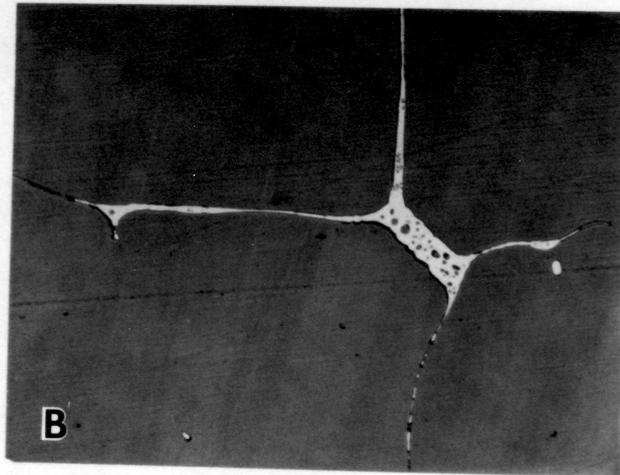
Figure 10: Microstructures of compounds at 100 \times , etched. AuIn_2 etches dark; AuIn remains light. Etchant: 100 mL acetic acid, 2/3 mL hydrofluoric acid, 33 mL nitric acid, 2 mL hydrochloric acid. Top image, A: AuIn matrix with AuIn_2 network. Bottom image, B: AuIn_2 matrix with AuIn at grain boundaries (this is the same field as Figure 9B, but rotated 90 degrees clockwise).

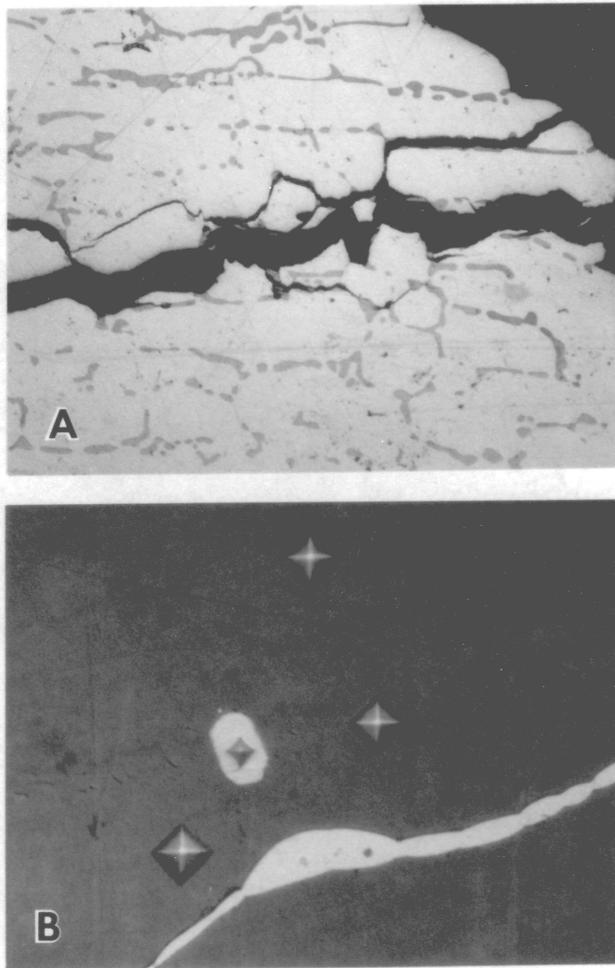
Figure 11: Microstructure of intermetallic compounds, etched. Top image, A: Brittle cracks in both AuIn and AuIn₂ phases. Bottom image, B: Microhardness indentations in AuIn (light) and AuIn₂ (dark) phases. A larger indentation indicates a softer material.

Some cracks were noted in the Au-In specimen, propagating through both phases (see Figure 11). It is not known if these cracks formed during the alloy preparation process or during the sectioning prior to metallographic mounting. In either event, the crack presents a brittle appearance.

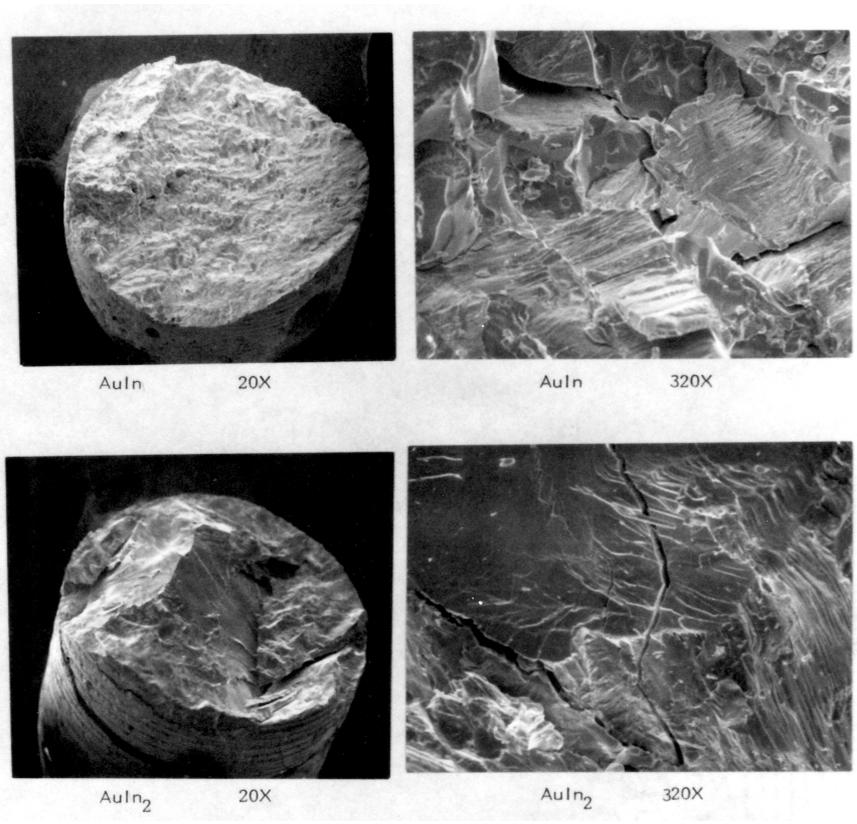
Figure 12: SEM Fractographs of AuIn and AuIn₂ ingots after shear testing. Both phases fractured in a brittle manner by cleavage.

SEM fractographs of both specimens are shown in Figure 12. In both specimens the overall fracture appearance was very brittle with little or no plastic deformation. Fracture was largely by transgranular cleavage with numerous subcracks in evidence. Some areas of the Au-In specimen failed through the AuIn₂ colonies in the grain boundaries.

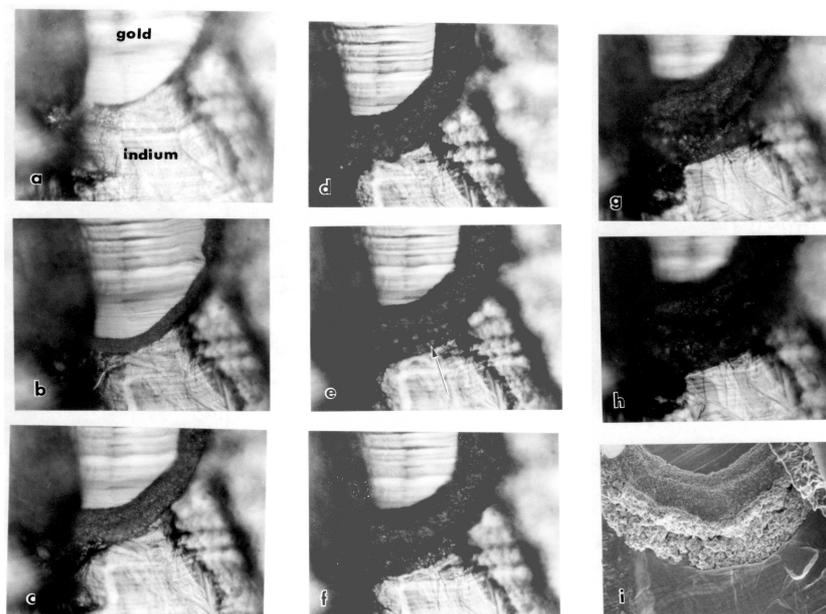
Figure 13: Hot stage optical microscope specimen, at 400 \times . Left top image, a: 15 minutes. Reaction product starting to grow at interface. Left middle image, b: 1.5 hours. Dark layer has spread. Left bottom image, c: 3 hours. Dark layer is consuming and/or covering both gold and indium surfaces. Center top image, d: 7 hours. Center middle image, e: 14 hours. Blocky grains visible in fissure (Arrow). Center bottom image, f: 21 hours. Right top image, g: 28 hours. Right middle image, h: 35 hours. Right bottom image, i: 35 hours, SEM photograph at 640 \times .

By the time the hot stage specimen had reached temperature and the camera had been readied, (about 15 minutes), a noticeable growth had occurred at the interface between the gold wire and the surrounding indium, Figure 13. (The razor cut surface was quite rough, but one segment of the interface was acceptable for microscopic observation.) As time progressed, the growth extended both outward over both the gold and indium surfaces and upward, forming a rounded ridge. The growth was dark gray in color, and appeared somewhat grainy. After about 14 hours, a fissure appeared revealing larger, blocky grains below the surface film: see the center middle image of Figure 13. This layer continued to grow in width for the remainder of the test. At this time the surface had become too irregular for useful microscopic examination: see the center bottom image, and the right top and middle image, of Figure 13. A SEM photo corresponding to the last optical photo is shown: see the right bottom image in

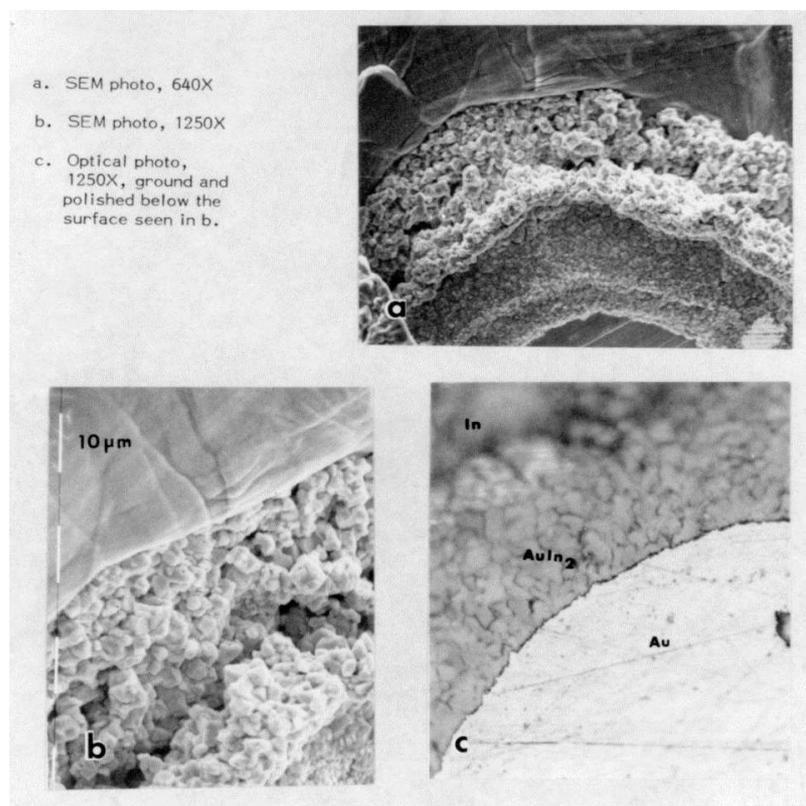
Figure 14: SEM photographs of surface compared with optical photographs of cross section through hot stage specimen.

Figure 14 compares higher magnification SEM photos with a photomicrograph of the specimen after it had been ground, polished, and etched. In the polished condition, the layer of fine grainy material on the gold wire surface has been removed. Once the surface layer has been removed, the blocky grain structure is seen to extend from the gold wire to the indium matrix. The grains do not appear to be bonded together very strongly.

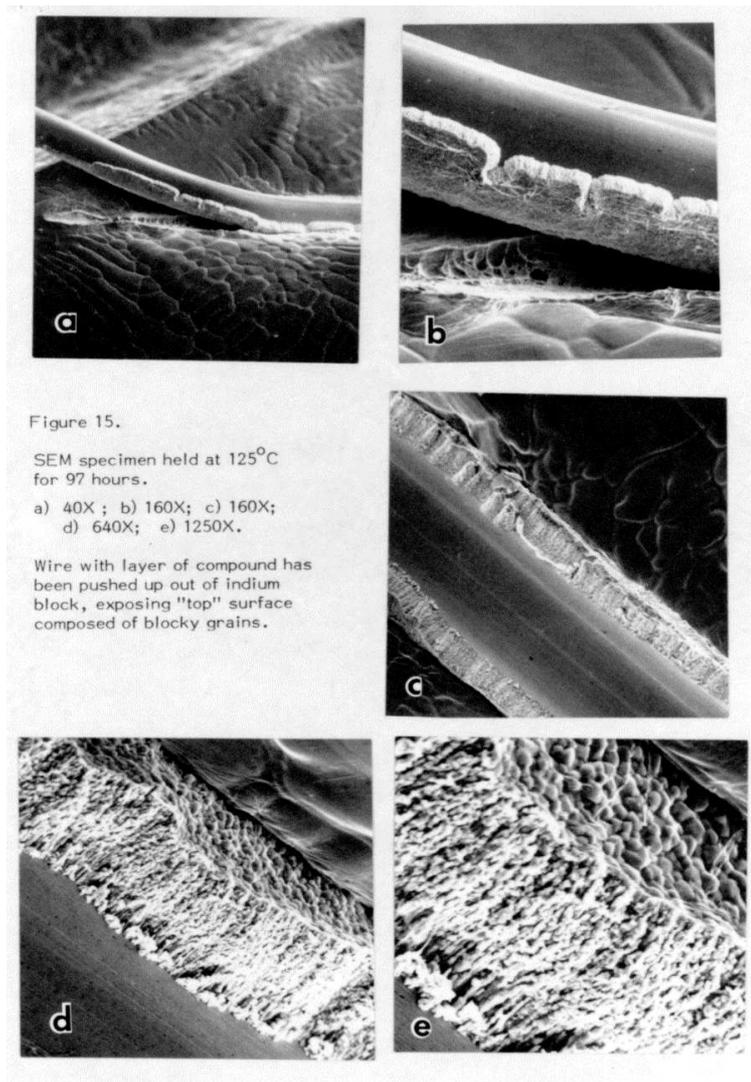
Figure 15:

a) 20X; b) 160X; c) 2500X;
d) 1250X; e) 5000X.

Fine grained surface layer and large
blocky grains which had formed
beneath the surface.

A specimen held at 125°C for 97 hours is shown in Figure 15. The upper two photographs show one end of the gold wire where it has been pulled away from the indium block. A heavy layer of Au-In intermetallic compound has formed where the wire had been in contact with the indium. A second area where the wire had not been pulled out is shown in images c to e of Figure 15.

The compound layer extends on the gold surface beyond the edge of the indium and the appearance of the “top” surface of this layer is quite different from that of the “side wall”. Apparently, the force of the growing compound layer has pushed the wire up out of the indium block, exposing the surface characterized by blocky grains which had previously been in contact with the bulk indium. The leading face, or “wall” of the compound layer is finer grained and/or columnar in appearance.

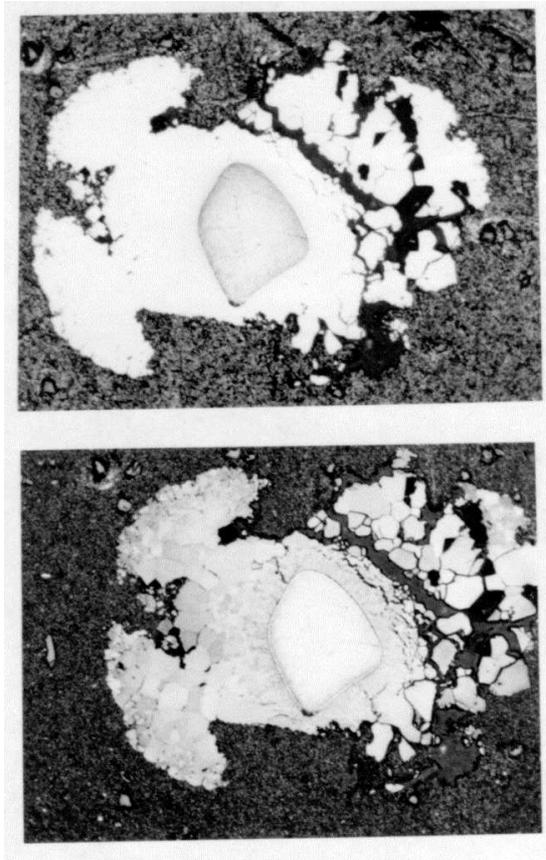
Figure 17: Cross section through specimen held at 125°C for 500 hours in the unetched (top image) and etched (bottom image) condition. Compound growth is very irregular and consists almost entirely of $AuIn_2$.

This dual surface morphology is also seen in a sample held 144 hours at 125°C, Figure 16. In addition, a crack has formed within the blocky structure along either side of the wire. A cross-section through a different specimen held for 500 hours at 125°C, Figure 17, shows many intergranular cracks, voids, and fissures within the compound layer. Layer growth has proceeded unevenly, resulting in a non-circular cross section of the unconsumed gold wire. This is probably the result of air bubbles or voids in the indium near the gold wire from the casting process. In the etched condition, the compound layer is seen to be formed of crystals of AuIn_2 of various sizes, smaller and columnar near the gold wire and large and blocky farther out. Verification of the compound composition was obtained by energy dispersive X-ray analysis (EDX). Some of the breakup near the outside of the layer is very likely due to damage during the sectioning process (early specimens were sliced after exposure to temperature; later ones were pre-cut) but some of the voids and cracks would correspond to those seen on the surface of the specimen pictured in Figure 16.

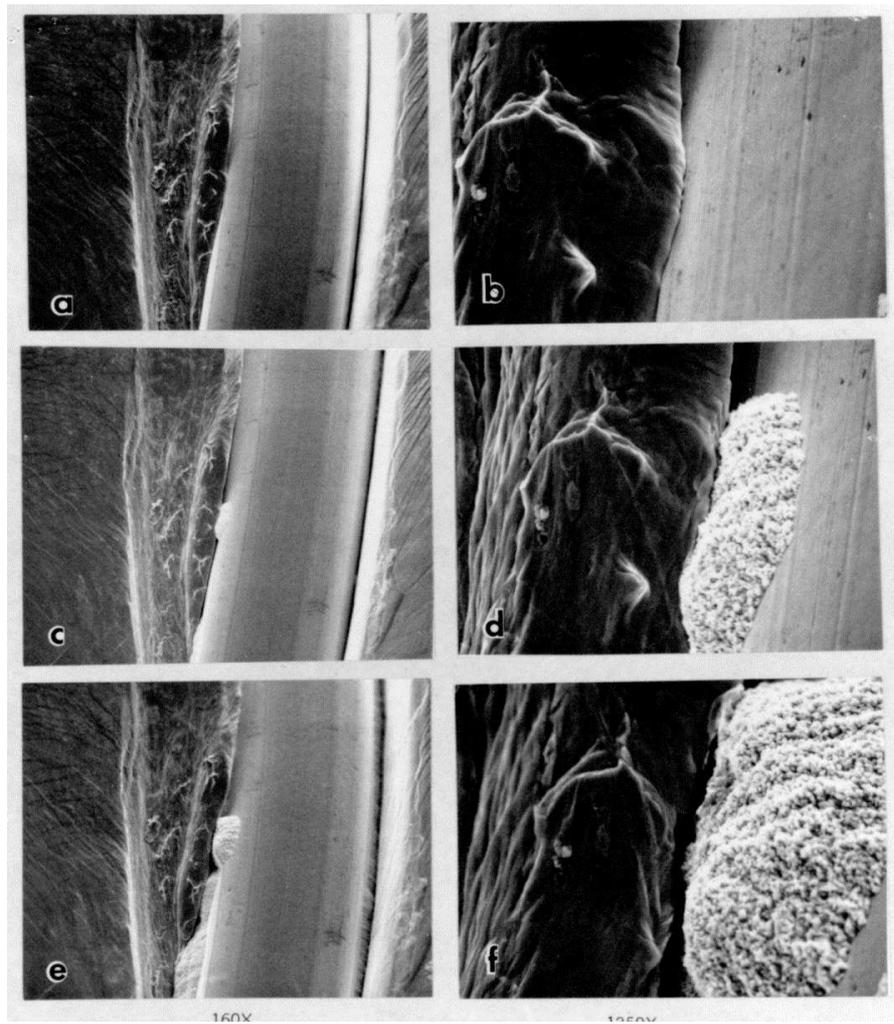
Figure 18: SEM specimen held at 100°C for the indicated times: images a & b for 0 hours; images c & d for 72 hours; and images e & f for 240 hours. A patch of Au-In compound developed where gold and indium were in close contact.

As the test temperature was lowered, the growth rate decreased, and it became increasingly easier to monitor compound growth in a given area as a function of time at temperature. Figure 18 illustrates the 100°C specimen at various time intervals and magnifications. At the start of the test, see images a and b in Figure 18, no compound was visible. The area shown in image b of Figure 18 was selected for a “before” photograph because the gold and indium were in close contact at the center of the field of view. After 72 hours, a colony of compound had obligingly formed at that spot, as shown in images c and d of Figure 18. As time passed, growth underneath the wire started to force the wire up out of the indium block, carrying this colony with it, see images e and f of Figure 18 (240 hours). After 312 hours, contact had been lost between the colony and the indium and growth in this area ceased except for a small area at the top of the photo where a ribbon-like feature connects the two. At 568 hours, images h and i of Figure 18, continued growth elsewhere has increased the separation and the ribbon has extended in length. The composition of the ribbon was not determined because its location made it inaccessible to the X-ray analyzer.

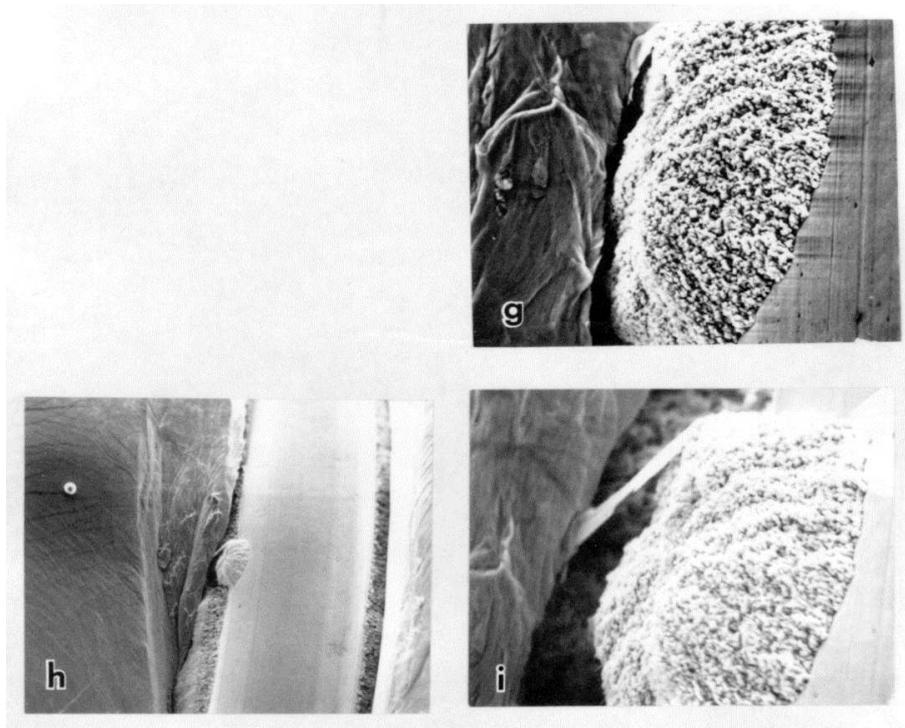
Figure 18: (continued) SEM specimen held at 100°C for the indicated times: image g for 312 hours, and images h & i for 568 hours. Continued growth beneath the wire has forced the compound patch area away from the indium and further patch growth ceased.

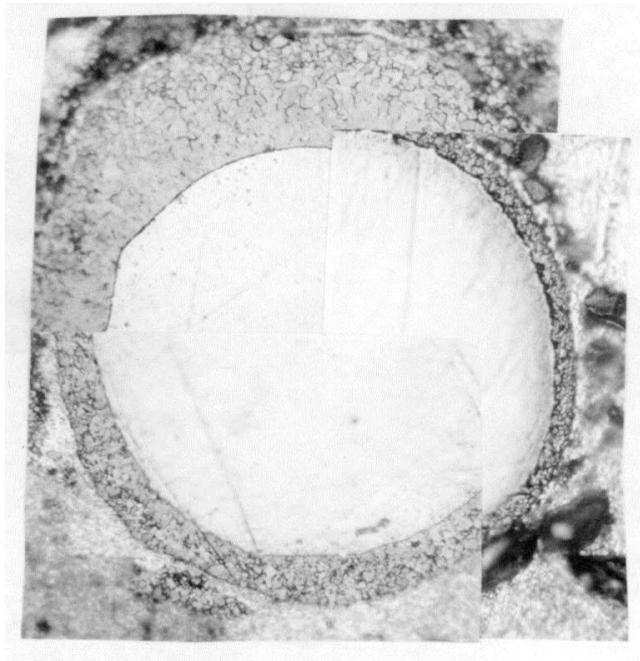
Figure 19: Composite photograph at 500 \times showing growth of intermetallic compound at 100°C. Clockwise: 72 hours \rightarrow 1 to 5 o'clock; 144 hours \rightarrow 5 to 9 o'clock; and 240 hours \rightarrow 9 to 1 o'clock.

Metallographic examination of cross sections of fully embedded wires exposed to 100°C are shown in Figure 19. Layer thickness was more uniform than at higher temperatures and contained fewer voids. Virtually all of the layer appeared to be fine grained AuIn₂ with some intergranular cracks.

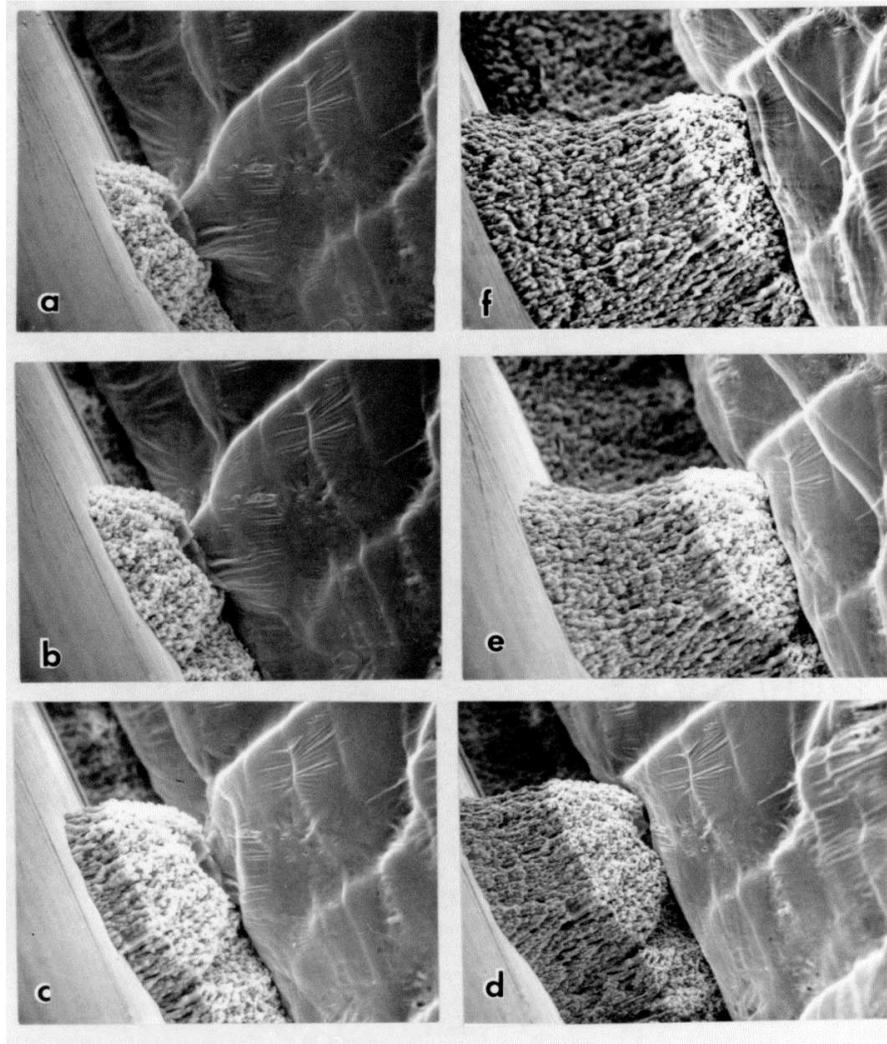
Figure 20: SEM specimen held at 80°C for the indicated times: image a for 164 hours; image b for 209 hours; image c for 357 hours; image d for 672 hours; image e for 900 hours; and image f for 1,072 hours. All images are at 1,250 \times . Demonstrates plastic deformation of the bulk indium caused by compound growth.

The 80°C SEM specimen provided a graphic illustration of the force exerted by continued intermetallic compound growth. Image a in Figure 20, taken after 164 hours at 80°C, shows a feature which can be visualized as an indium angel fish nibbling some intermetallic algae. As the compound continued to grow, the front part of the fish’s face became wrinkled and compressed. By 357 hours, the mouth was pushed back close to the eye and a crease in the indium has formed just in front of the eye. As the process continued, the face was totally consumed and new creases were formed in the bulk indium. It was observed that the new growth appears on the gold side of the intermetallic compound layer, with previously formed features being displaced toward the indium side. In Figure 21, also taken from the 80°C SEM sample, this is particularly evident because of the development of columnar or elongated features at 357 hours which are recognizable in the 1072 hour photograph more than half-way up the compound layer face (circled areas). Also noted was the displacement of the indium ball at the apex of the compound stack: it has been forced into the bulk of the indium by 1072 hours.

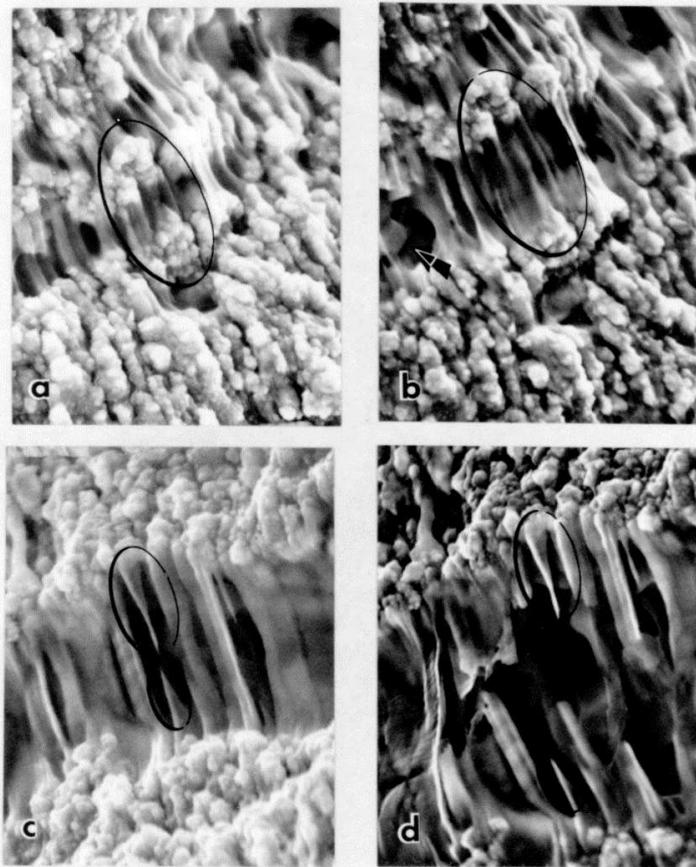
Figure 22. SEM specimen held at 80°C. Circled areas show ductile elongation of surface features. All at 5000X.

Some of the regions of elongated features noticed at 900 and 1072 hours appeared to be extremely ductile, Figure 22. It is believed that this is a surface layer, possibly oxidized, and is not representative of the bulk compound layer. Image b in Figure 22 shows some of the blocky structure visible through a hole in the veil of ductile material (arrow at left center) and similar indications were noted elsewhere on this specimen.

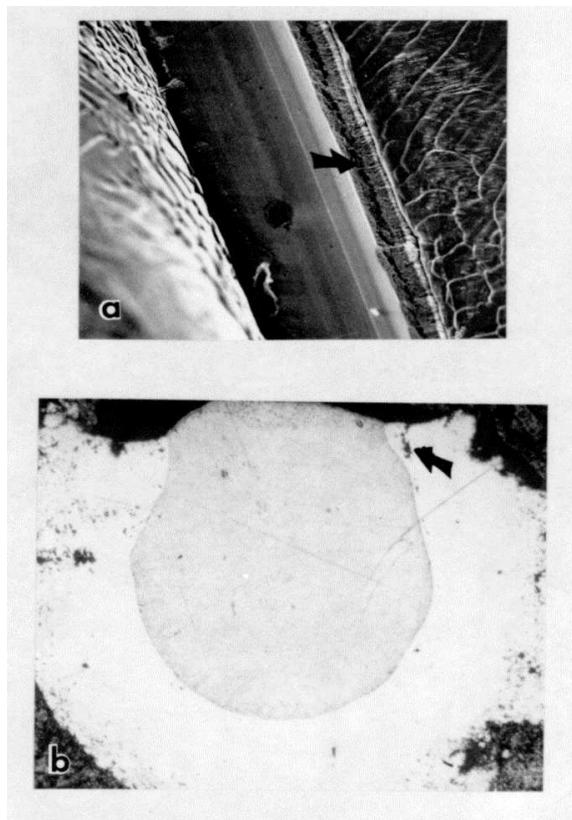
Figure 23: SEM specimen held at 80°C for 1,072 hours. Image a: SEM photograph at 160×; the arrow points to a fissure. Image b: Cross section through this area at 400×. Crack at arrow corresponds to fissure in image a.

growth, the 80°C SEM specimen was cross-sectioned after 1072 hours at temperature. Figure 23 compares a SEM photograph with an optical photomicrograph of a section through the general area of the SEM photo. The fissure in the compound on the right hand side of the wire in the SEM photo appears as a crack in the cross section. This crack extends a short distance into the bulk compound layer and is believed to be caused by stresses imposed by the extensive subsurface compound growth. A SEM photo and a cross section through a region showing the elongated ductile features is presented in Figure 24. Again the fissure can be seen in both views, but the veil material is apparently too superficial as well as too delicate to be seen in cross section. Etching revealed the blocky grain structure common to all specimens at all temperatures. More intergranular cracking occurred near the surface than in the bulk of the layer, again apparently because of higher unbalanced stresses in this area.

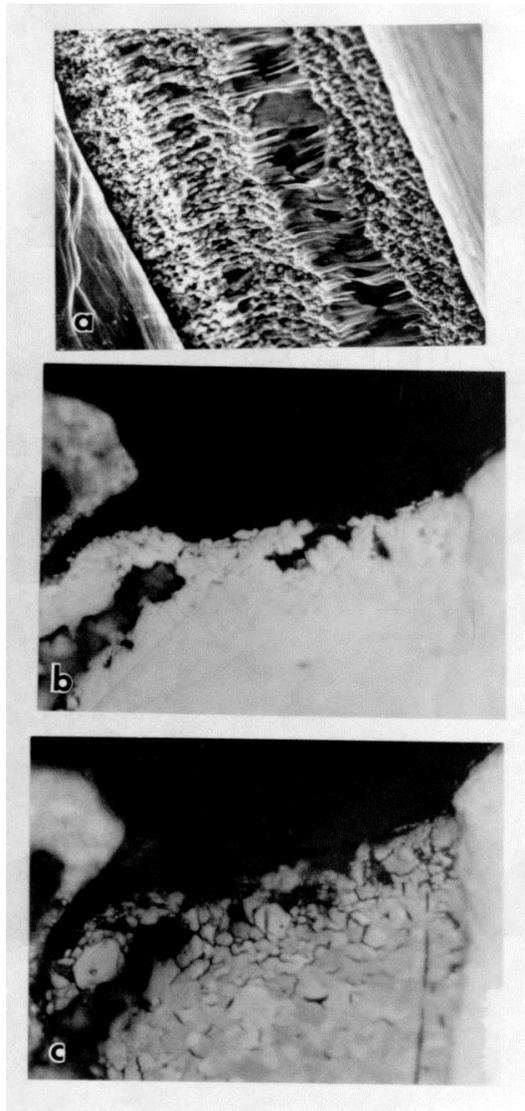
Figure 24: Top image, a: SEM specimen held at 80°C for 1,072 hours. Middle image, b: Cross section through an area as in image a, unetched, 1,250×. Bottom image, c: Area b etched, showing blocky grains of AuIn₂.

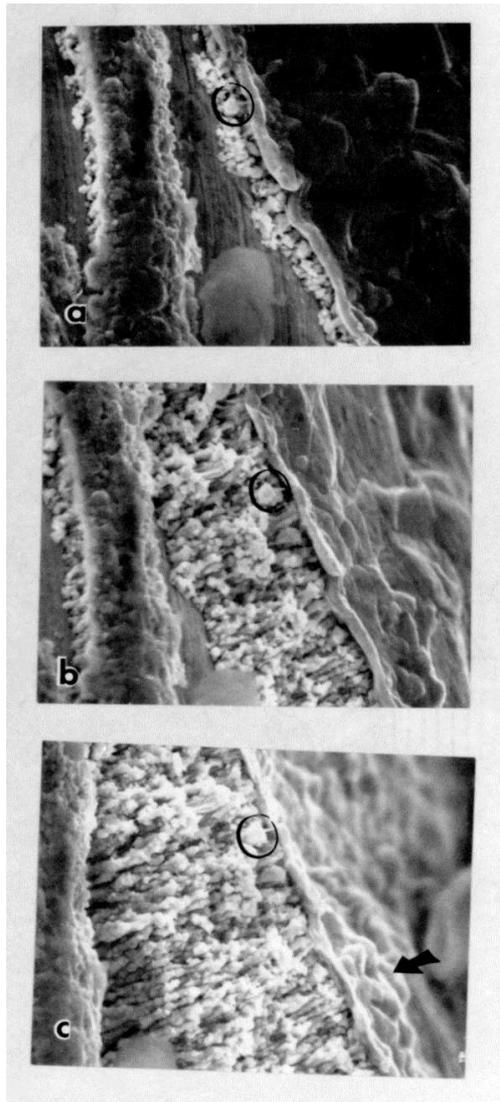
Figure 25: SEM specimen held at 80°C. Compound growth at an area where a thin layer of indium covered the gold. Arrow indicates blocky grains visible through thin film remaining unreacted. All images at 2,500×. Top image, a: 68 hours. Middle image, b: 154 hours. Bottom image, c: 357 hours.

Figures 25 and 26 compare surface morphology at 80°C and at 40°C in areas where a relatively thin layer of indium had spread out over the gold surface. Growth characteristics appear to be the same for both temperatures. On the 80°C specimen after 357 hours, image c of Figure 25, the indium layer has been essentially used up, and the blocky intermetallic structure can be seen through the remaining thin layer of indium and/or indium oxide (arrow).

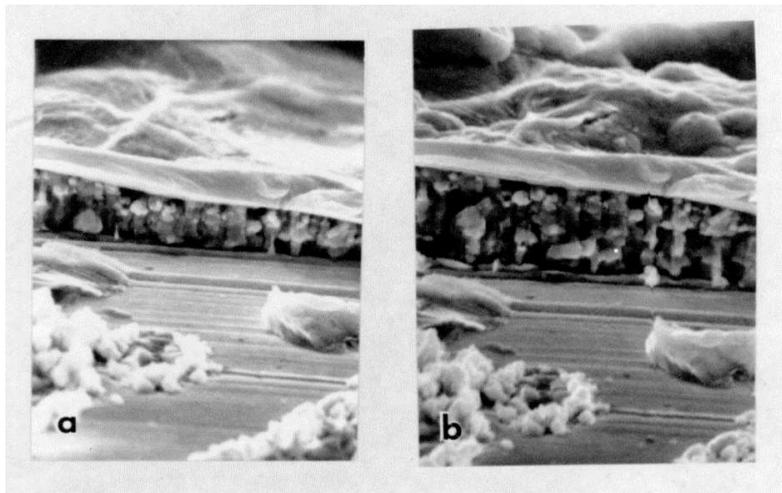
Figure 26: SEM specimen held at 40°C for 4 months (image a) and for 6 months (image b). Layer growth is proceeding as at higher temperatures.
