Gold-Indium Intermetallic Compounds: Properties and Growth Rates

Jane E. Jellison
Code 313:
Materials Control and Applications Branch (MC&AB)

8 November 1979

Note: Jane Jellison originally composed this as a memo to the TIROS Project to describe her study of failures on gold-ball bonds in detectors made by Honeywell for a TIROS satellite. Henning Leidecker recast her memo into the present article in July 2003.

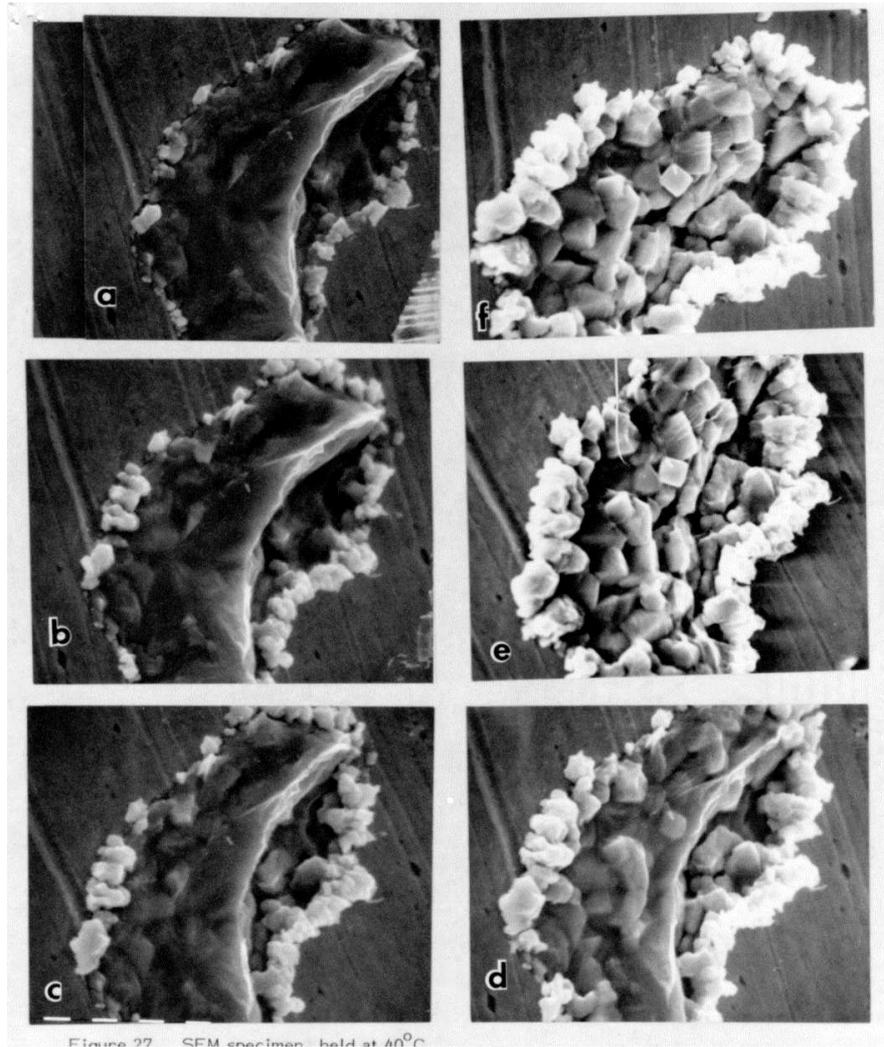
Figure 27: SEM specimen held at 40°C for 2 weeks (image a); 4 weeks (image b); 6 weeks (image c); 9 weeks (image d); 3 months (image e); and 4 months (image f). All at 5,000 \times . Final product is loosely connected grains of AuIn₂ which would be very poor mechanically.

This latter phenomenon is illustrated in Figures 27 and 28, which are both of areas where small patches of indium about 10 micrometers across were isolated on the gold wire surface. At first, visible growth is confined to the surface interface between the indium and the gold, and is of the fine-grained type noted on the surface of the compound layers formed at higher temperatures. After about 9 weeks at 40°C, blocky grains can be seen growing up through the indium. Indium depletion was complete in Figure 27 at 3 months; no further change occurred with additional holding time. The resulting blocky structure is loosely jumbled together with many voids, as perhaps the last indium to react migrates to some crystallographically preferred site at the expense of mechanical integrity. The area pictured in Figure 28 has virtually completed the reaction in 6 months time.

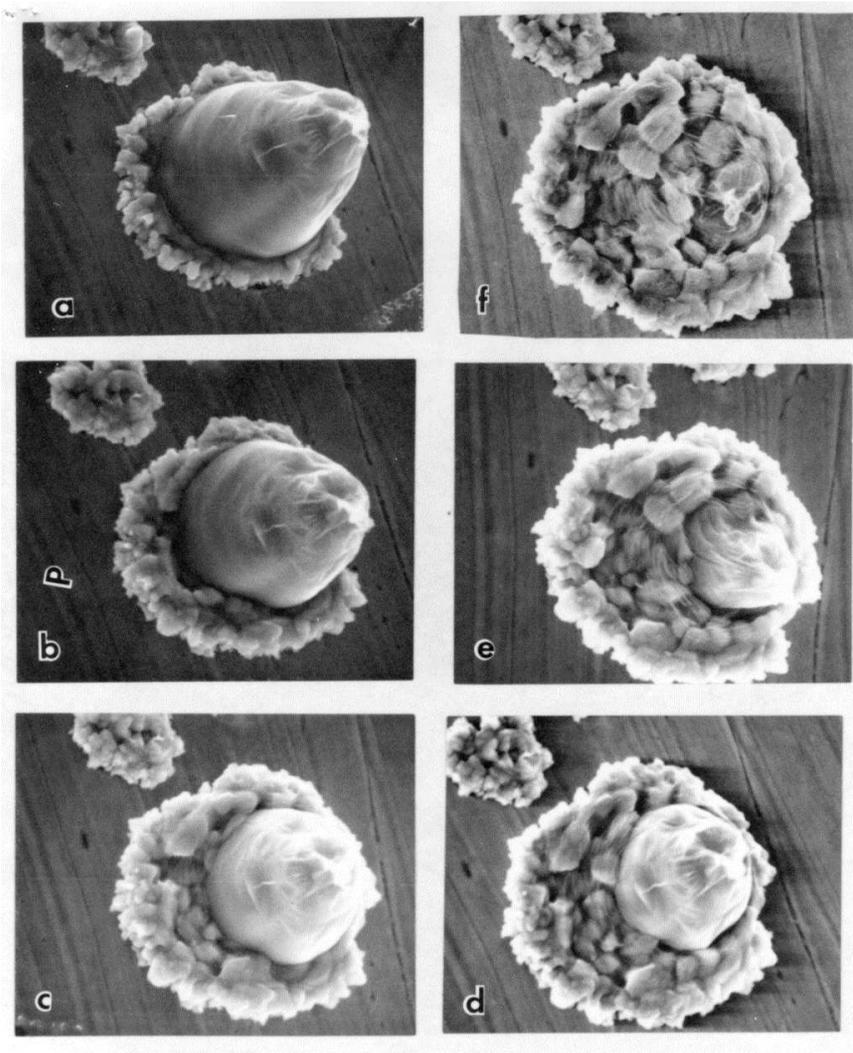
Figure 28: SEM specimen held at 40°C for 3 weeks (image a); 6 weeks (image b); 9 weeks (image c); 3 months (image d); 4 months (image e); and 6 months (image f). All at 5,000 \times . Formation of blocky Auln₂ almost complete after 6 months.

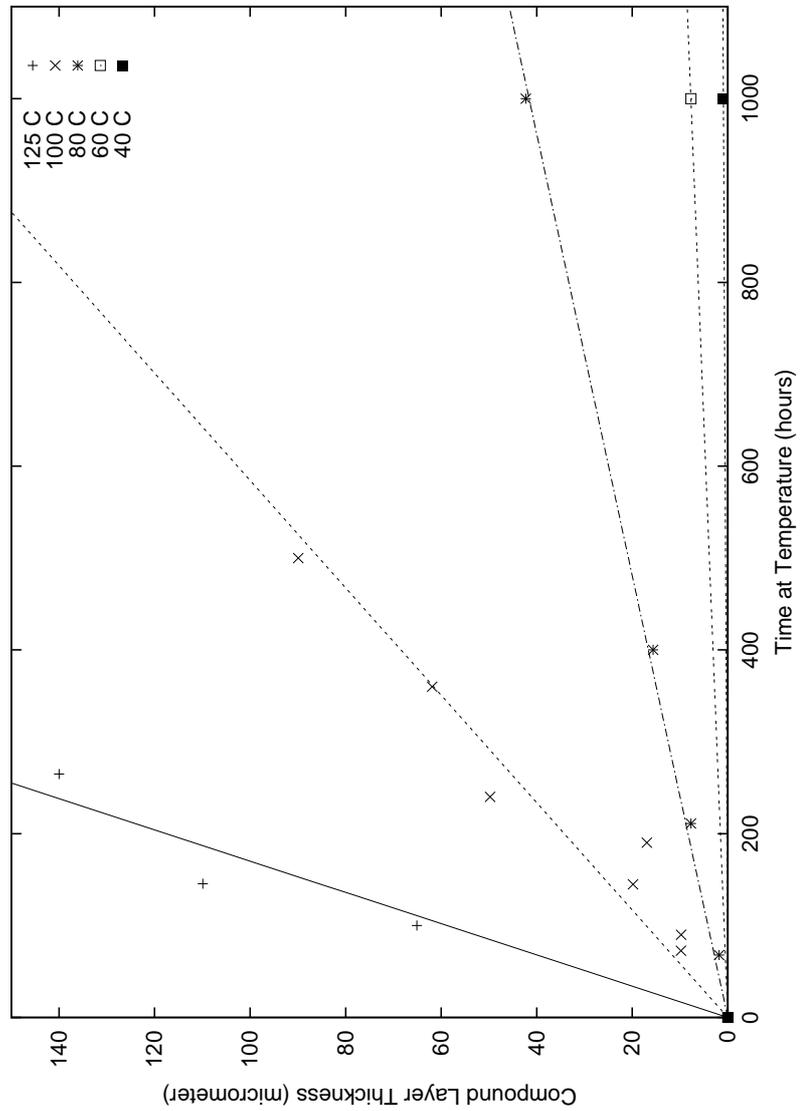
Figure 29: Plot of the thickness h of the intermetallic Au-In compound at selected times t up to 1,000 hours, for specimens held at selected temperatures, T . The least-square fitted lines are also shown: $h = \beta(T) \cdot t$; $\beta(125^\circ\text{C}) = 0.588 \mu\text{m/hr} \pm 9\%$; $\beta(100^\circ\text{C}) = 0.171 \mu\text{m/hr} \pm 6\%$; $\beta(80^\circ\text{C}) = 0.0416 \mu\text{m/hr} \pm 2\%$; $\beta(60^\circ\text{C}) = 0.00773 \mu\text{m/hr}$; and $\beta(40^\circ\text{C}) = 0.00092 \mu\text{m/hr}$. The uncertainty of the last two values for β are roughly 10%, based on the difficulties of measuring the thickness of the single specimen at 40°C and at 60°C .

The thickness of the intermetallic compound layer after various time-temperature exposures was determined by measurements taken from 1000× photographs of the polished cross-sections. At the higher temperatures (100°C and above) the layer thickness was non-uniform and considerable scatter in the data was observed. At temperatures of 80°C and lower, layer growth was more even; however, the percent error in measuring a thin layer is higher. The difficulty of preparing the metallographic specimens also contributes to the scatter in the measurements.

The resulting data were plotted in Figure 29 as layer thickness versus hours at temperature, and a linear time-temperature relationship was assumed.

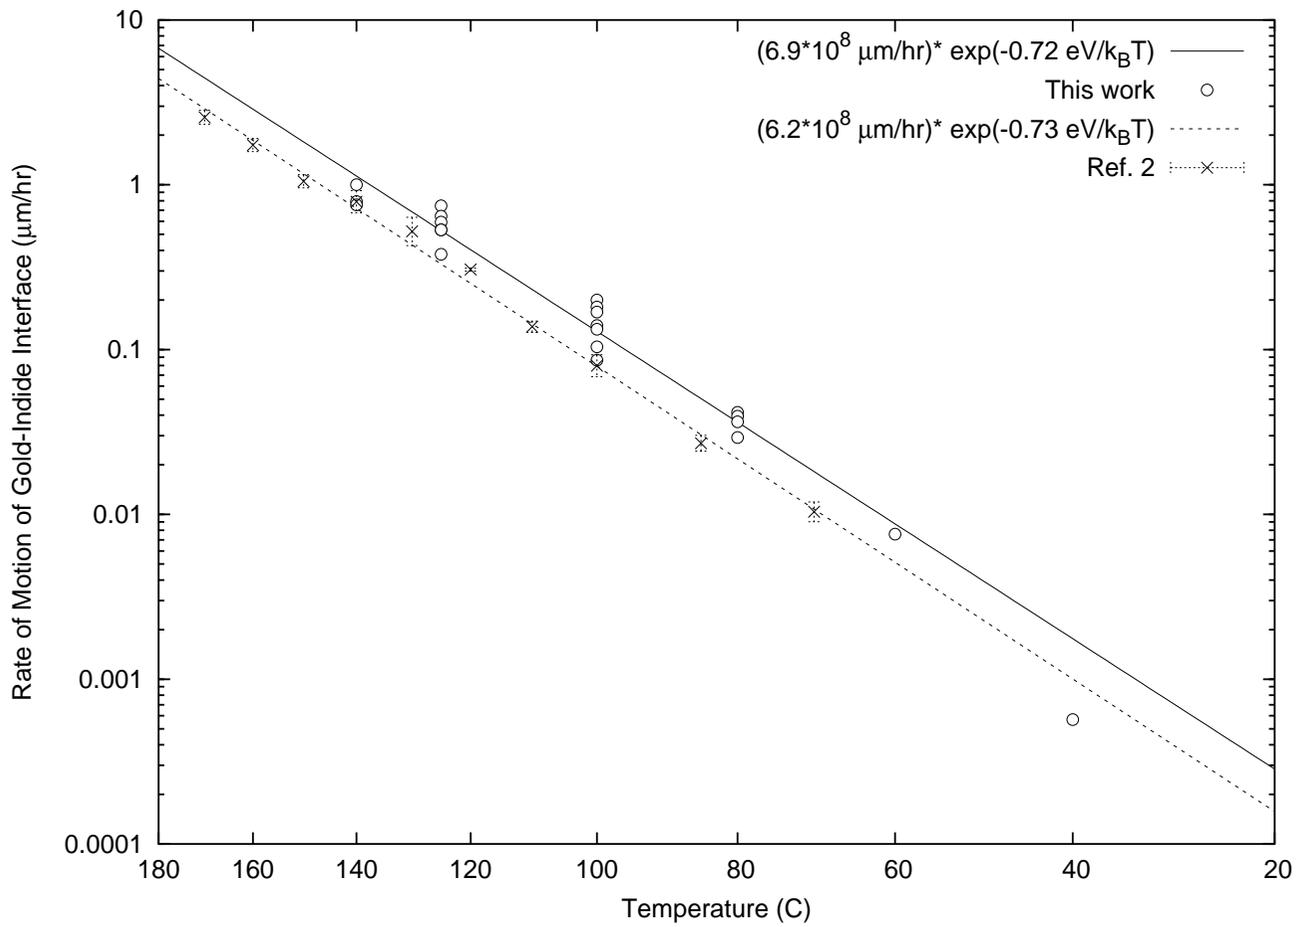
Figure 30: Arrhenius plot of rate of motion of gold-indium interface. "This work" labels data acquired in this study, a few of which were shown in the previous figure.

Reaction layer thickness measurements were then plotted as micrometer per hour versus the reciprocal of the holding temperature and a straight line resulted when the graph was plotted on semi-log paper (Figure 30). From this graph the equation for the reaction rate, β , was found to be

$$\beta = (6.88 \times 10^8 \text{ } \mu\text{m/hr}) \cdot \exp\left(-\frac{0.72 \text{ eV}}{k_B T}\right), \quad (1)$$

where k_B is the Boltzmann constant and T is the absolute temperature in kelvins. The activation energy is expressed as 0.72 eV.

For comparison, a similar curve derived for the reaction of lead-indium solder with gold by F.G. Yost et al. (Reference 3) is also presented in Figure 30. In both cases the bulk of the reaction layer consisted of AuIn_2 . The reaction rates in both cases are also quite similar, and may well be the same if the variations in materials and technique between the two experimental programs could be fully taken into consideration.

To answer the first question, reaction rates were taken from Figure 30 for the pertinent temperatures, and the following calculation was made:
