**Failure Analysis Study and Long-Term Reliability of Optical  
Assemblies with End-Face Damage  
Technical Assessment Report**

***Phase I: International Space Station (ISS) Termini Root Cause  
Analysis Report***

**August 3, 2006**

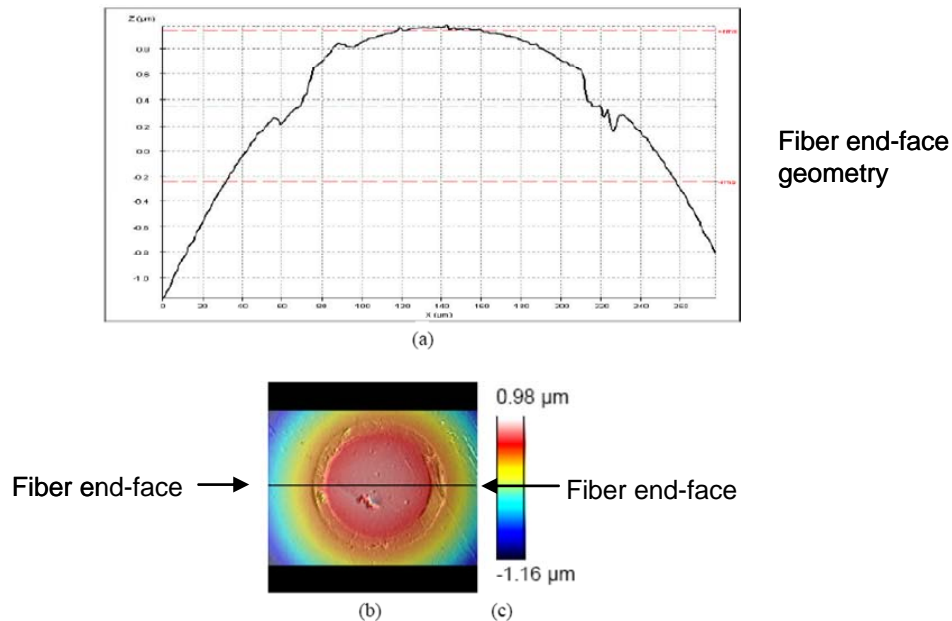
**Figure 4.0-2. Confocal Profile**

In many applications, a physical contact connection is implemented to mate fiber optic connectors such that the insertion losses are reduced. In the case of this connector, the high vibration levels originally used to “qualify” the connectors for military standard applications showed data indicating that the terminus/connector system should not be of a physical contact type. Therefore, the same processes were specified in this application. For a “concave” polish, it is imperative that the glass end-faces do not come in contact with one another in order to comply with the military standard method and reasoning for non-contact. As stated in OHB’s “Fibre Optic Manufacturing Procedure” Section 4.6: “Inspect the profile of the terminus end-face under 40X magnification. The surface should be slightly concave with the face of the ceramic tip.” This is not an effective method for determining the fiber’s profile. Figure 4.0-1 shows what the profile looks like at 40X magnification. The end-face appears to be flat, and not protruding. This method is non-conclusive for true determination of the end-face profilometry. The profile should be determined using an interferometer or confocal microscopy as illustrated in Figure 4.0-2. The confocal data clearly shows the end-face of the fiber to be convex, which should have failed inspection.

The horizontal line appearing in the top chart of Figure 4.0-2 corresponds to the profile plot shown in the colored image figure below the chart.

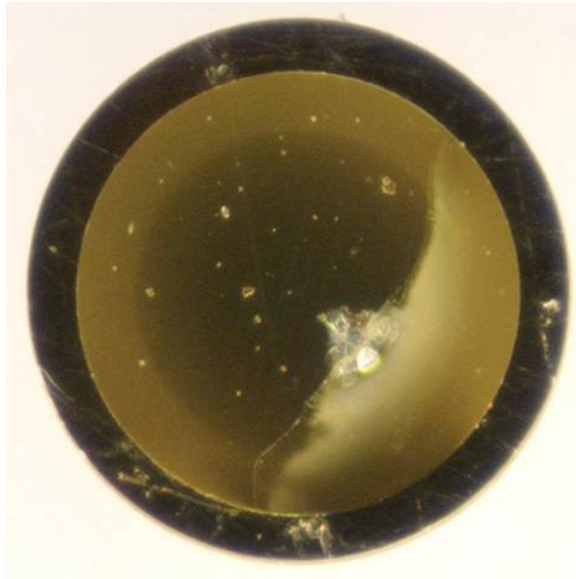
**Figure 7.1-2. Dark Field Image**

The origin of the impact fracture needs to be observed closer. If a higher magnification were used with the microscope, the features of the fracture would not be clear, and no solid conclusions could be made. To analyze the fracture closer, the terminus was observed using SEM.

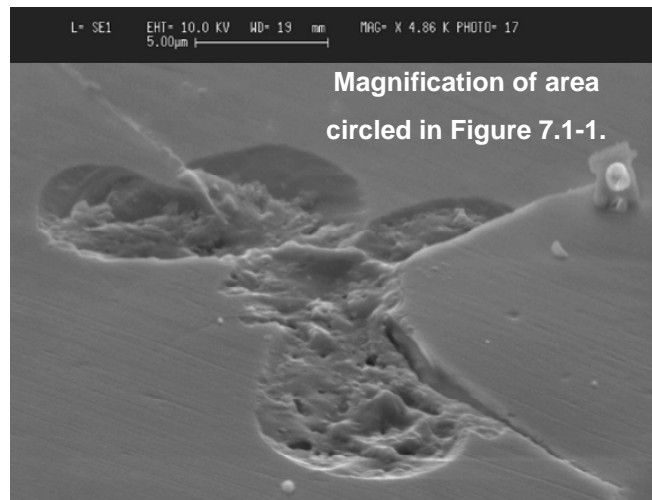
**Figure 7.1-3. Magnification of 4,860X SEM Images**

The SEM images in Figures 7.1-3 and 7.1-4 were taken to identify stress signatures in the origin. At  $4.86 \times 10^3$  and  $12.1 \times 10^3$  magnifications, a corrosive attack on the glass inside the impact fracture was observed. The elements that are causing the corrosion cannot be identified visually, so EDS was performed to identify what was attacking the glass.

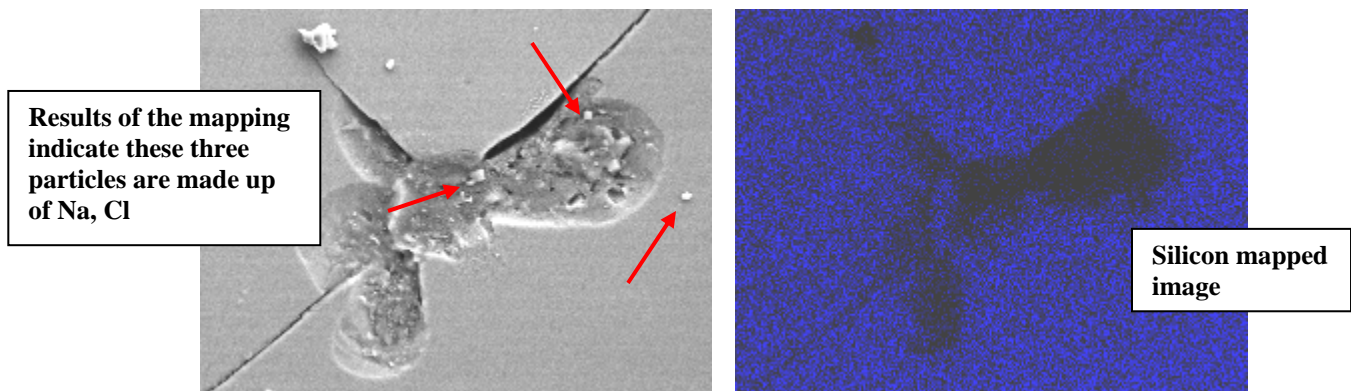
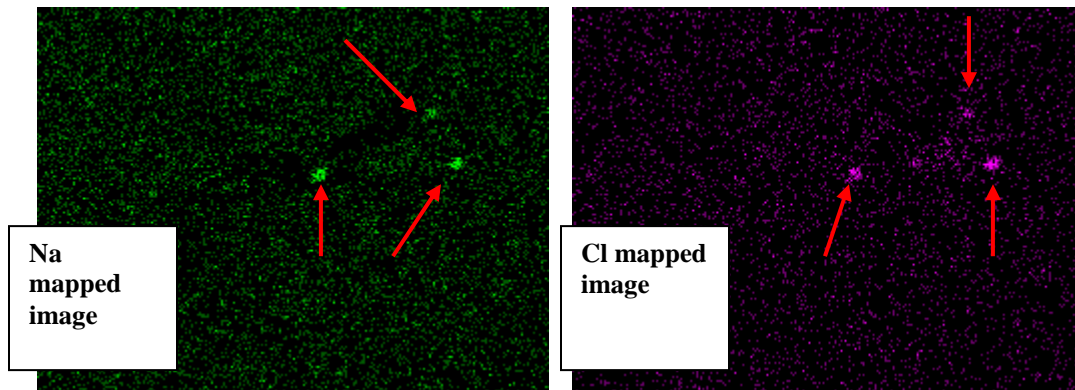
**Figure 7.1-6. Elemental Mapping of Si, Na and Cl**

The discovery of salt crystals in the glass was puzzling. To identify where the salt crystals are located on the end-face, elemental mapping was performed. Elemental mapping was not effective at 500X magnification to locate small traces of certain elements, so to locate Na and Cl, a higher magnification was used. Figure 7.1-6 shows the results when this sample was mapped for Si, Na, and Cl.

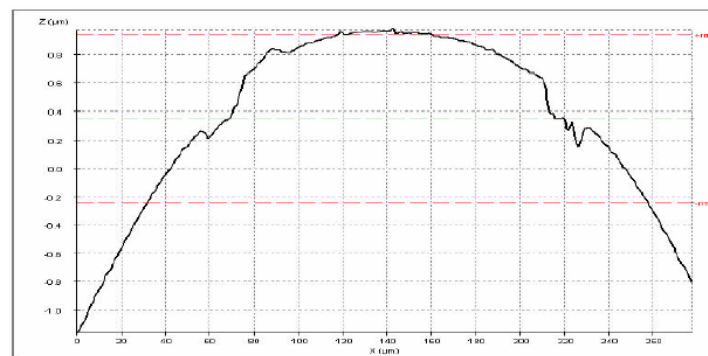
These termini are supposed to be manufactured with a slight concave end-face as observed in Figure 7.3-5. This is per the manufacturing procedure [ref. 4]. Since this particular sample has a convex end-face, the fiber more than likely contacted what it was mated to and was damaged.

The horizontal line appearing in the top chart of Figure 7.1-8 corresponds to the profile plot shown in colored image figure below the chart.

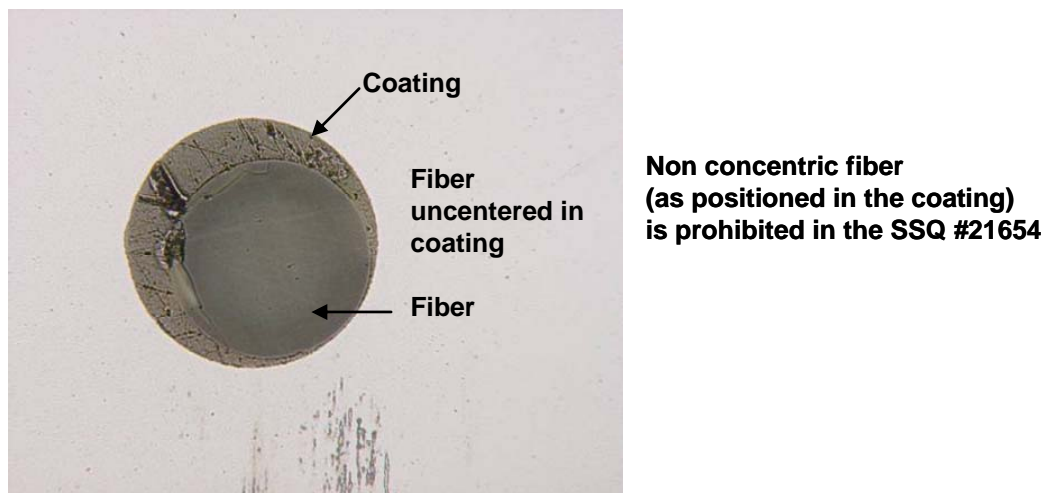
**Figure 7.2-2. Magnification of 200X Optical Image**

At 500X, a gouge in the coating has an interesting V-shaped pattern and is quite a deep cut. It was noted that the point of the V and the heavy damage at the origin of the break do not line up. The origin of the break suggests an impact fracture from the side. This fracture could easily have been caused by thermal-induced stresses from non uniform CTE distribution around the fiber

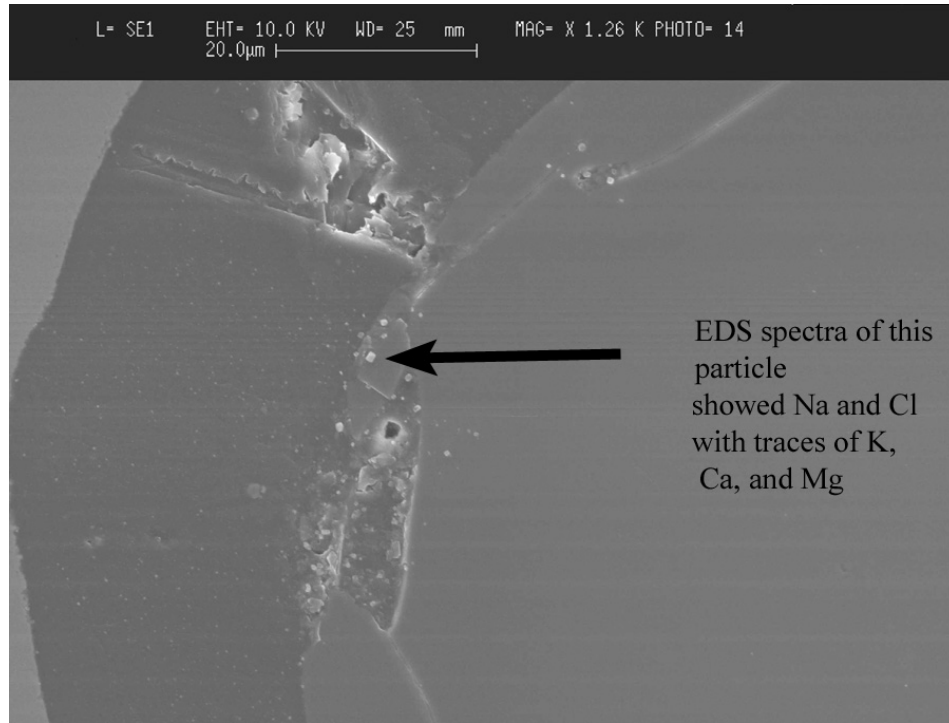
**Figure 7.2-4. Magnification of 1,260X SEM Image**

The SEM images were taken at  $1.26 \times 10^3$  and  $3.32 \times 10^3$  magnifications (Figure 7.2-4). At the higher magnification (Figure 7.2-5), there is similar corrosion as in HMU-302 P21-UP4 SKT A.

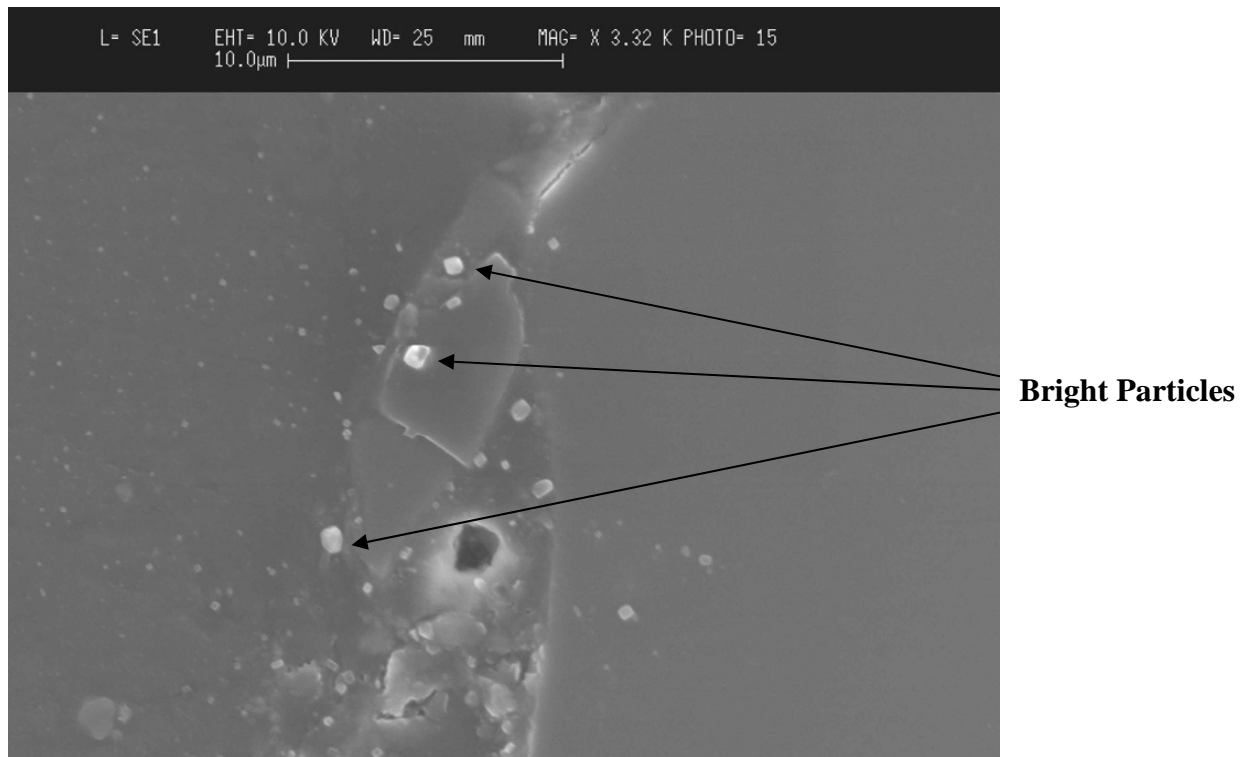
**Figure 7.2-5. Magnification of 3,320X SEM Image**

An EDS data analysis was performed on one of the “bright” particles and traces of oxygen, Na, magnesium, aluminum, Si, Cl, potassium, and calcium were found.

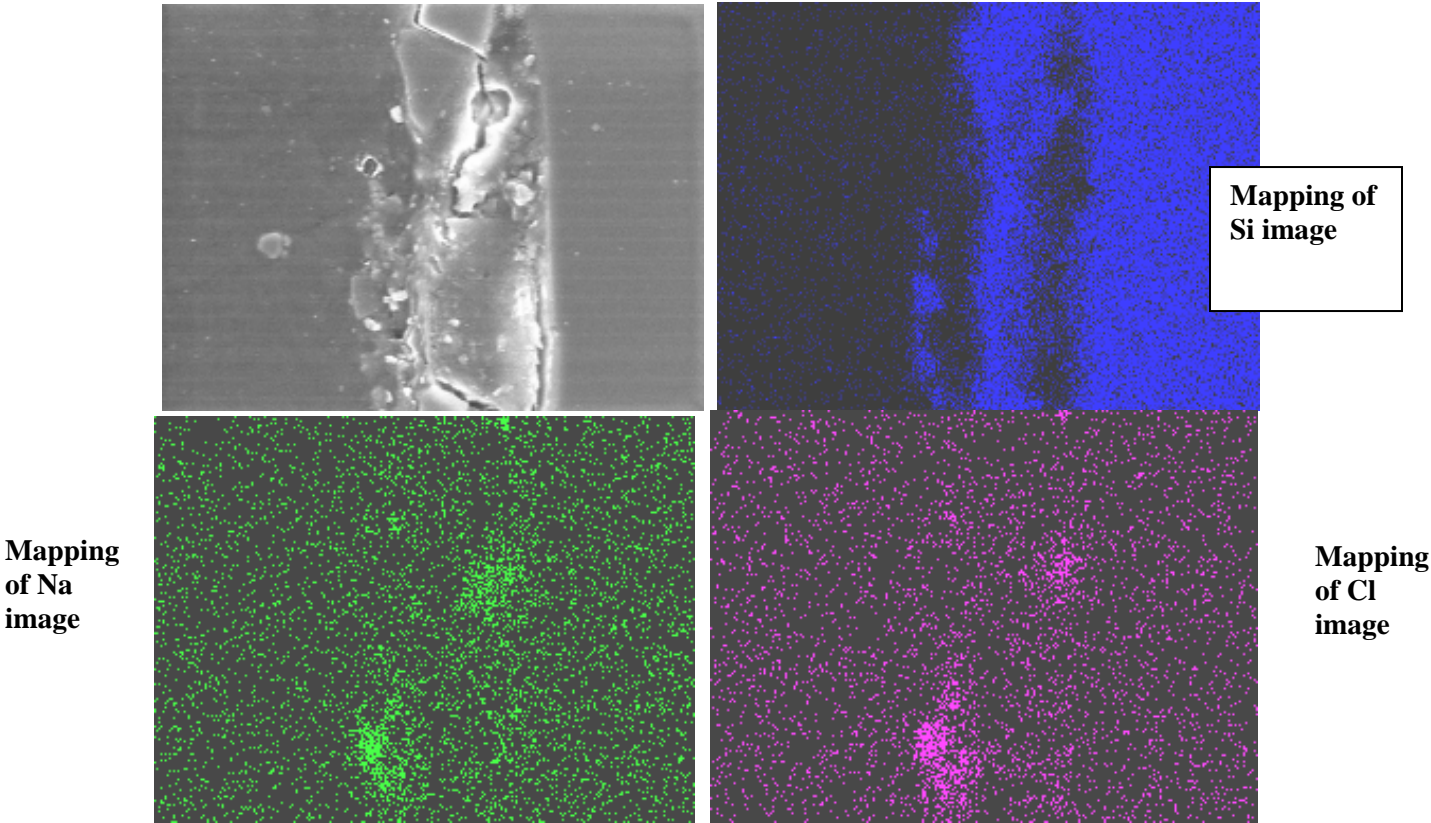
**Figure 7.2-7. Elemental Mapping of Corrosion**

Elemental mapping of the debris on this sample was performed very similar to the previous sample. At higher magnifications, traces of Na and Cl can clearly be identified. The bright areas of the images in Figure 7.2-5 are the elements that have been mapped. Refer to Figure 7.2-7.

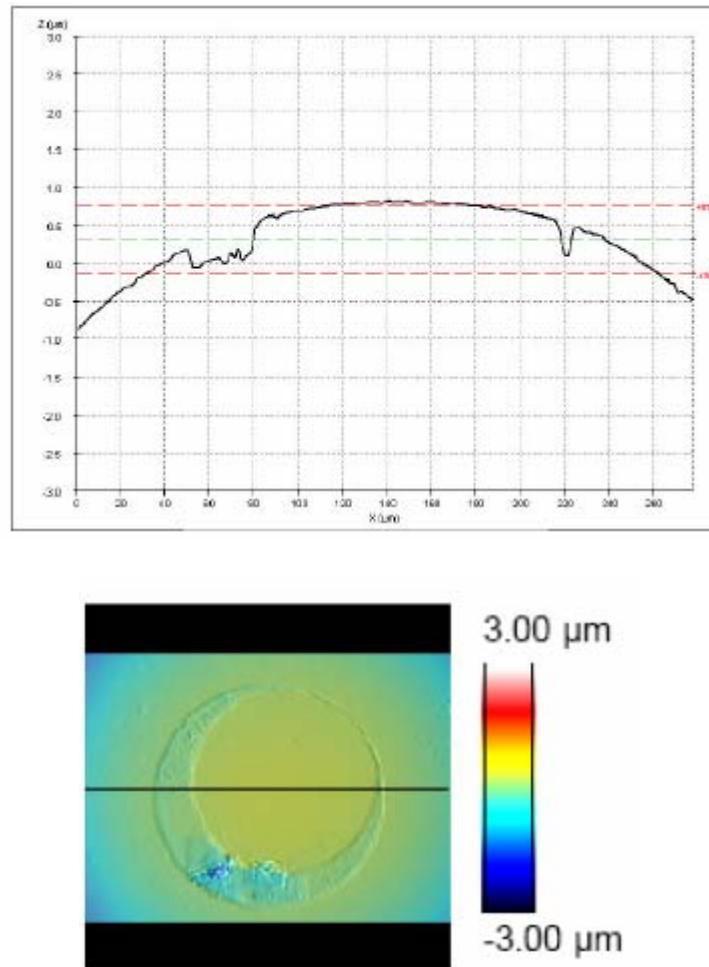
**Figure 7.2-8. Confocal Data**

Confocal microscopy data (Figure 7.2-8) indicates a convex profile of the end-face, which violates the specification. The radius of convex curvature is 9.0 mm.

The horizontal line appearing in the top chart of Figure 7.2-8 corresponds to the profile plot shown in colored image figure below the chart.

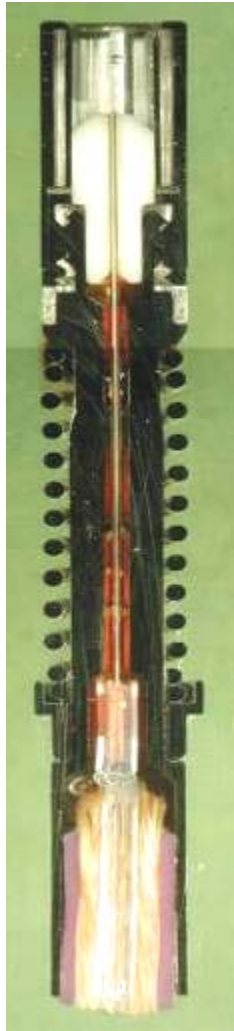
**Figure 7.3-2. Cross-Section View of the Optical Fiber Termini**

This sample was cross-sectioned to get a profile view of the fiber end, and identify features that have not yet been observed in other termini. There was some large metallic debris observed in Figure 7.3-2 that may have initiated the flaw.

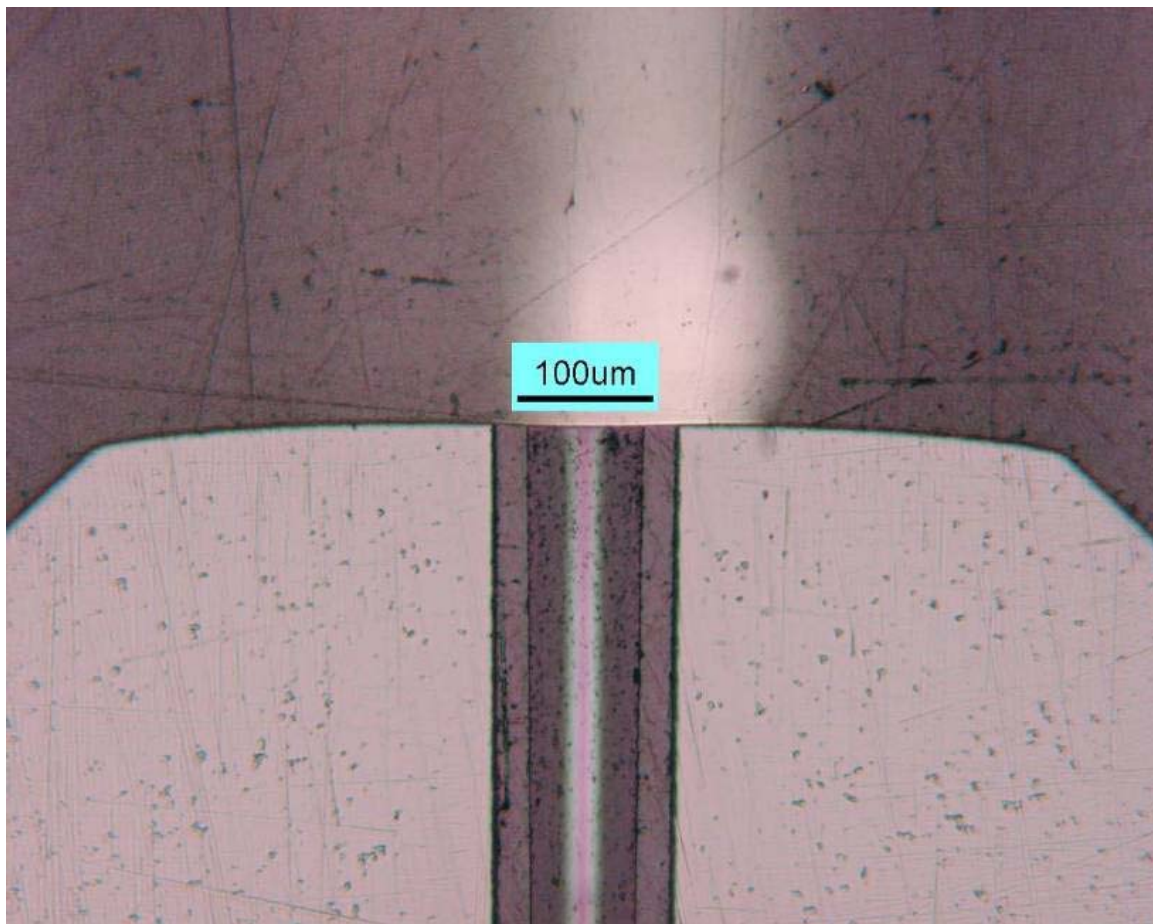
**Figure 7.3-4. Magnification of Cross-Section @ 100X**

The magnified images in Figures 7.3-4 and 7.3-5 indicate (without a doubt) that the end-face is concave. This is by design so the glass does not make physical contact to another terminus end-face when mated into the connector. Note that the crack has not propagated all the way to the edge of the fiber, leaving the fiber intact.

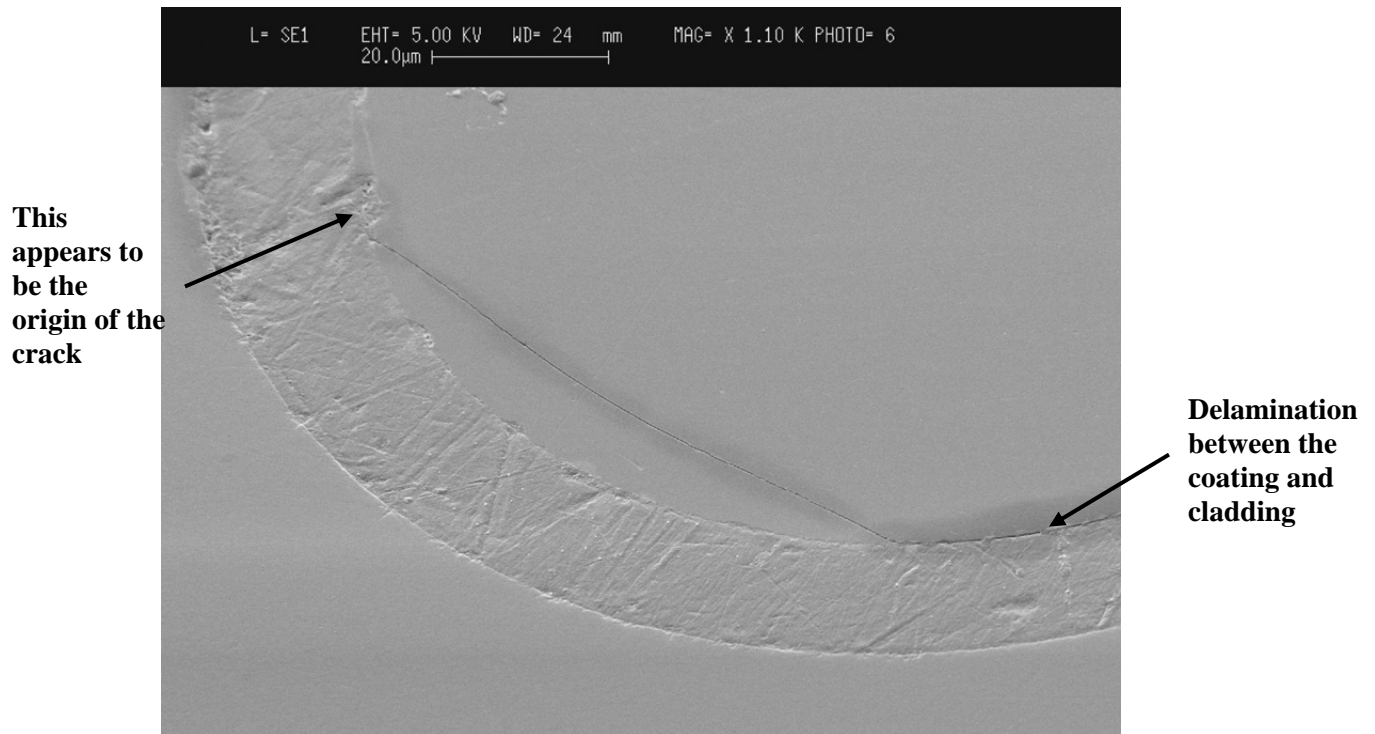
**Figure 7.4-3. Magnification of 1,100X SEM Image**

The SEM image taken at  $1.1 \times 10^3$  magnification (Figure 7.4-3) shows an area suspected of being the break origin, a crack propagating through the cladding, and delamination between the coating and glass where the crack ends. If this is in fact the origin, the crack could have propagated with the help of shrinkage of the epoxy.

1. The location of the suspected origin suggests the flaw started from the edge of the fiber. This likely was caused by an abrasive particle used to wipe the fiber.
2. The scratches observed in Figure 7.4-1 are fairly deep, and this terminus should have been polished with a finer grit lapping film to remove them.
3. Debris on the end-face suggests the cleanliness was not maintained.

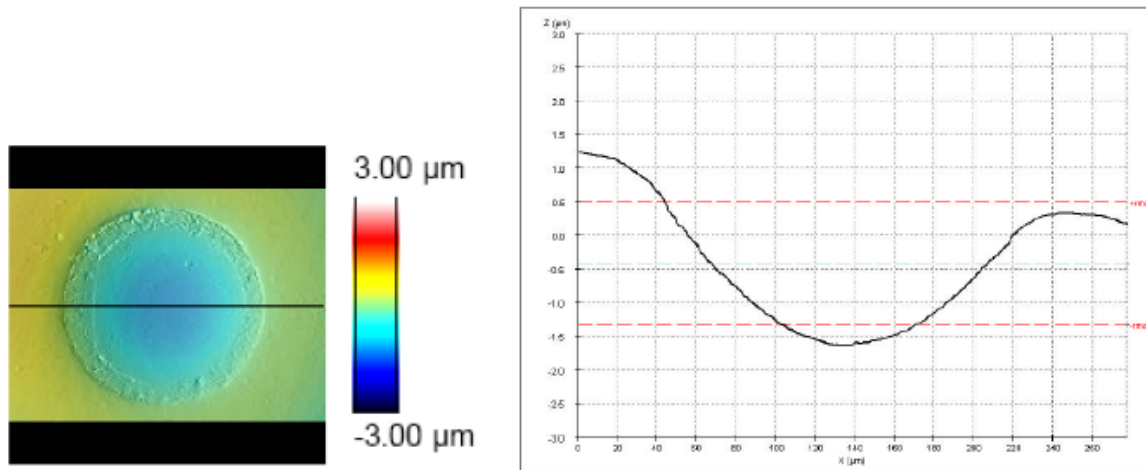
**Figure 7.4-6. Confocal Data**

The confocal microscopy data (Figure 7.4-6) indicates the end-face has a concave profile. This conforms to the manufacturing procedure [ref. 3]. The radius of curvature measures 2.0 mm.

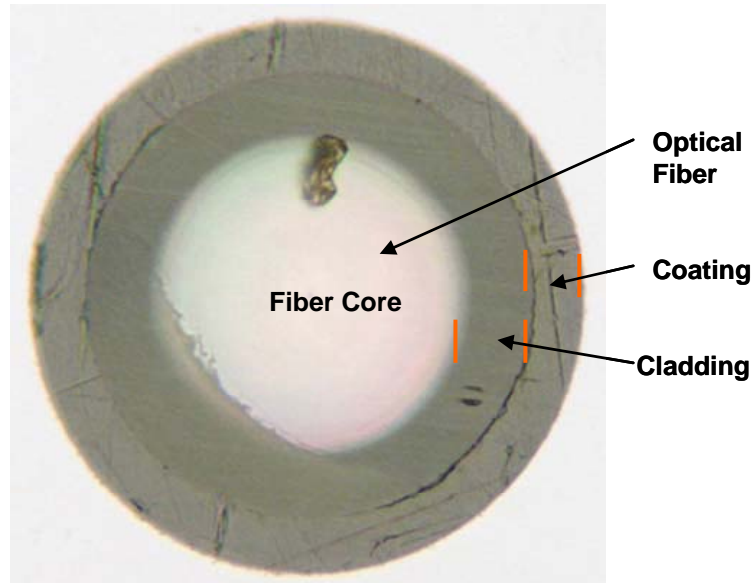
**Figure 7.5-2. Magnification of 200X Optical Image**

At 200X magnification (Figure 7.5-2), deep scratches and a crack in the core can be seen (Figure 7.5-3).

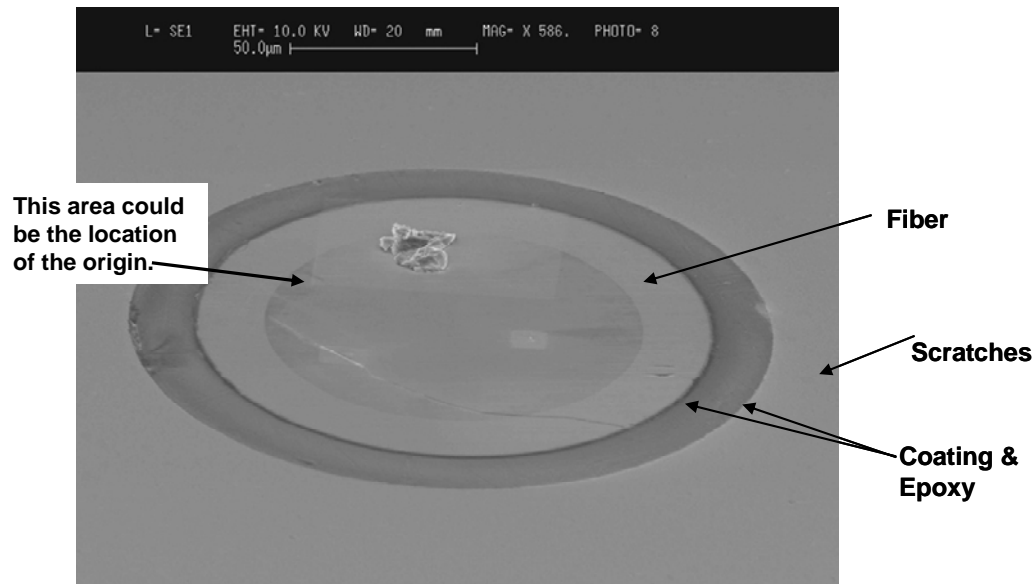
**Figure 7.5-4. Magnification of 586X SEM Image**

The SEM image taken at 586X magnification (Figure 7.5-4) identified two small scratches in the cladding area that appeared to be debris under the microscope. Connecting the termination when debris was present was likely the cause.

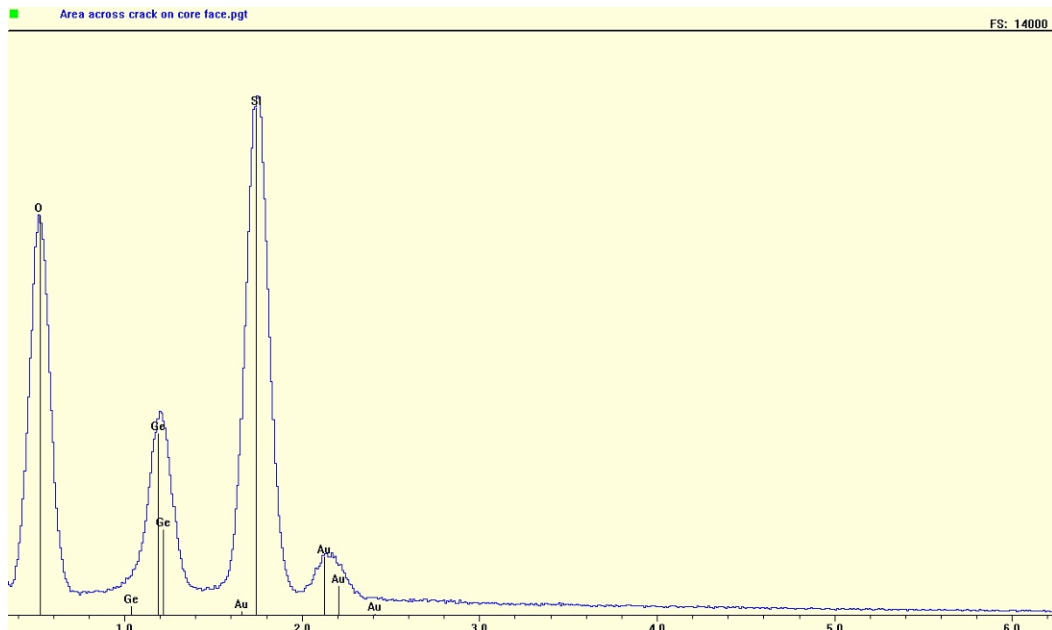
**Figure 7.5-6. EDS of Crack Area**

An EDS data analysis (Figures 7.5-6 through 7.5-9) was performed on several areas of the sample.

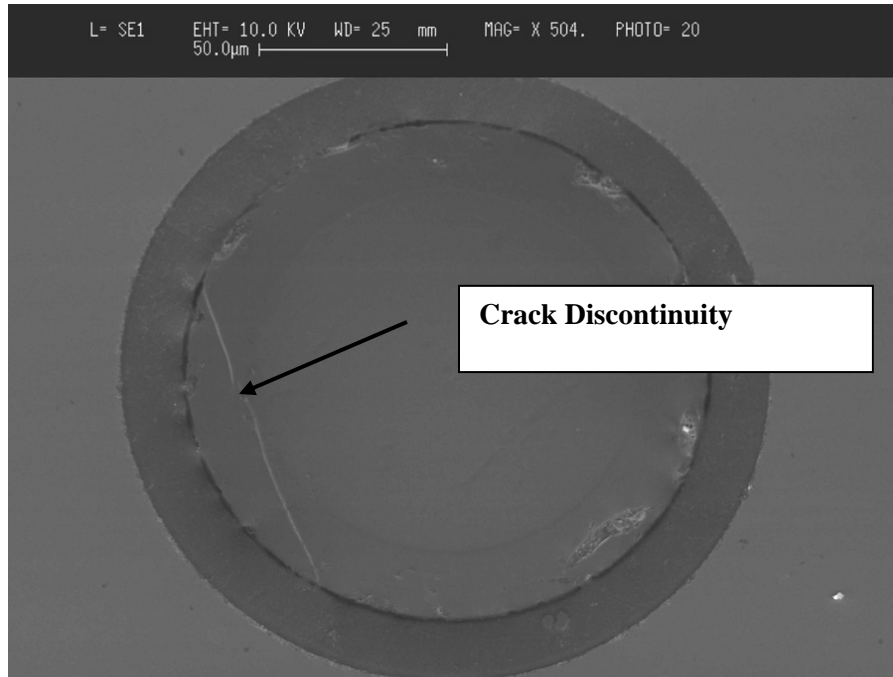
**Figure 7.6-2. Magnification of 504X SEM Image**

This SEM image at 504X (Figure 7.6-2) shows a feature in the crack that may suggest two separate cracks. There appears to be a discontinuity.

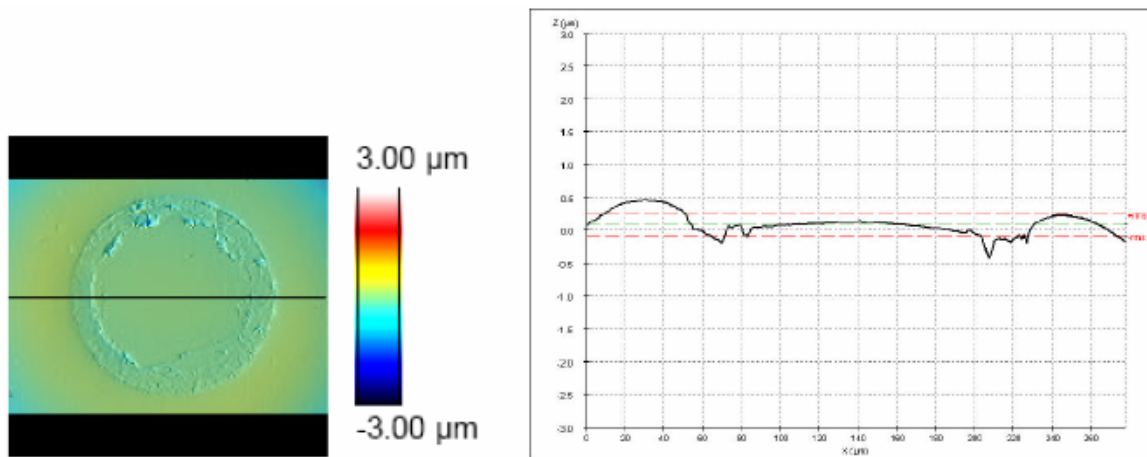
**Figure 7.6-7. Confocal Data**

Confocal microscopy was performed and indicated the fiber end-face is convex (Figure 7.6-7). The radius of curvature is 13.5 mm.

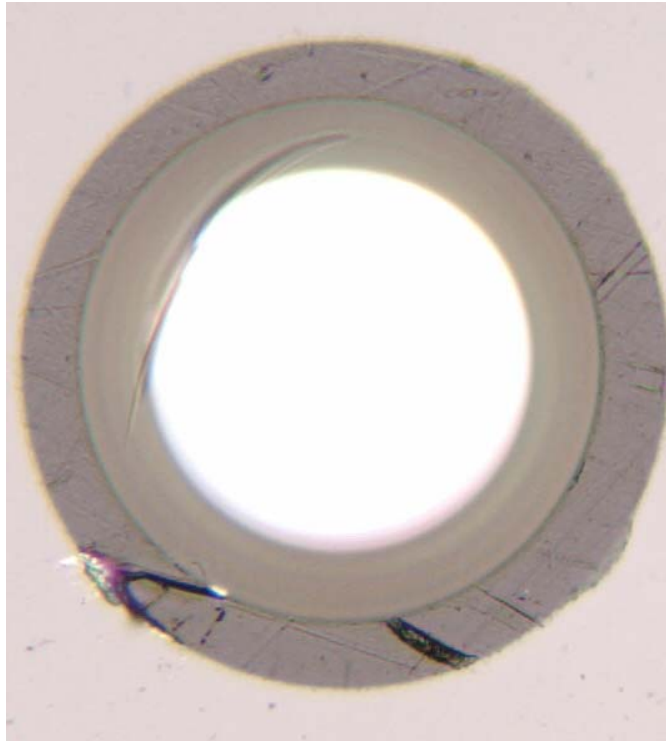
**Figure 7.7-2. Bright Field Image @ Magnification of 200X**

These termini are inserted into a sleeve when mated. The signature of the scratch might indicate the end-face was not clean when the connection was made.

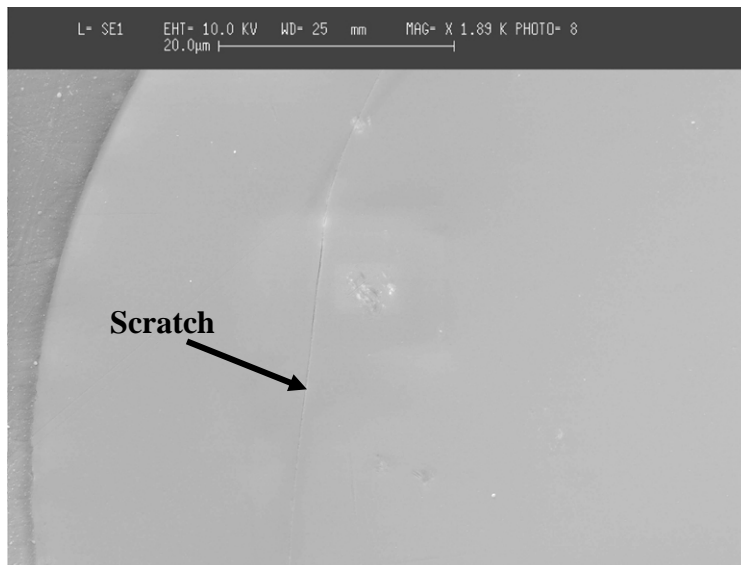
**Figure 7.7-4. Scratch at Magnification of  $1.89 \times 10^3 \times$**

Under SEM, the surface scratch is not quite as visible at  $1.89 \times 10^3 \times$  magnification (Figure 7.7-4), but at  $3.63 \times 10^4 \times$  magnification, the indentation from the scratch is very visible (Figure 7.7-5).

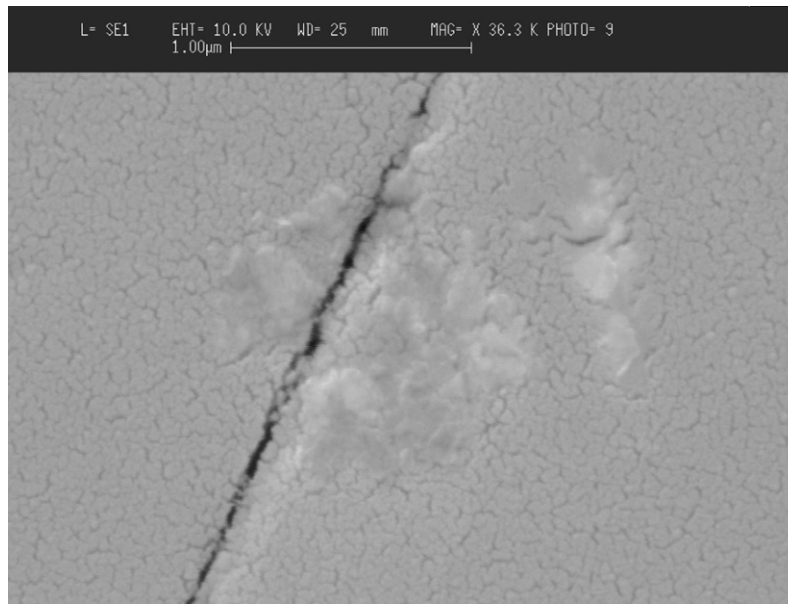
**Figure 7.7-5. Scratch at Magnification of  $3.63 \times 10^4 \times$**

1. Although the termination appeared fairly clean, the curvature in the scratch could suggest that the end-face was wiped with an abrasive material or perhaps the other mating termini had debris that scratched the end-face of the termini as it was mated into a connector.
2. The crack could have originated by coarse grit lapping film.
3. The geometry of the larger abrasions (non-linear) in the coating suggests the damage did not occur during polishing as a result of debris during polishing.

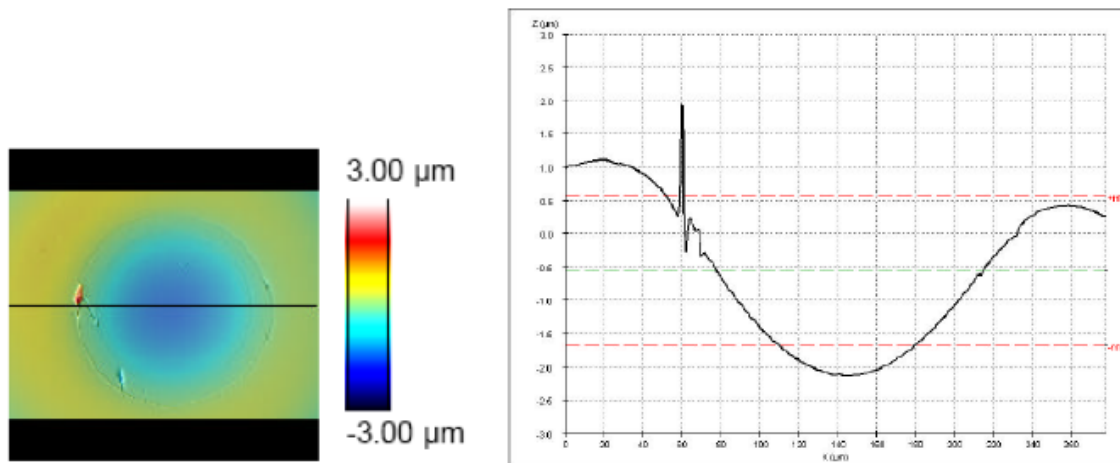
**Figure 7.7-6. Confocal Data**

Confocal microscopy (Figure 7.7-6) indicates the end-face is concave per requirements of the manufacturing procedure [ref. 3]. The radius of curvature is 1.4 mm.

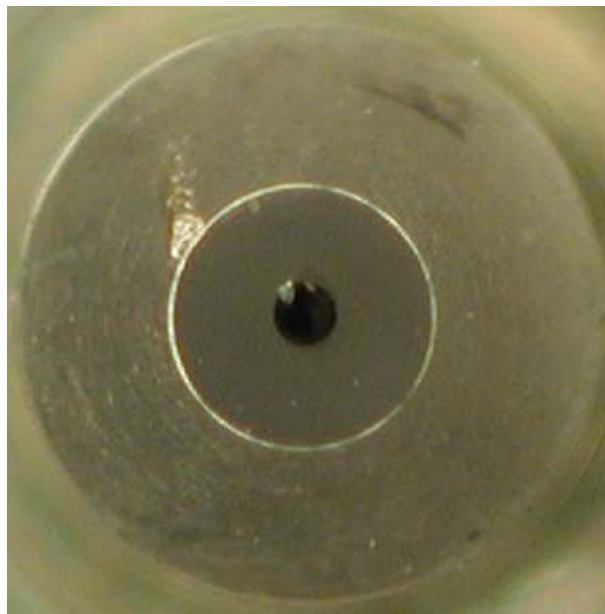
**Figure 7.8-1. Optical Image at Magnification of 10X**

At 10X magnification (Figure 7.8-1), it is very difficult to identify any possible defects in the fiber. Some debris is present over the fiber area and would appear to only need a cleaning.

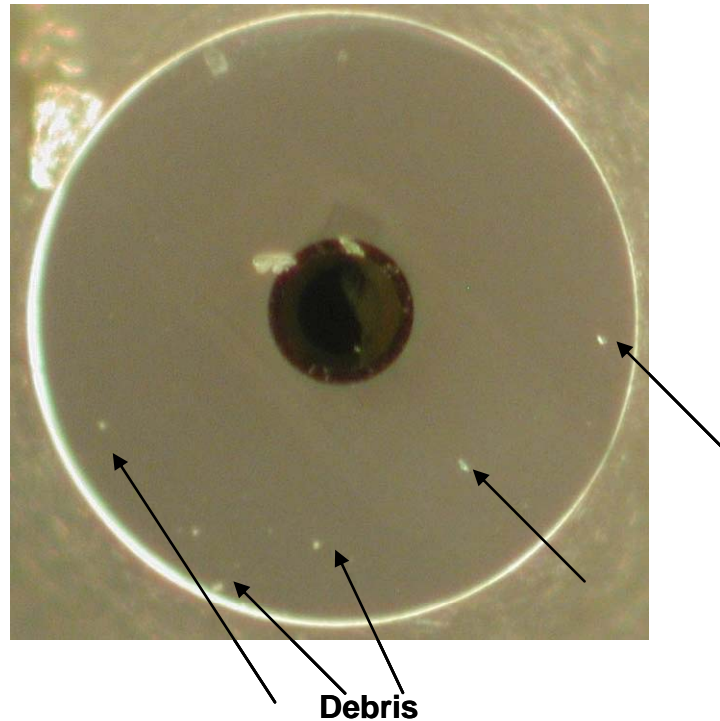
**Figure 7.8-2. Optical Image at Magnification of 40X**

At 40X magnification (Figure 7.8-2), debris can be seen in several areas in and around the fiber. There also appears to be a smudge over the core. When a defect cannot be removed by means of cleaning, it must be observed at higher magnifications.

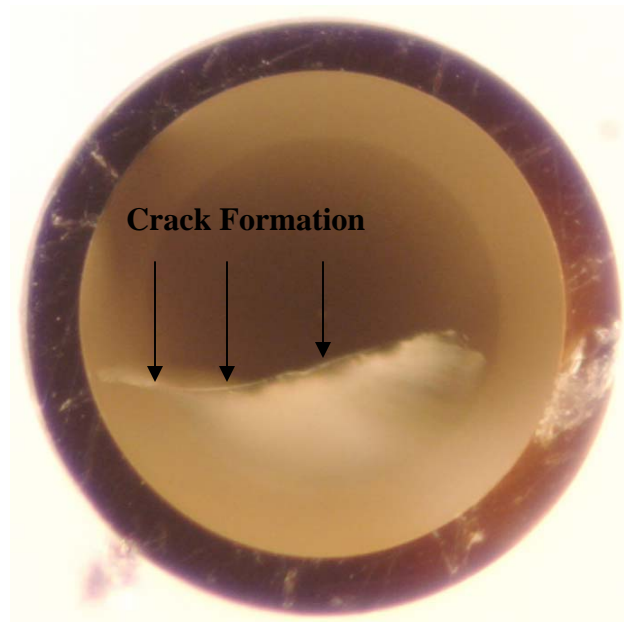
**Figure 7.8-3. Dark Field Image at Magnification of 200X**

At 200X magnification (Figure 7.8-3), a crack formation can be seen, and the “smudge” appears to be sub-surface cracking. Optical microscopy is not enough to identify an origin of the crack, so SEM will need to be performed.

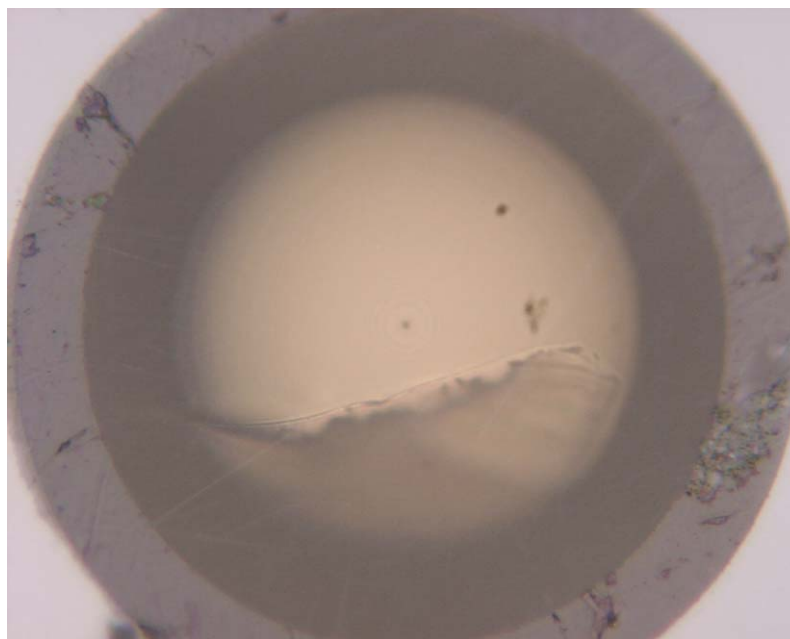
**Figure 7.8-4. Bright Field Image at Magnification of 500X**

With an adjustment of the lighting, features on the surface become clearer.

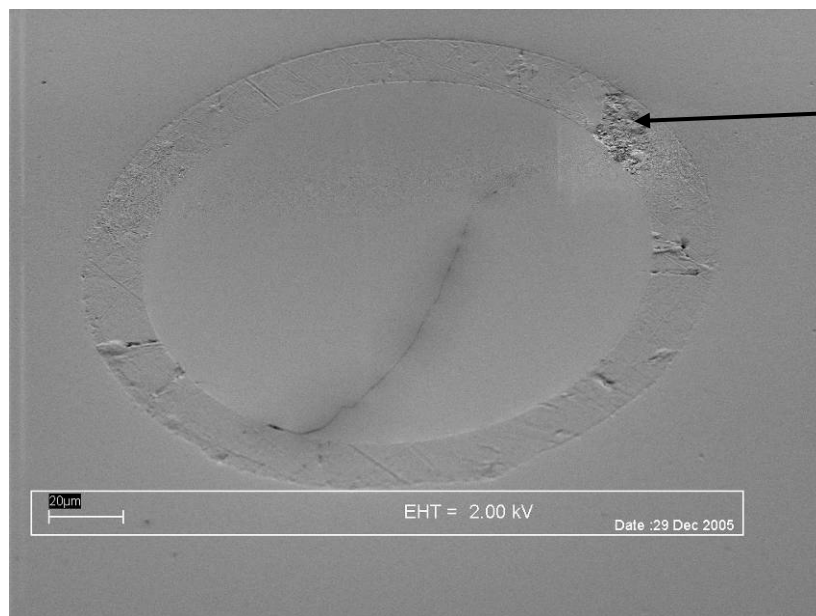
**Figure 7.8-6. Clear View of Crack**

SEM was performed (Figure 7.8-6), which enabled the crack to be clearly observed.

1. The origin of the crack does not appear to be on either end, so it may have originated in the middle.
2. The cleanliness of the termination was not maintained.
3. Deep scratches indicate an improper polishing procedure was conducted.

Crack propagation occurred due to the deep scratches. The scratches are linear, which is an indication the fiber was wiped with an abrasive material, or remnants of the coarse lapping film were not removed during the final stages of polishing.

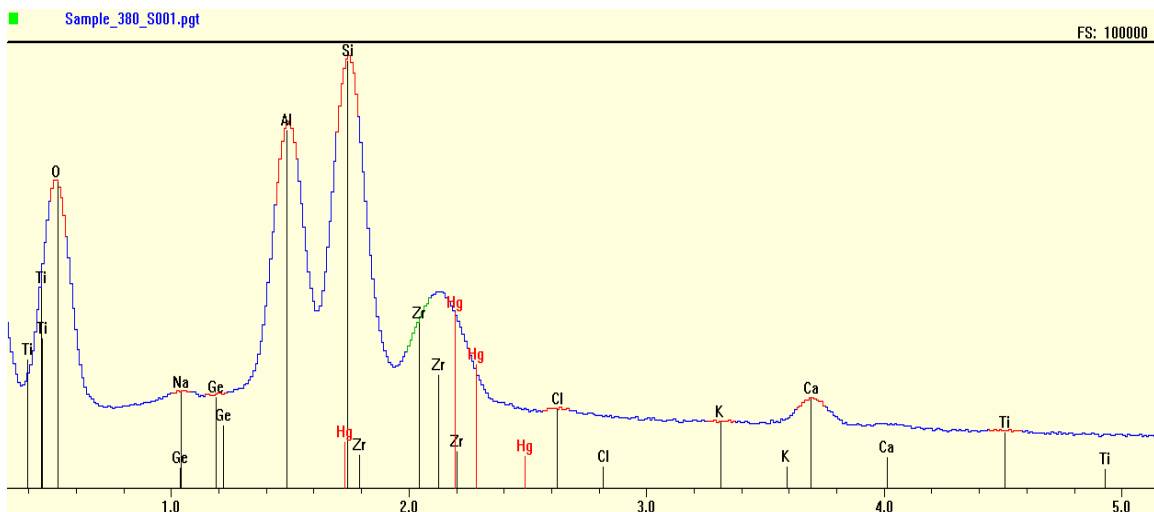
**Figure 7.8-8. EDS Data**

An EDS data analysis (Figure 7.8-8) of the corrosive area indicates the presence of Na and Cl.

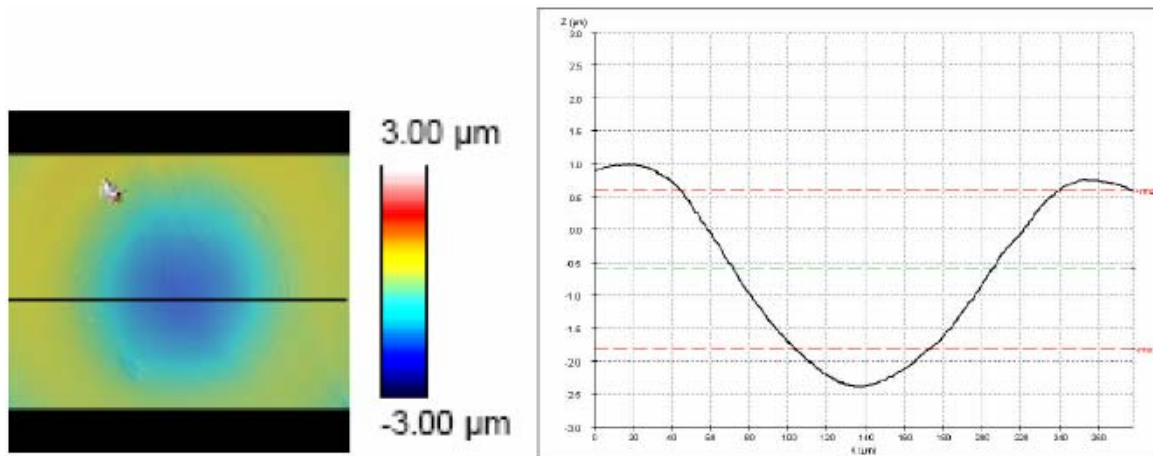
**Figure 7.8-9. Confocal Data**

Confocal microscopy (Figure 7.8-9) indicates the end-face of the fiber is concave. The radius of curvature is 1.3 mm.

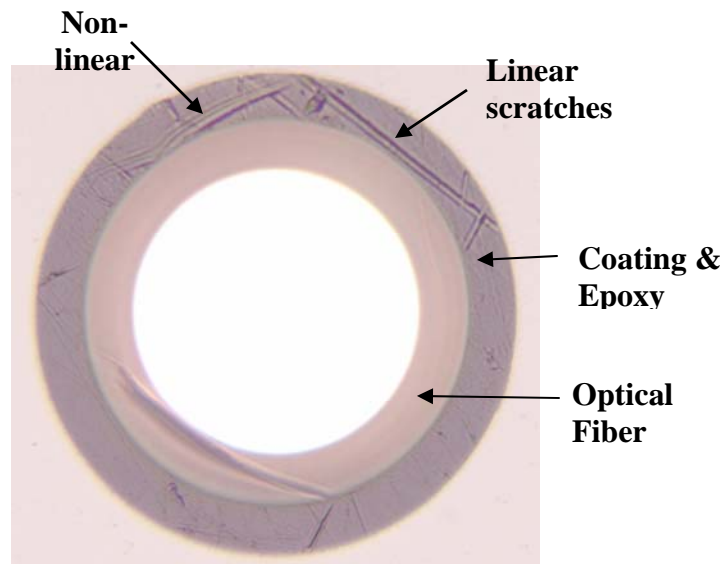
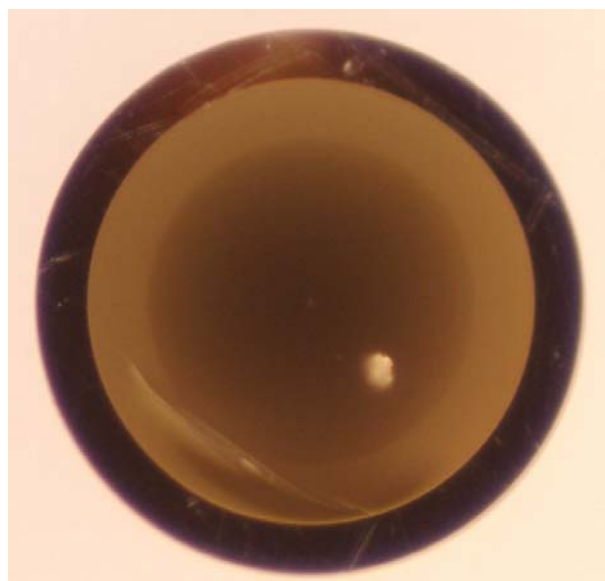
This sample has damage very similar to HMU-303 P3-DAIU SKT C, whereas it appears to have been connected with debris present on the end-face. The scratches in the coating are evidence of a foreign substance being dragged or scraped in a non-linear direction. There is some unidentified debris in the core region that will need to be analyzed with EDS.

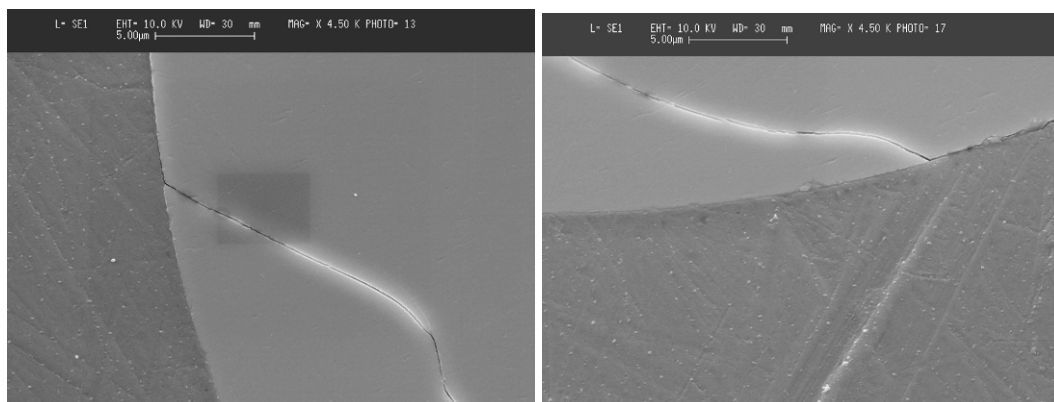
**Figure 7.9-4. Crack Ends**

SEM shows a clearer picture of the damage (Figure 7.9-3), and what was thought to be a surface scratch becomes a crack in the end-face. There is no obvious origin of the crack. The crack ends at the coating in two locations, and the process of de-lamination occurs (Figure 7.9-4).

1. The origin of the crack does not appear to be on either end, so it may have originated in the middle.
2. The formation of the scratches in the glass and coating may suggest it was mated with debris present.
3. The cleanliness of the termination was not maintained.

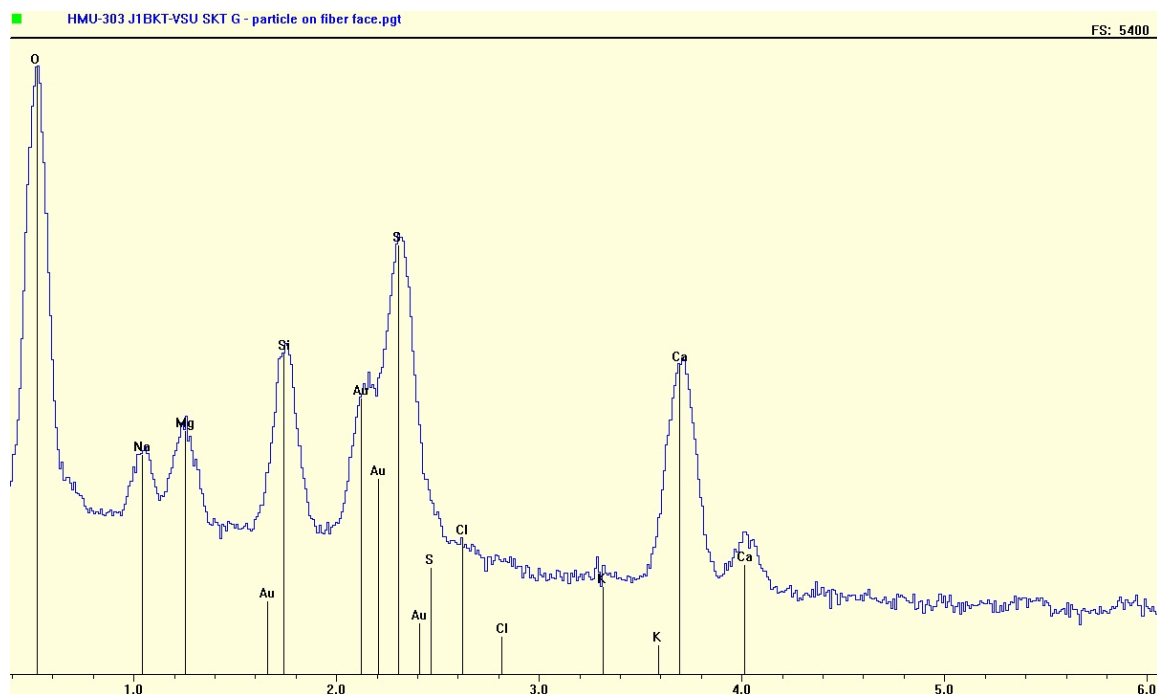
**Figure 7.9-5. EDS Data of End-Face**

No areas of visible corrosion were discovered, but EDS does indicate the presence of Na and Cl (Figure 7.9-5). Figure 7.9-6 shows a comparison of this EDS data to an area free of debris.
