**Failure Analysis Study and Long-Term Reliability of Optical  
Assemblies with End-Face Damage  
Technical Assessment Report**

***Phase I: International Space Station (ISS) Termini Root Cause  
Analysis Report***

**August 3, 2006**

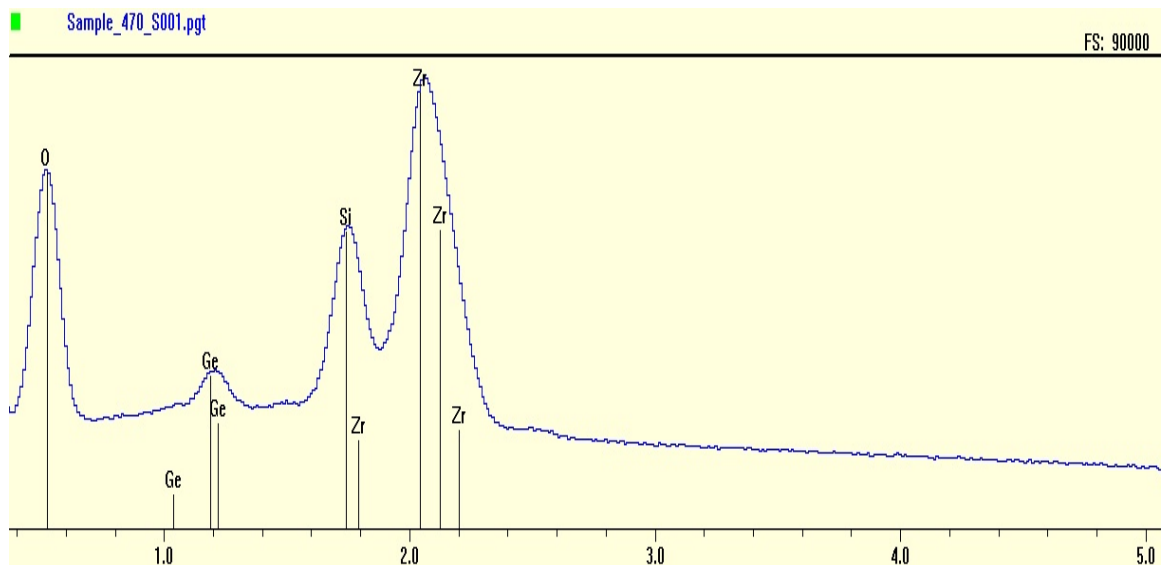
**Figure 7.9-6. EDS Data of Uncontaminated Area**

No areas of visible corrosion were discovered, but EDS does indicate the presence of Na and Cl (Figure 7.9-5). Figure 7.9-6 shows a comparison of this EDS data to an area free of debris.

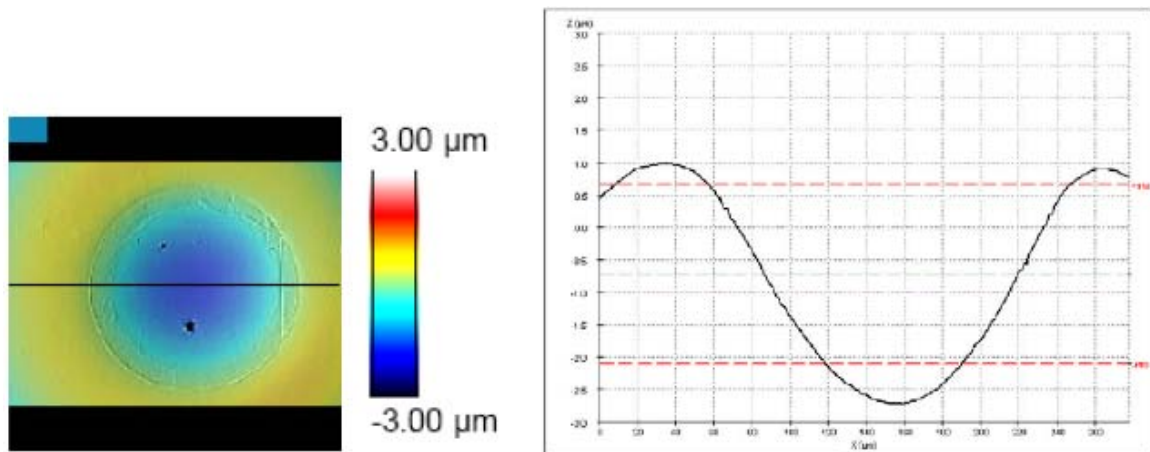
**Figure 7.9-7. Confocal Data**

Confocal data (Figure 7.9-7) indicates the end-face has a concave profile, with a radius of 1.1 mm.

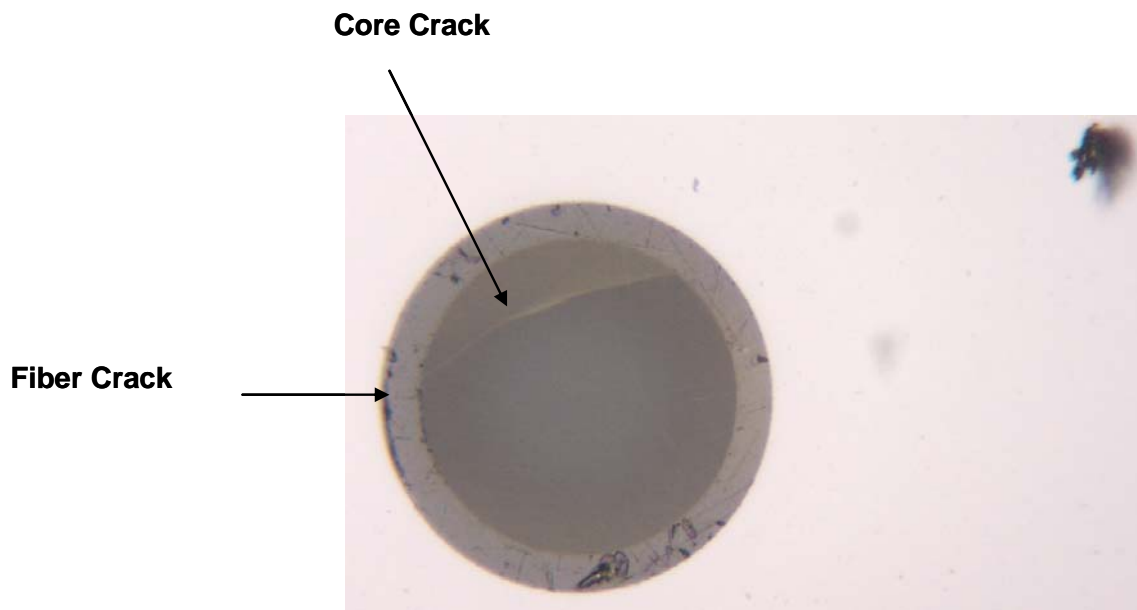
**Figure 7.10-1. Bright Field Image**

This termination is cracked partially through the core and deep into the fiber (Figure 7.10-1). There is some debris present on the ferrule end, and some damage/debris on the bottom of the coating.

1. The origin of the crack does not appear to be on either end, so it may have originated in the middle, suggesting the fiber is possibly convex.
2. The cleanliness of the termination was not maintained.

This sample was unsuccessfully cross-sectioned when attempting to determine the profile geometry. The root cause of the damage could not be identified.

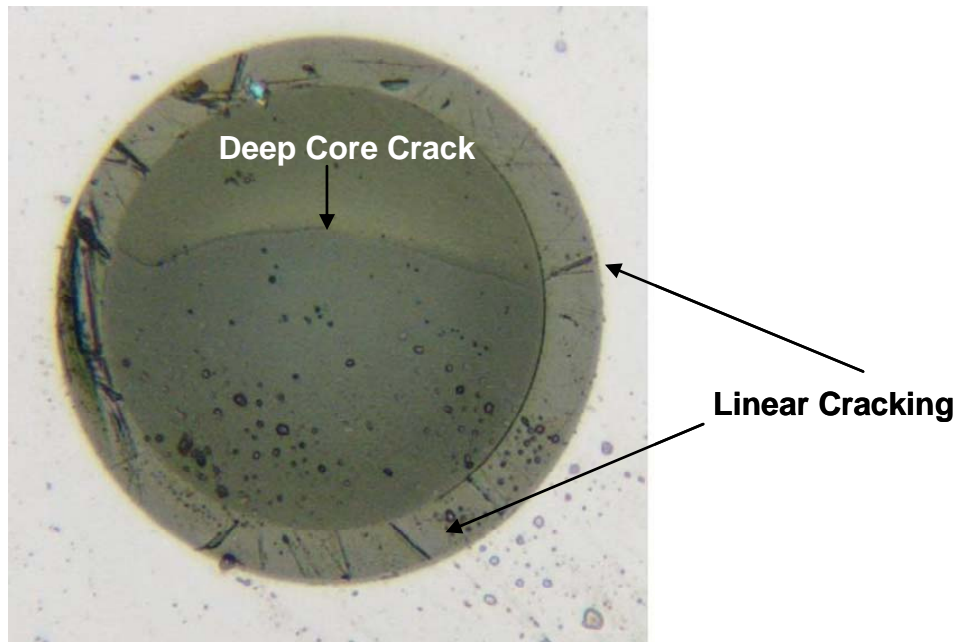
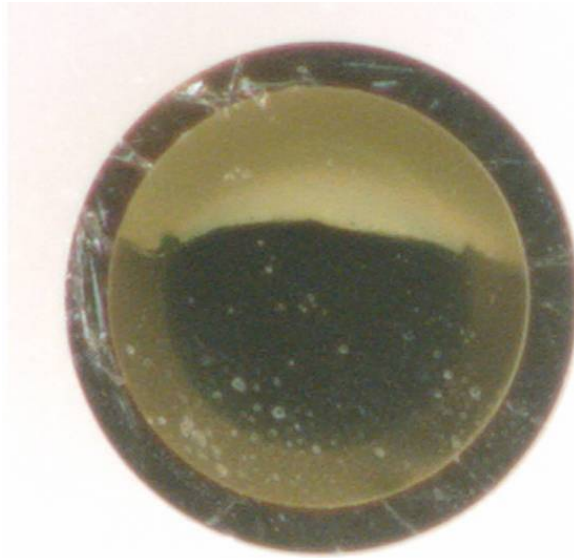
Some of the initial observations made at 200X magnification, and shown in Figures 7.11-1 and 7.11-2, were:

1. There was a deep crack through the core.
2. There were deep scratches in the coating, which appear linear.

1. The deep scratches in the fiber coating are indication the glass could have been damaged during the polishing or cleaning process.
2. The cleanliness of the termination was not maintained.

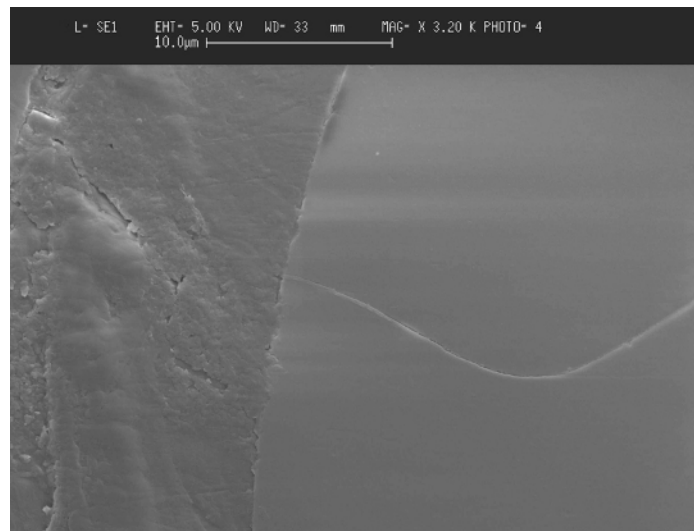
**Figure 7.11-3. Magnification of 3.2 KX**

The ends of the crack can be clearly analyzed under  $3.2 \times 10^3$  and  $2.8 \times 10^3$  X magnifications (Figure 7.11-3), but no definitive origin was identified.

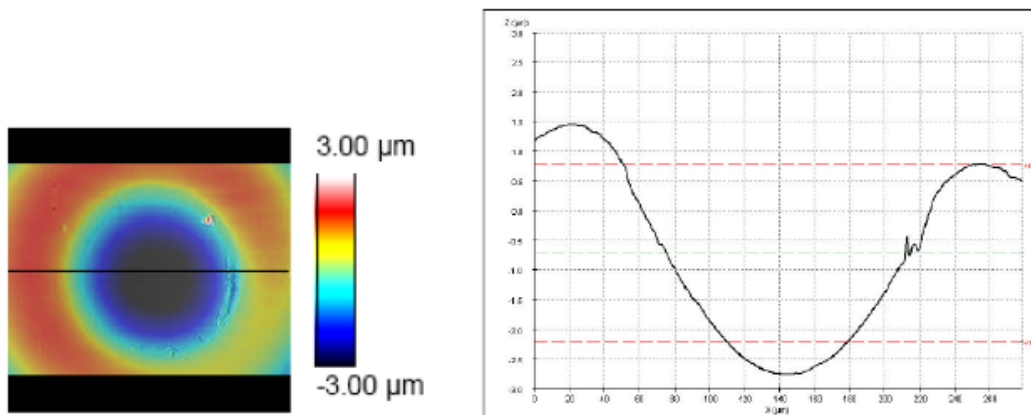
**Figure 7.11-5. Profile of End-Face**

Confocal data (Figure 7.11-5) indicates the end-face has a concave profile, with a radius of 1.2 mm.

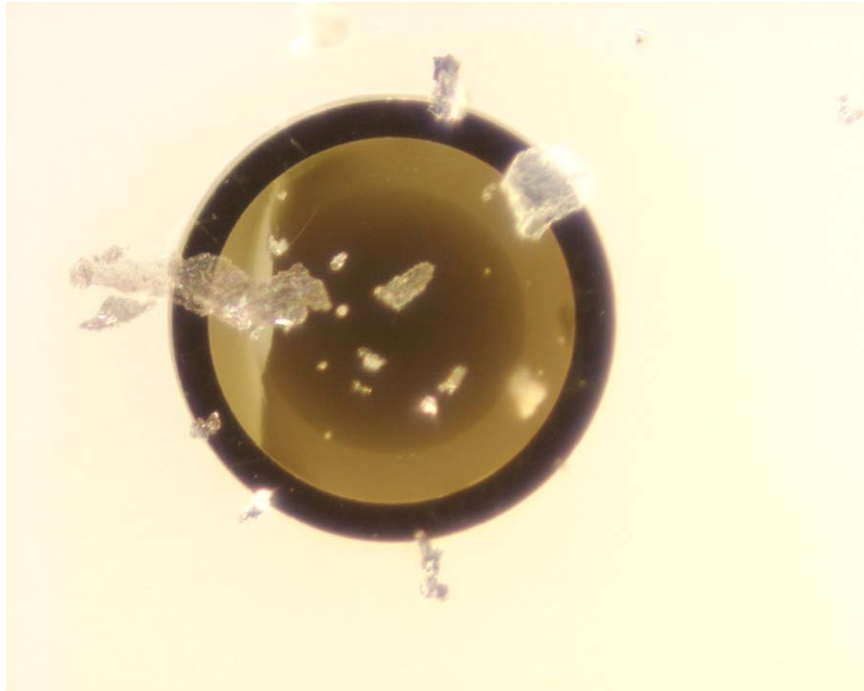
**Figure 7.12-2. Magnification of 200X Bright Field Illumination**

The crack can easily be observed at a 200X magnification (Figure 7.12-2) and with dark field illumination.

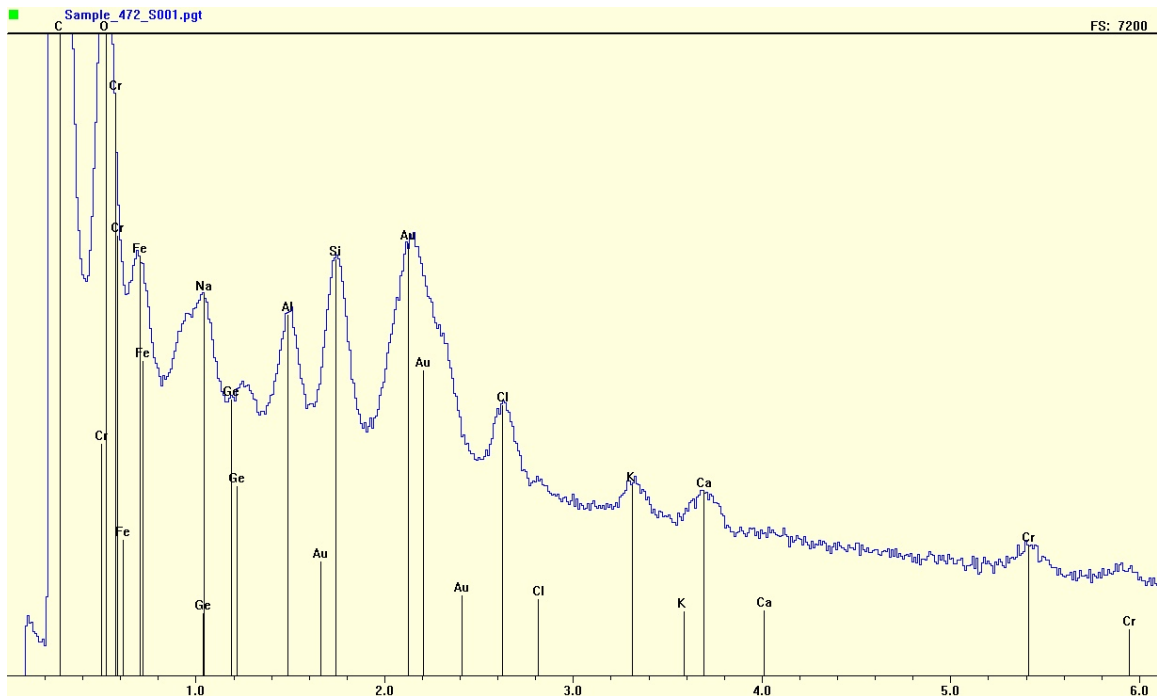
**Figure 7.12-3. EDS Data of Debris on End-Face**

An EDS data analysis (Figure 7.12-3) of the end-face identifies many foreign elements that make up the debris.

1. The end-face has considerable debris which suggests the glass was damaged due to improper cleaning techniques. Mating unclean connectors can cause damage to fiber optic end-faces.
2. The confocal data suggests the convex fiber end-face extends beyond the ferrule.

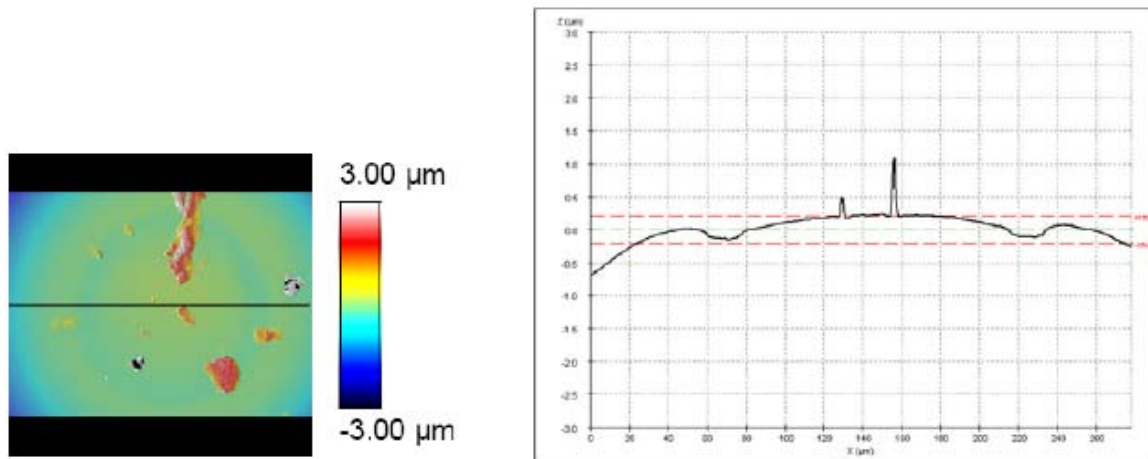
**Figure 7.12-4. End-Face Profile**

Confocal data (Figure 7.12-4) suggests the end-face has a slight convex profile. However slight it may be, the fiber still extends beyond the ferrule. The radius of curvature measured 8.7 mm. It is important to note the height of the contamination showed in Figure 7.12-4. The large spike in the center of the graph shows the particles height at that location as being well above the surface of the optical fiber terminus. When this terminus is mated to another terminus in close proximity that particle will undoubtedly make contact with both surfaces as it is compressed between the two interfaces. This impact can cause damage to both optical fibers being mated together.

The cleanliness of the fiber was not maintained which would have caused damage to the fiber when mated.

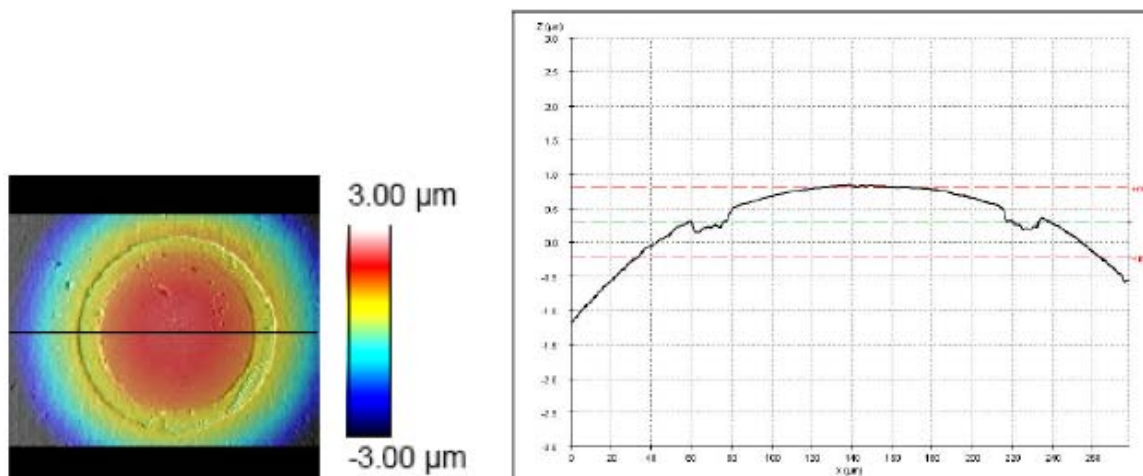
**Figure 7.13-3. Confocal Data**

Confocal microscopy data (Figure 7.13-3) identifies the profile of the end-face to be convex, with a radius of curvature measuring 7.4 mm.
